RE: **MEMBER** **City of Cape Coral**
CLAIM NUMBER: **GC2022106844**
DATE OF LOSS: **09/28/2022**
LOCATION # - DESCRIPTION: **048024 - Yacht Club House Building**
ORIGINAL P&C DEDUCTIBLE: **\$25,000.00**

Report Number	:	FIRST AND FINAL
Named Insured / Member	:	CITY OF CAPE CORAL
FMIT Number	:	0074
FLC Claim Number	:	GC2022106844
Date of Loss	:	9/28/2022
Loss Location	:	048024 - Yacht Club House Building 5819 Driftwood Parkway Cape Coral, FL, 33904
Description of Loss	:	Hurricane
Sedgwick File Number	:	TMP22110700

We inspected this loss with the insured on 10/27/2022. The scope of damages includes wind damage to the metal roof fascia, and roof edge on the main Yacht Club House. The main roof had tarping in place from a previous wind event and the tarping needs re-installation in some places due to Hurricane Ian. There is also wind damage to wood fence that surrounds the Air Conditioner outside back left of the main building. There is also damage on gutters on the attached Locker room building which is directly behind the main building from a tree falling on the roof edge.

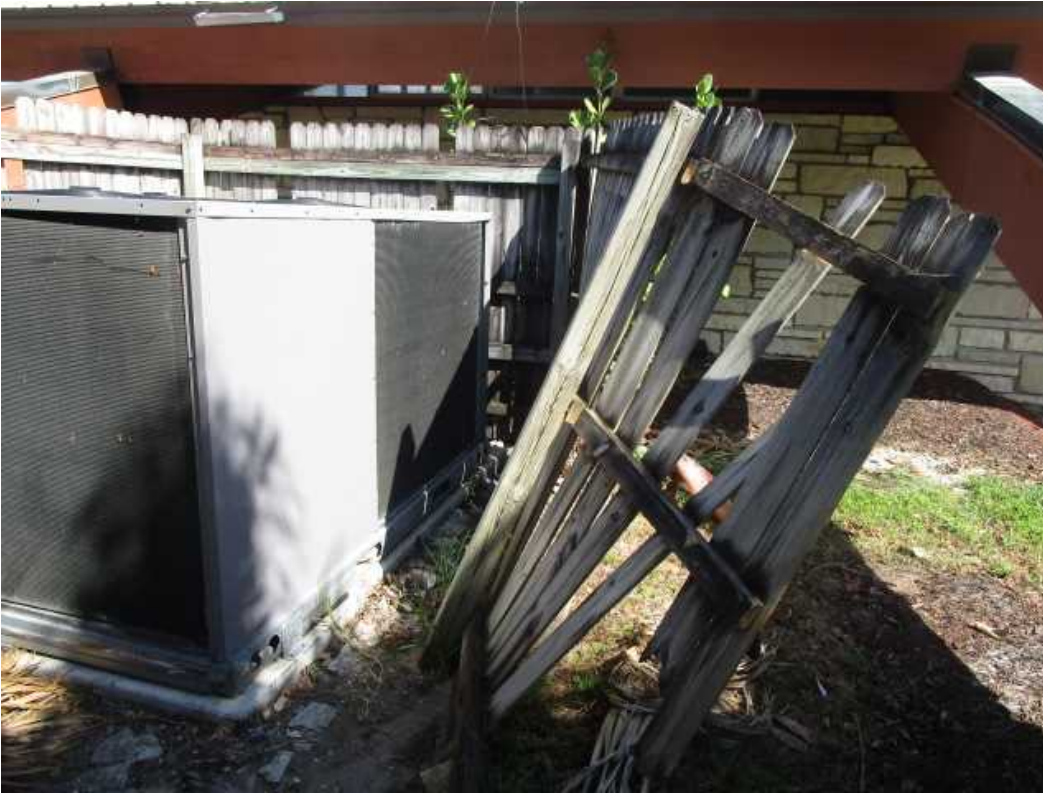
7

Back left side Fence around A/C blown down

DESCRIPTION	QUANTITY	UNIT PRICE	TAX	O&P	RCV	DEPREC.	ACV
6. R&R Wood fence slat 5' - 6' high - treated Fence around A/C back left attached	40.00 EA	7.52	0.00	60.16	360.96	(222.00)	138.96
Totals: Exterior			0.00	60.16	360.96	222.00	138.96

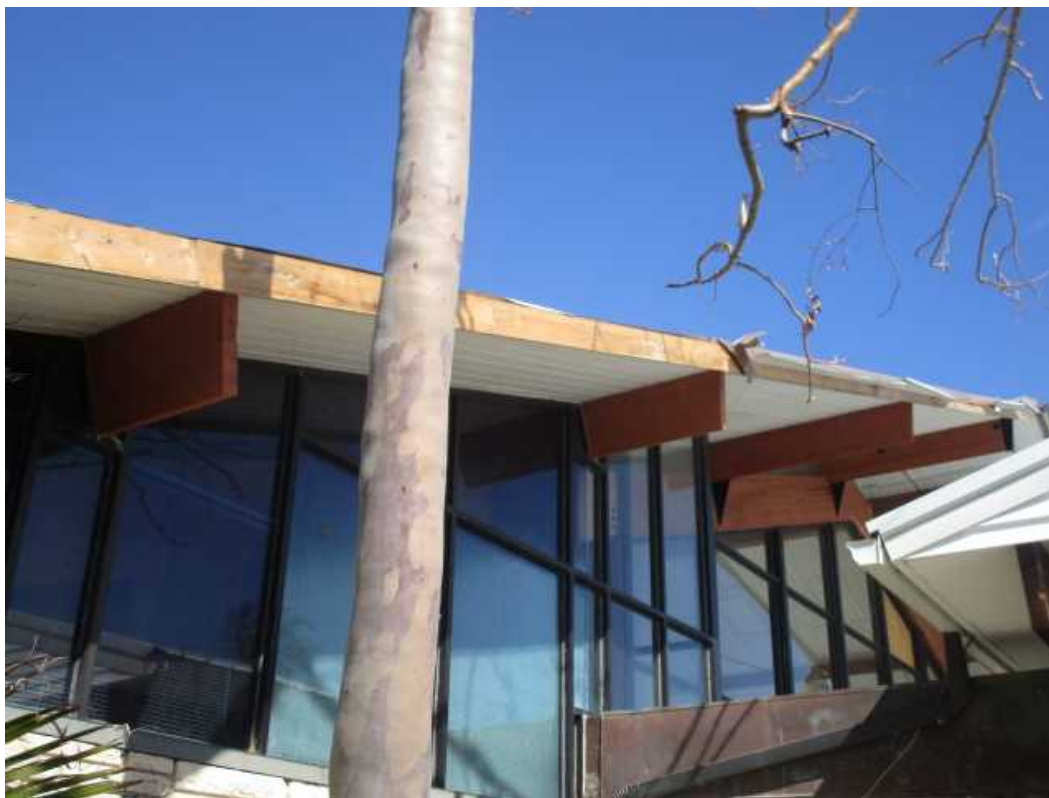
9

Fascia damage at front roof edge

DESCRIPTION	QUANTITY	UNIT PRICE	TAX	O&P	RCV	DEPREC.	ACV
1. R&R Fascia - metal - 8"	120.00 LF	6.65	0.00	159.60	957.60	(221.04)	736.56
Front roof edge							
2. R&R Tarp - all-purpose poly - per sq ft (labor and material)	2,880.00 SF	1.56	0.00	898.56	5,391.36	(0.00)	5,391.36
Re-install existing tarp							
3. Roofing Repair - Minimum Charge - Labor and Material	1.00 EA	851.72	0.00	170.34	1,022.06	(0.00)	1,022.06
front roof edge							
4. Roofing - General Laborer - per hour	8.00 HR	49.43	0.00	79.08	474.52	(0.00)	474.52
Additional allowance for high roof work							
Totals: Yacht Club House			0.00	1,307.58	7,845.54	221.04	7,624.50

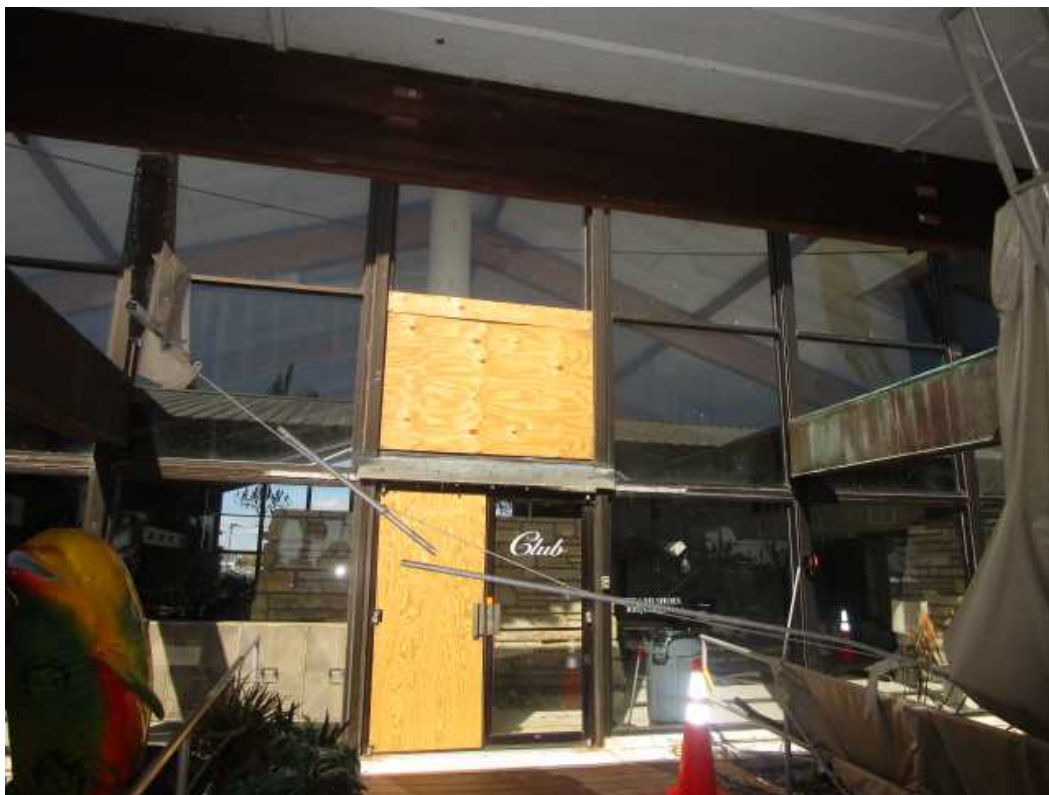
13

Front entry window boarded up

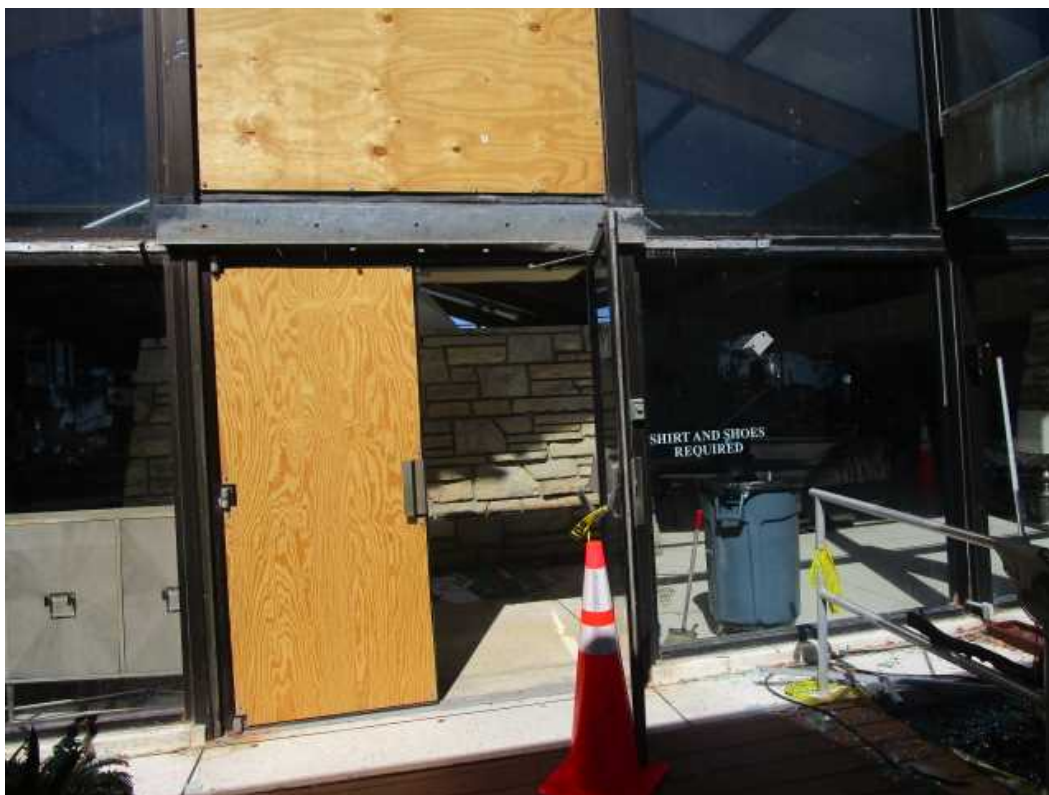
14

The front of the building doors and windows were damaged by wind and water enter through broken windows. Windows will require replacing and cleaning of the floor and entry area will be needed. Allowances have been made in our estimate due to the height of the work being done.

Entry doors and windows damaged

DESCRIPTION	QUANTITY	UNIT PRICE	TAX	O&P	RCV	DEPREC.	ACV
11. Reglaze 1/4" tempered glass - single pane 3 large windows at front	72.00 SF	13.53	0.00	194.84	1,169.00	(730.62)	438.38
12. R&R Storefront door - alum. anodized frame, 3'x7' -Single pane	1.00 EA	1,463.44	0.00	292.68	1,756.12	(1,054.66)	701.46
13. Window - General Laborer - per hour Additional allowance for height of work on windows	4.00 HR	49.43	0.00	39.54	237.26	(164.77)	72.49
14. Scaffolding Setup & Take down - per hour for high windows	2.00 HR	49.43	0.00	19.78	118.64	(0.00)	118.64
15. Scaffold - per section (per day)	10.00 DA	25.28	0.00	50.56	303.36	(0.00)	303.36
16. Clean floor - tile - Heavy clean	6,000.00 SF	1.05	0.00	1,260.00	7,560.00	(0.00)	7,560.00
17. Clean fireplace face & mantel	92.00 SF	1.73	0.00	31.84	191.00	(0.00)	191.00
Totals: Main Room			0.00	1,889.24	11,335.38	1,950.05	9,385.33

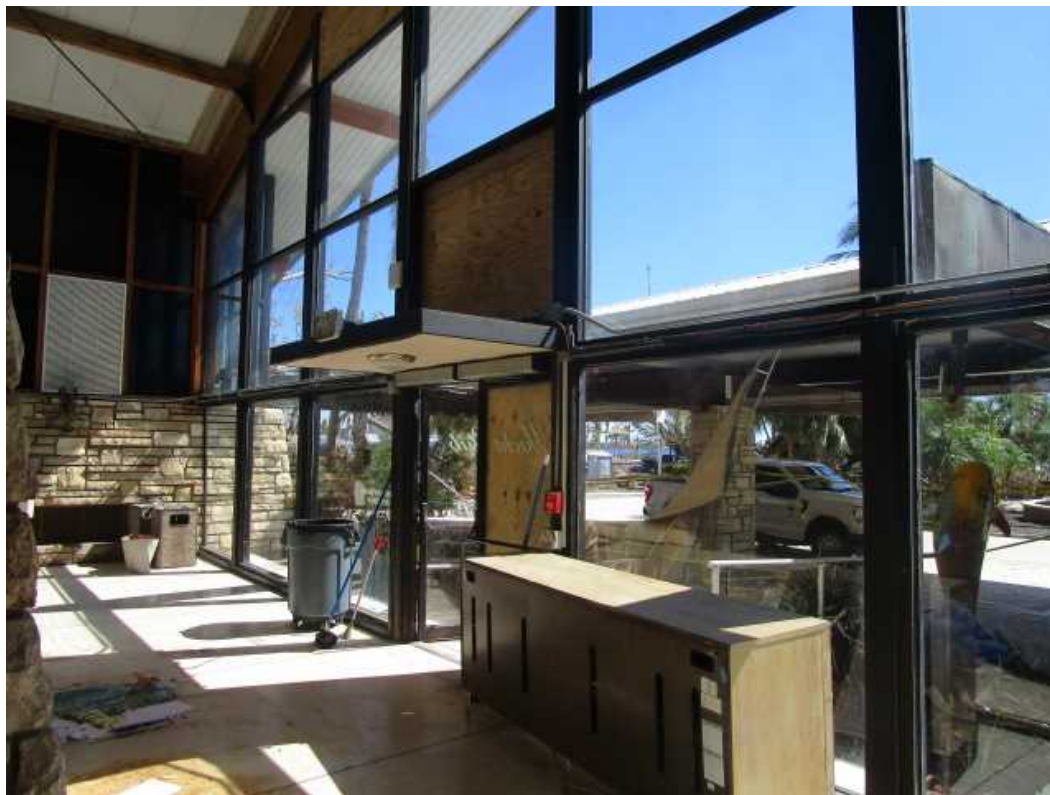
16

Front from inside- Windows broken

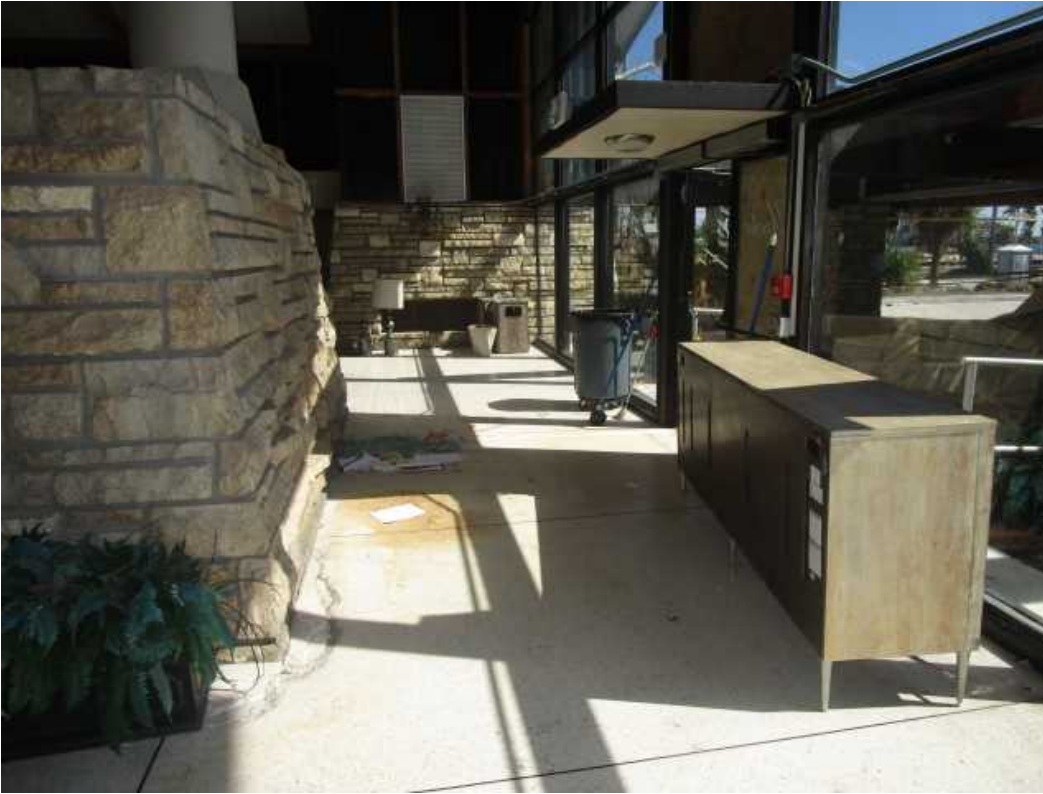
17

Debris on floor entry- water was on floor
from broken windows

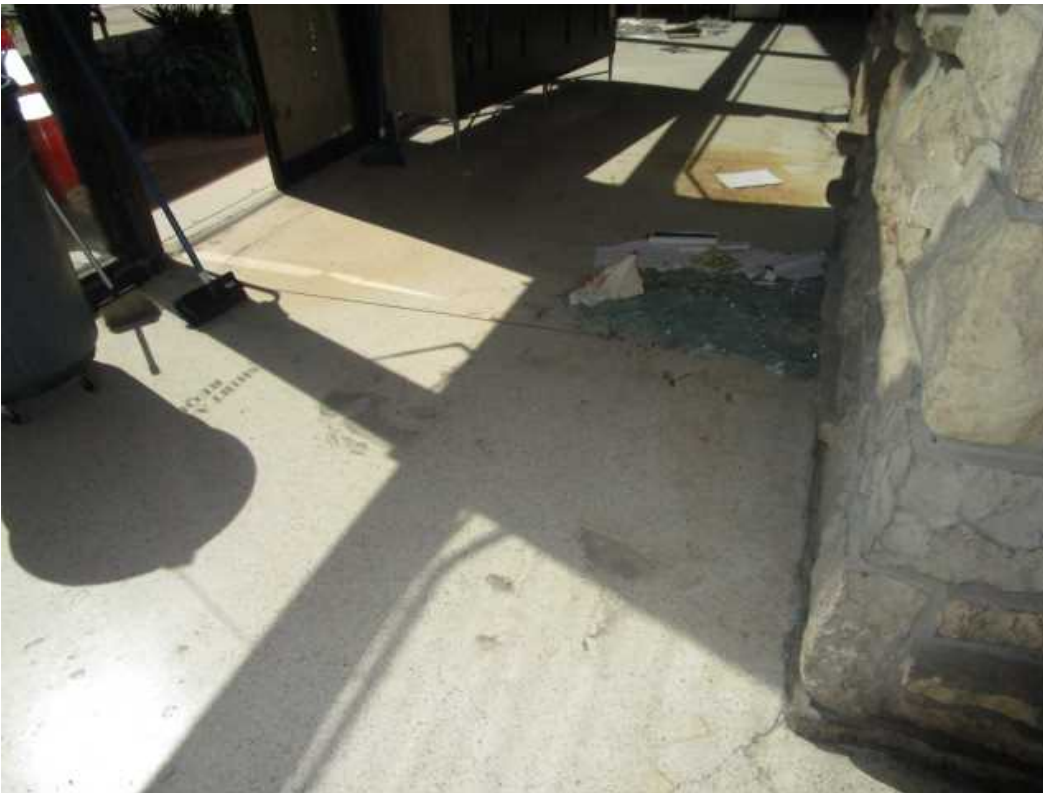
18

Rain water stains from rain entering

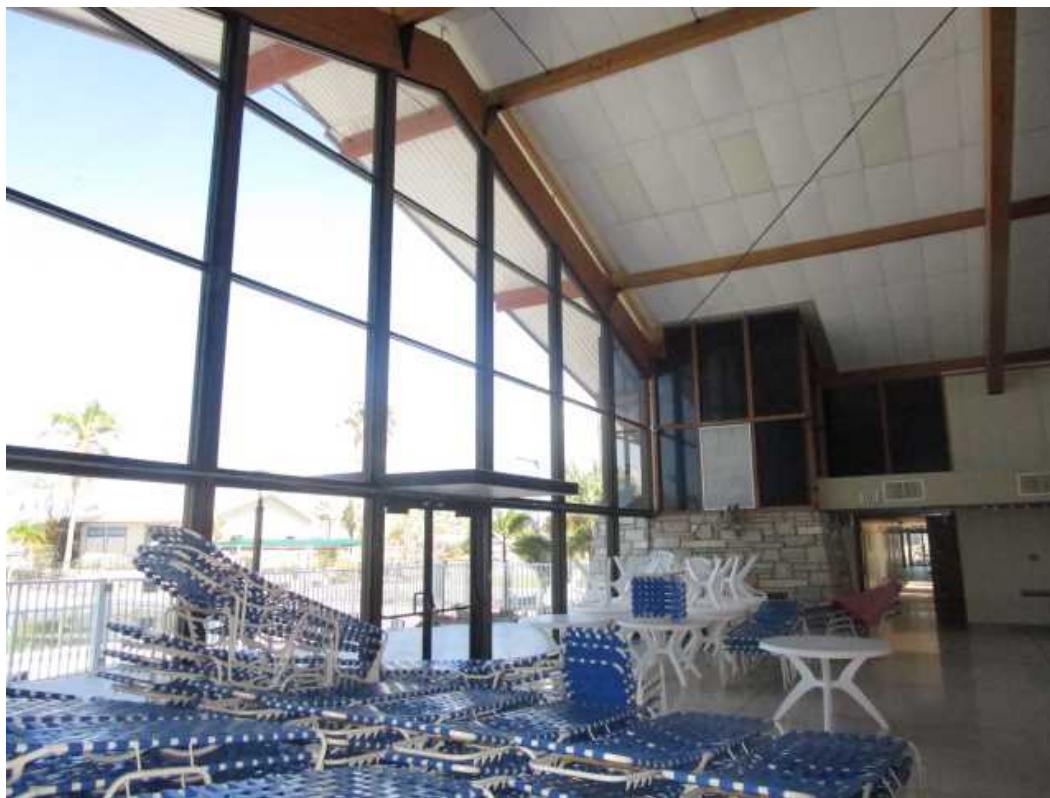
21

Rear wall glass not damaged

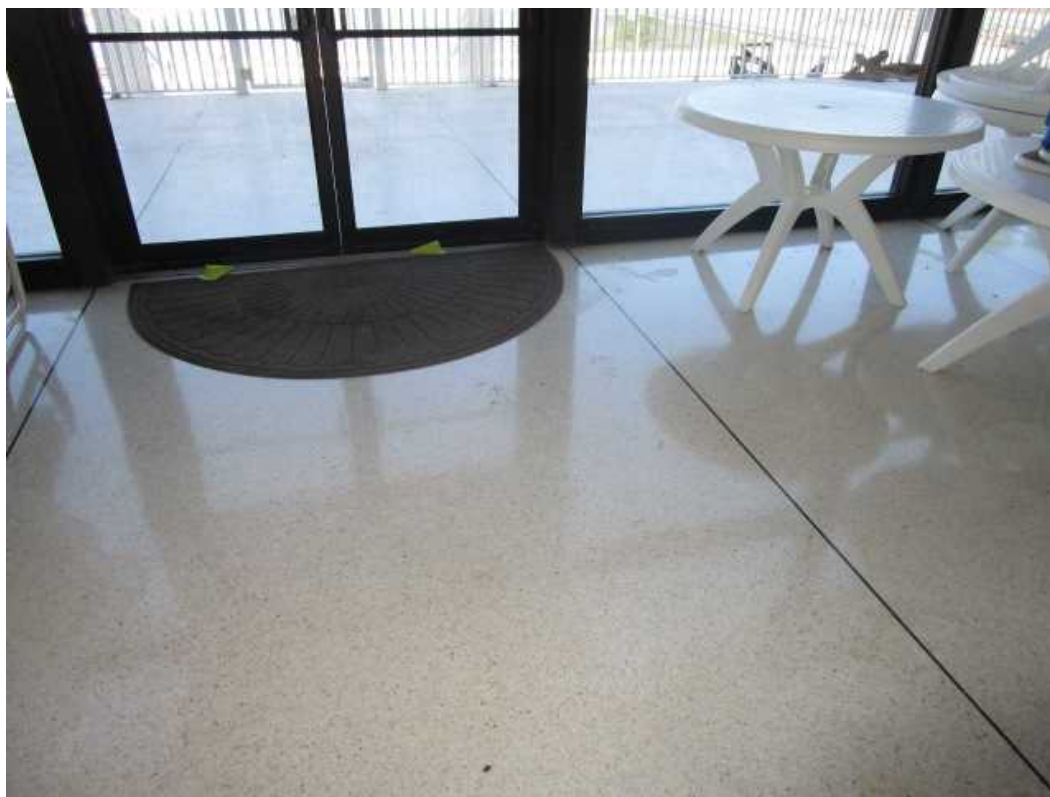
22

Building (Storm Surge) – There is no evidence of surge getting in the building, and the city employee stated there was none. Water that entered was rainwater through broken windows.

No surge water either end

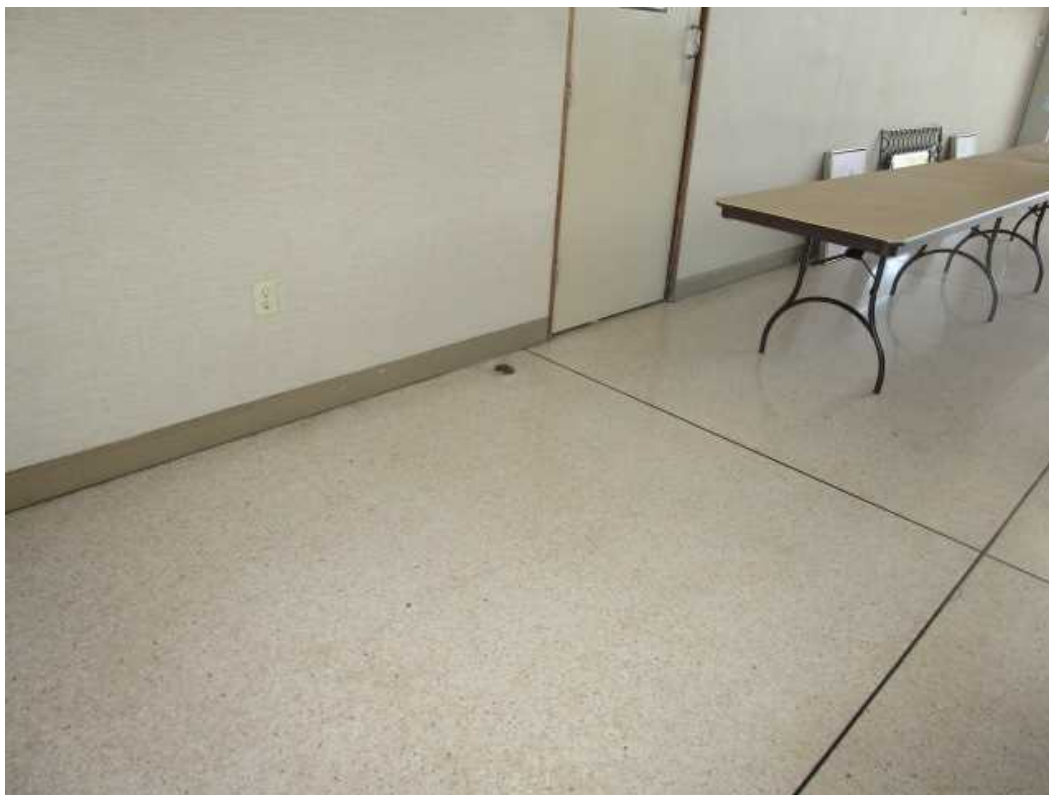
23

No water lines throughout

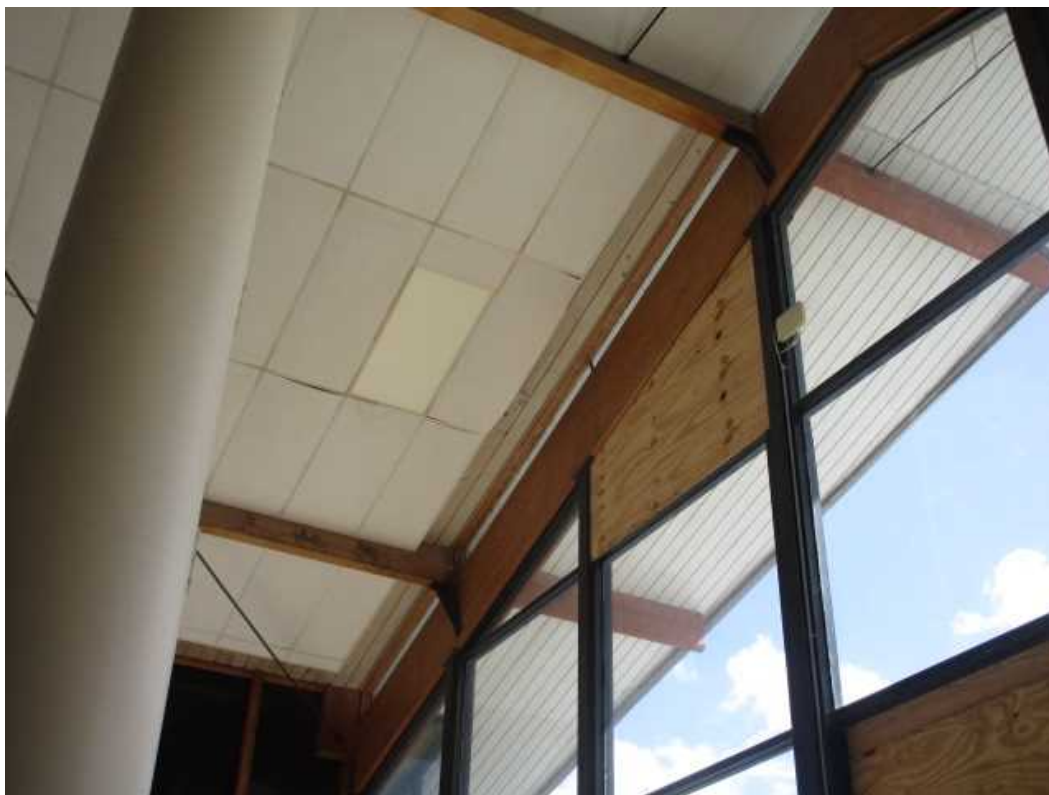
25

Ceiling tile replace befor IAN. Upper
window broken from IAN

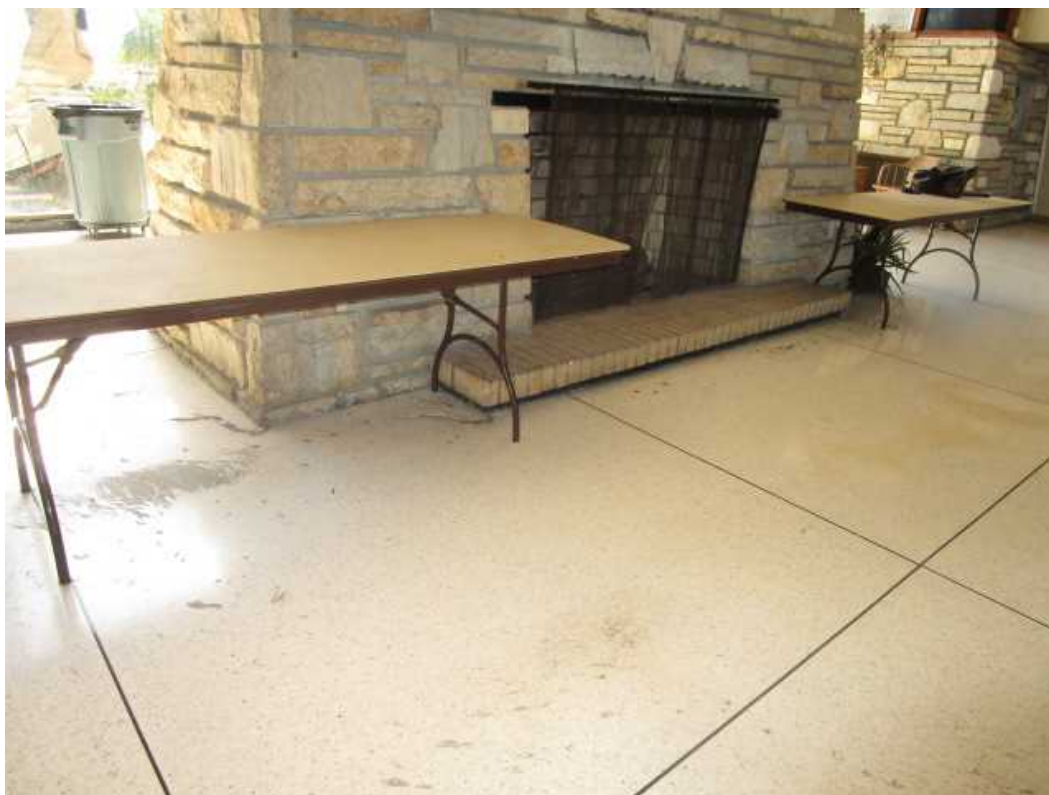
26

Water on floor around entry fireplace

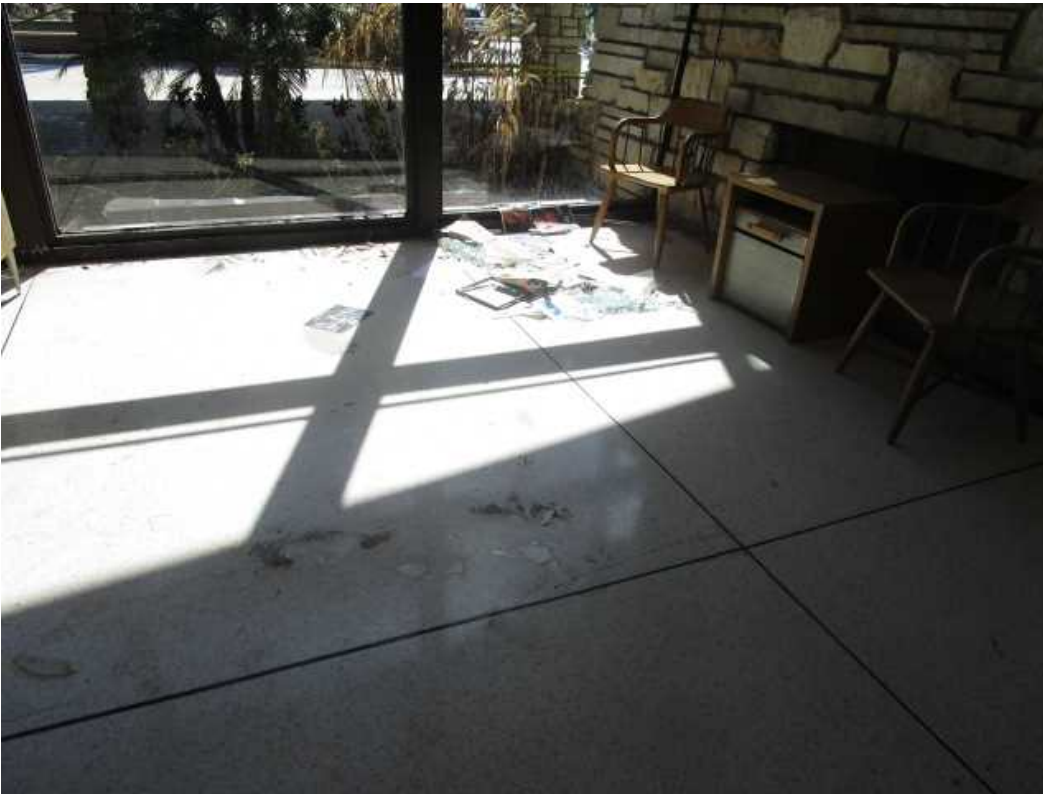
27

Glass debris on floor at entry

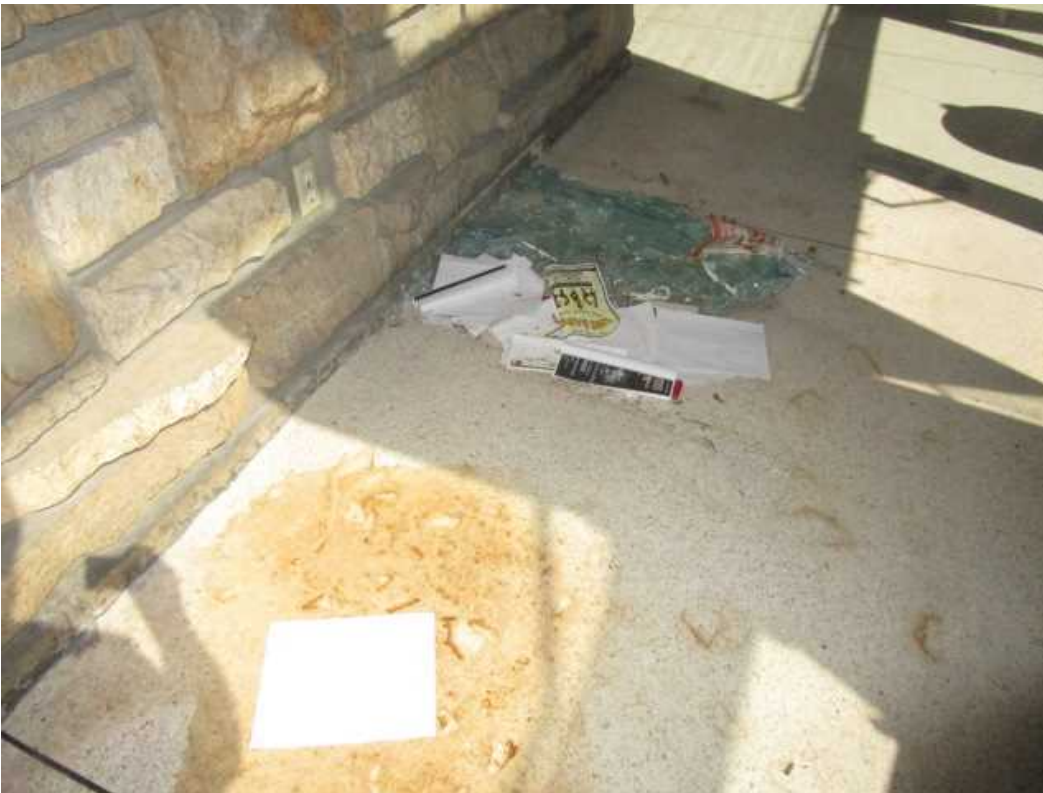
28

Water stains on tile floor

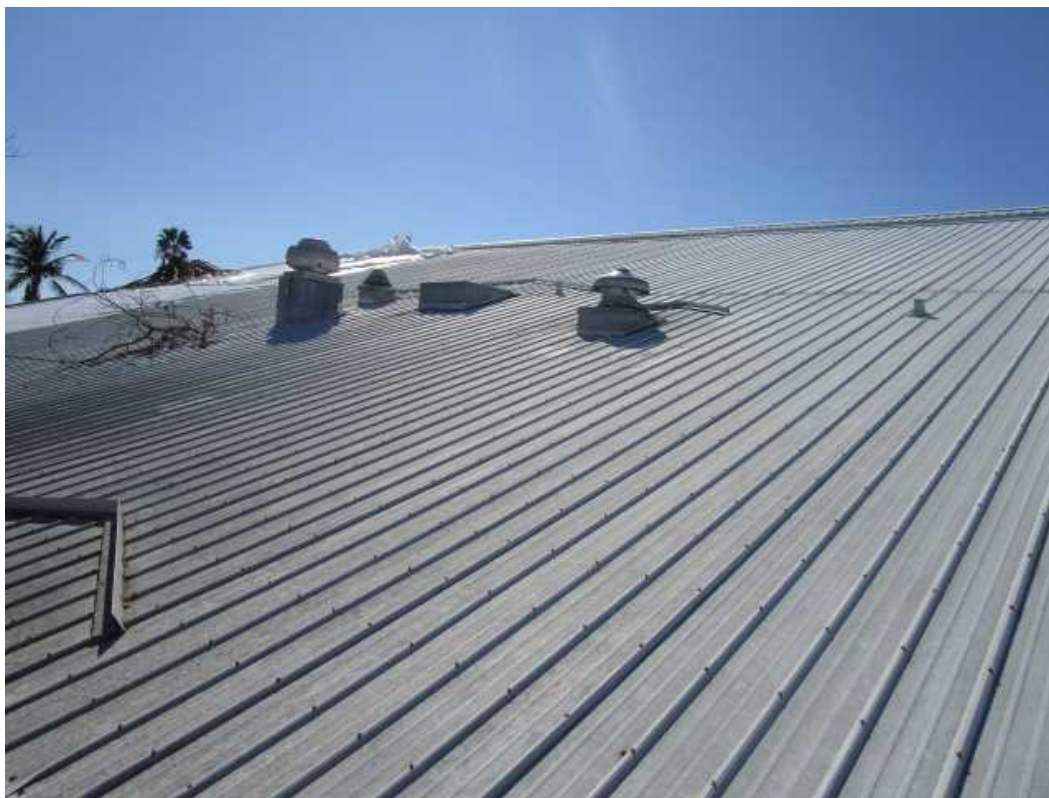
29

Rigth slope metal no damage

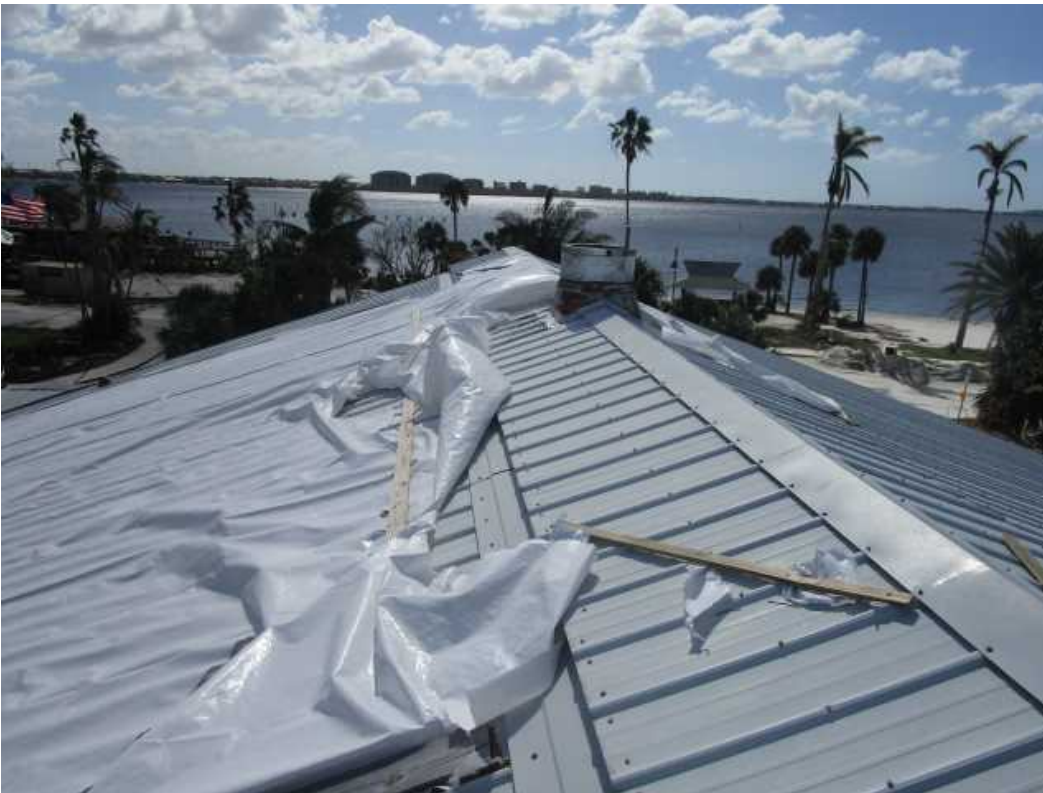
34

Some tarping damage due to IAN

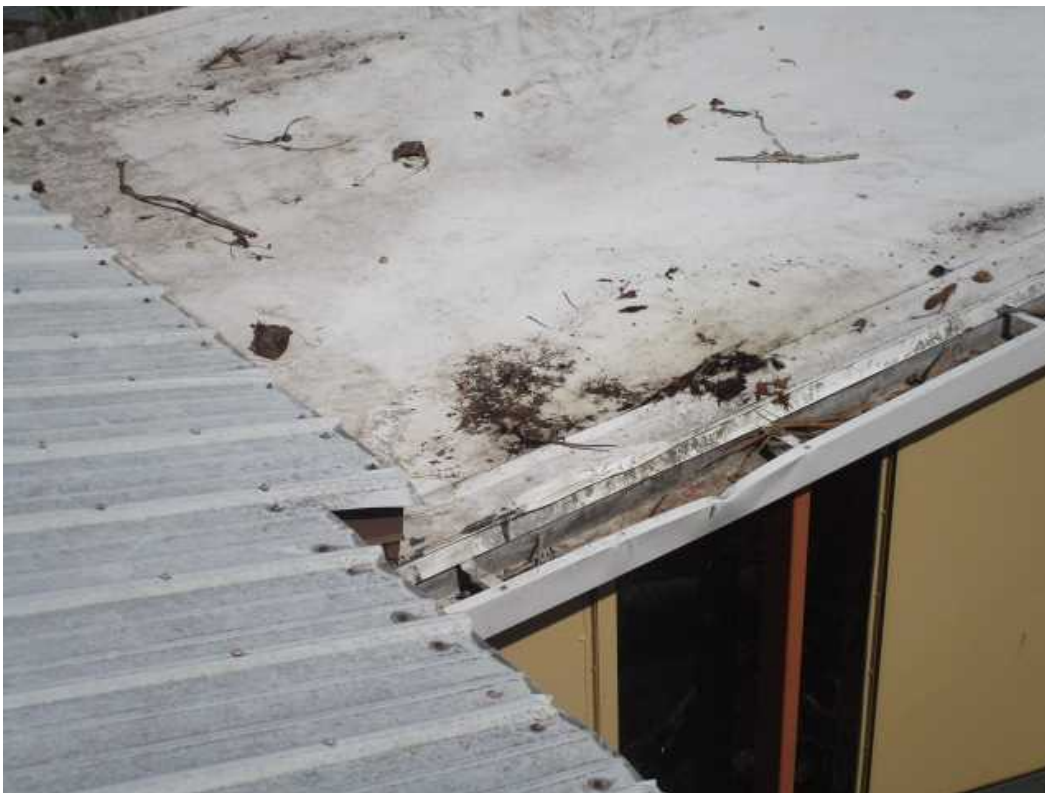
36

Gutter damage on right rear addition
from tree

DESCRIPTION	QUANTITY	UNIT PRICE	TAX	O&P	RCV	DEPREC.	ACV
5. R&R Gutter / downspout - aluminum - up to 5"	28.00 LF	9.10	0.00	50.96	305.76	(139.94)	165.82
Back right where locker room attaches to club house							
Totals: Lock Rm			0.00	50.96	305.76	139.94	165.82

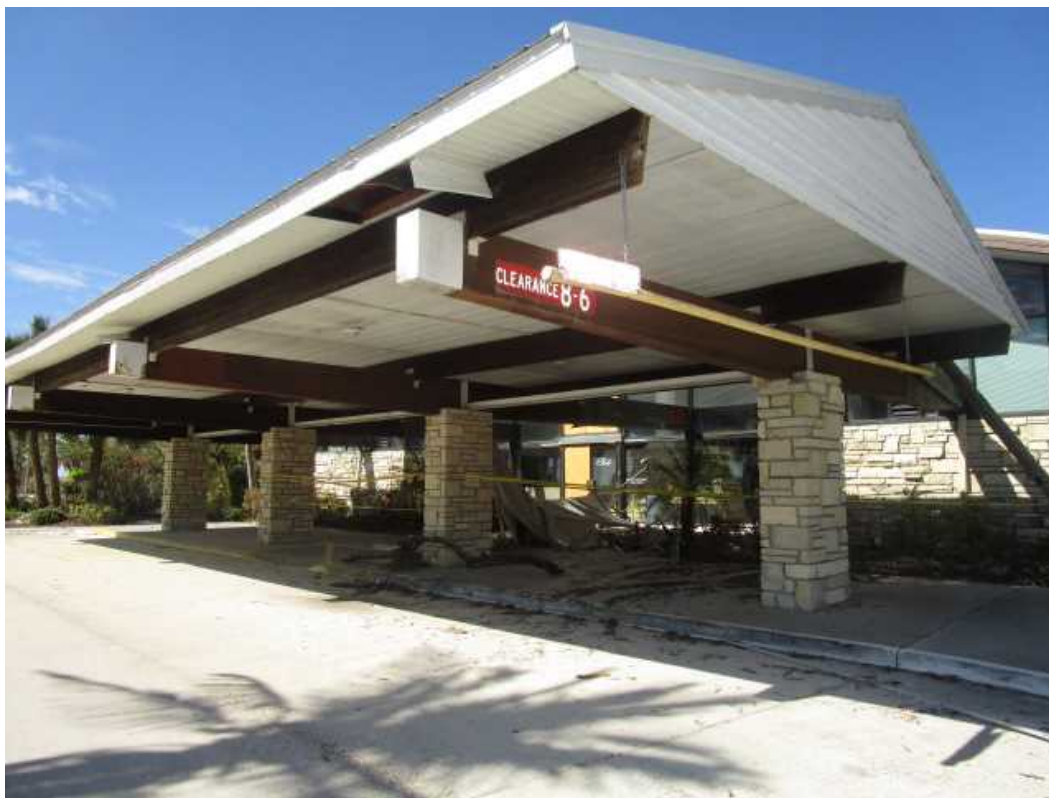
39

Right front - soffit damage

DESCRIPTION	QUANTITY	UNIT PRICE	TAX	O&P	RCV	DEPREC.	ACV
7. R&R Soffit - metal	24.00 SF	6.94	0.00	33.32	199.88	(46.58)	153.30
8. R&R Gutter / downspout - aluminum - up to 5" Across back side near main building	75.00 LF	9.10	0.00	136.52	819.02	(374.85)	444.17
9. R&R Siding - steel - Commercial - High grade Cross beams under roof	96.00 SF	11.56	0.00	221.94	1,331.70	(104.06)	1,227.64
10. R&R Siding - steel - Commercial - High grade Around beams attached to main building	144.00 SF	11.56	0.00	332.94	1,997.58	(156.10)	1,841.48
Totals: Portico			0.00	724.72	4,348.18	681.59	3,666.59
Total: Main Level			0.00	2,143.42	12,860.44	1,264.57	11,595.87
Total: Roof			0.00	2,143.42	12,860.44	1,264.57	11,595.87

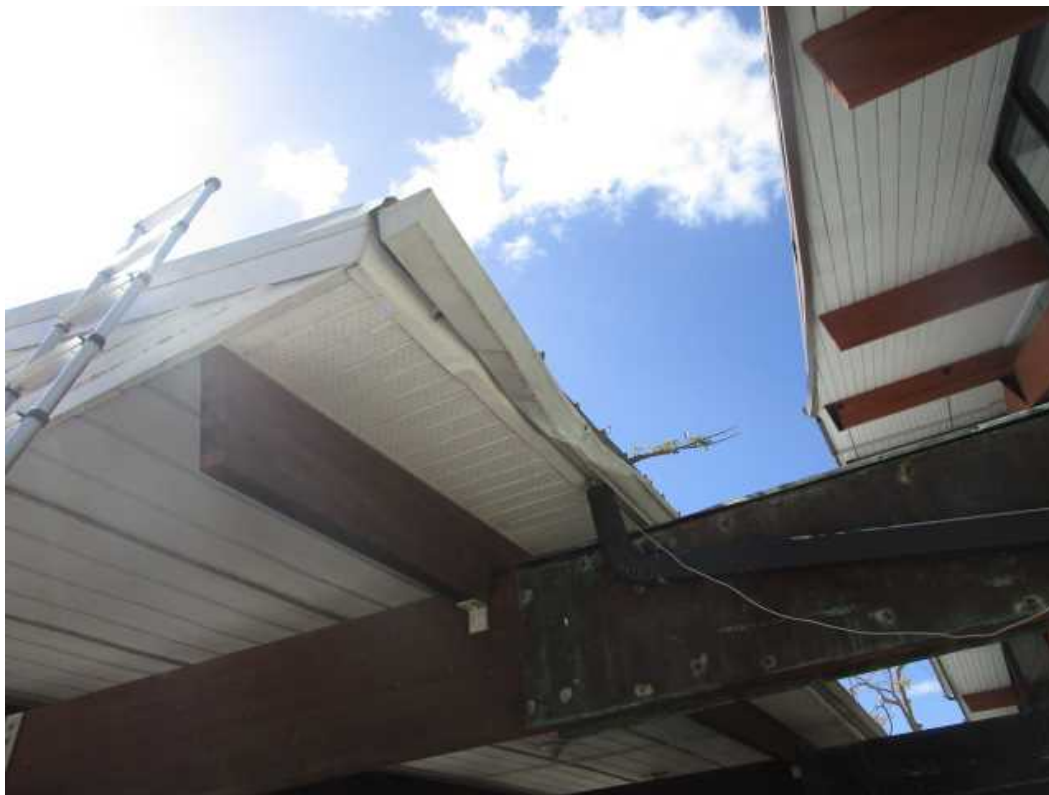
40

Gutter damage on right rear

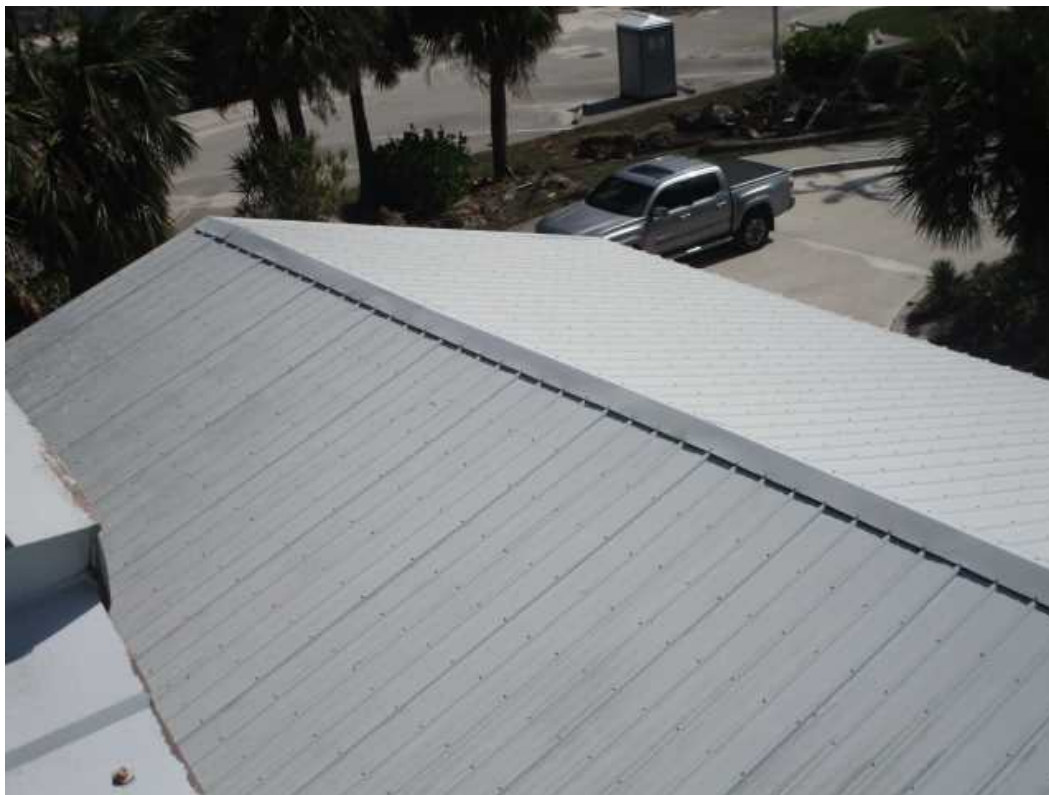
42

Portico roof no damage

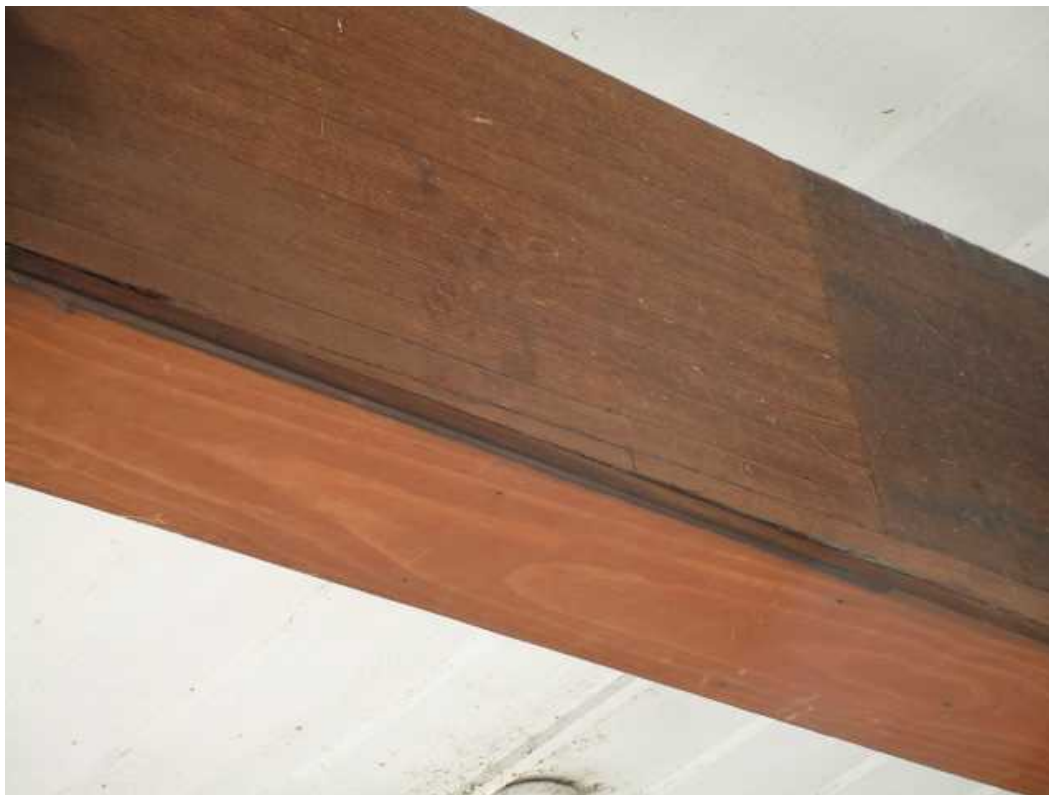
46

The front entry driveway Portico sustained wind damage to soffit metal, Gutters along the back side, and metal siding around beams. The support timbers under the Portico roof show stress cracks in some areas from age. Some of the cracks appear to have opened up due to the strong winds. We do not see it as permanent damage, however the Insured may want to have engineering inspect to be certain the integrity of the large beams is intact.

Stress cracks appear from age

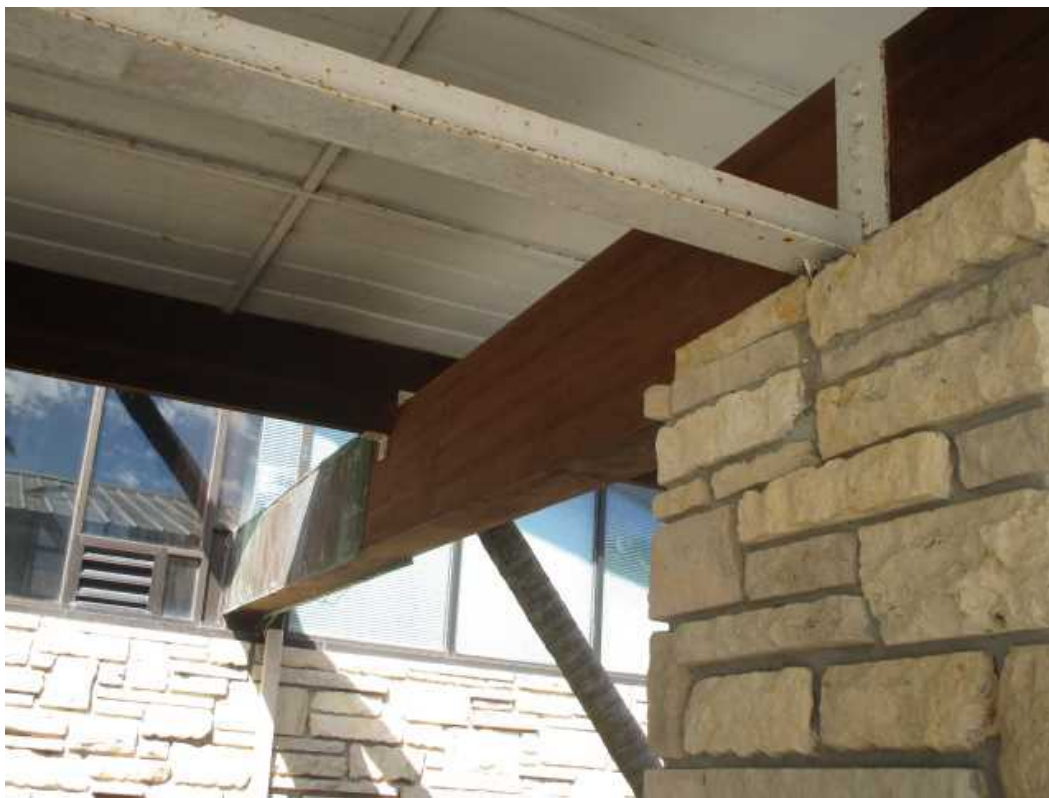
47

Beams at building covered with metal
siding blown off

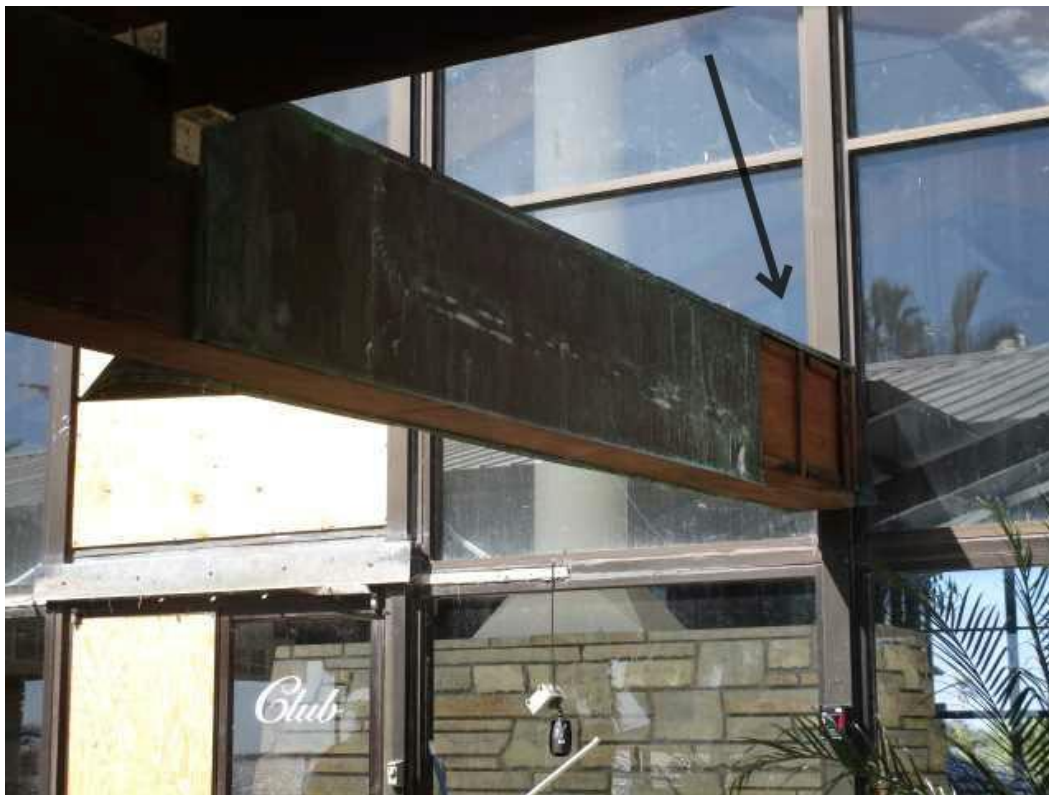
48

Metal covering of beams damaged

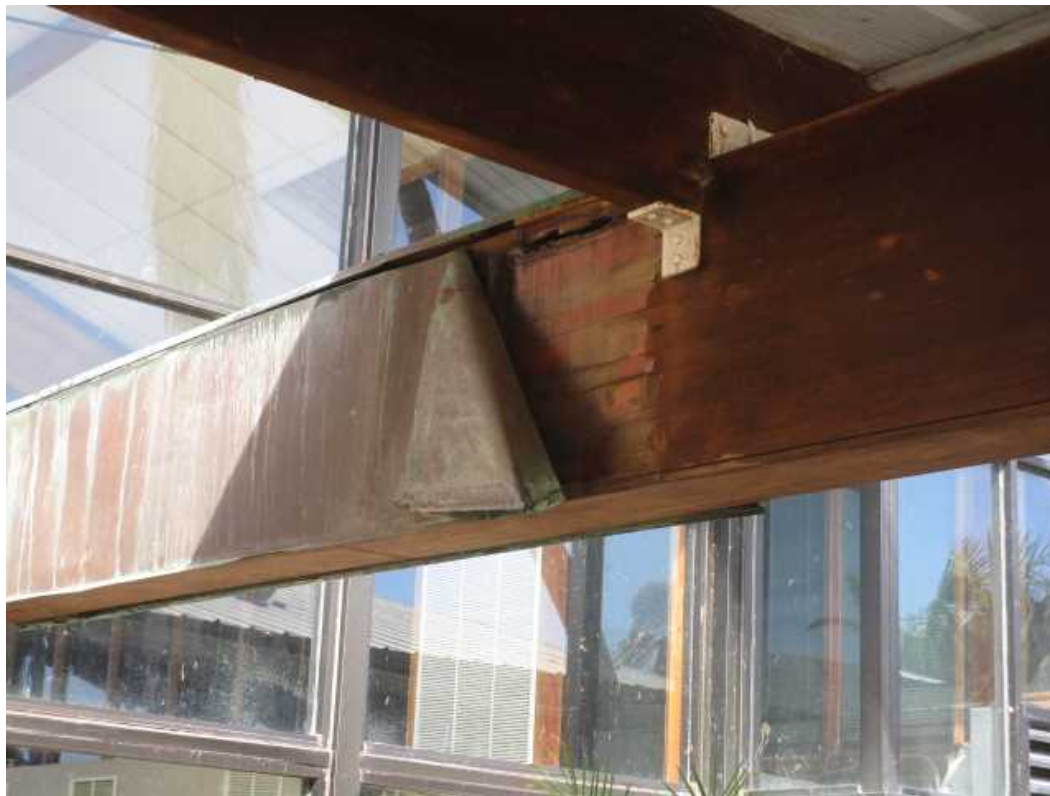
49

Wind damage on beams

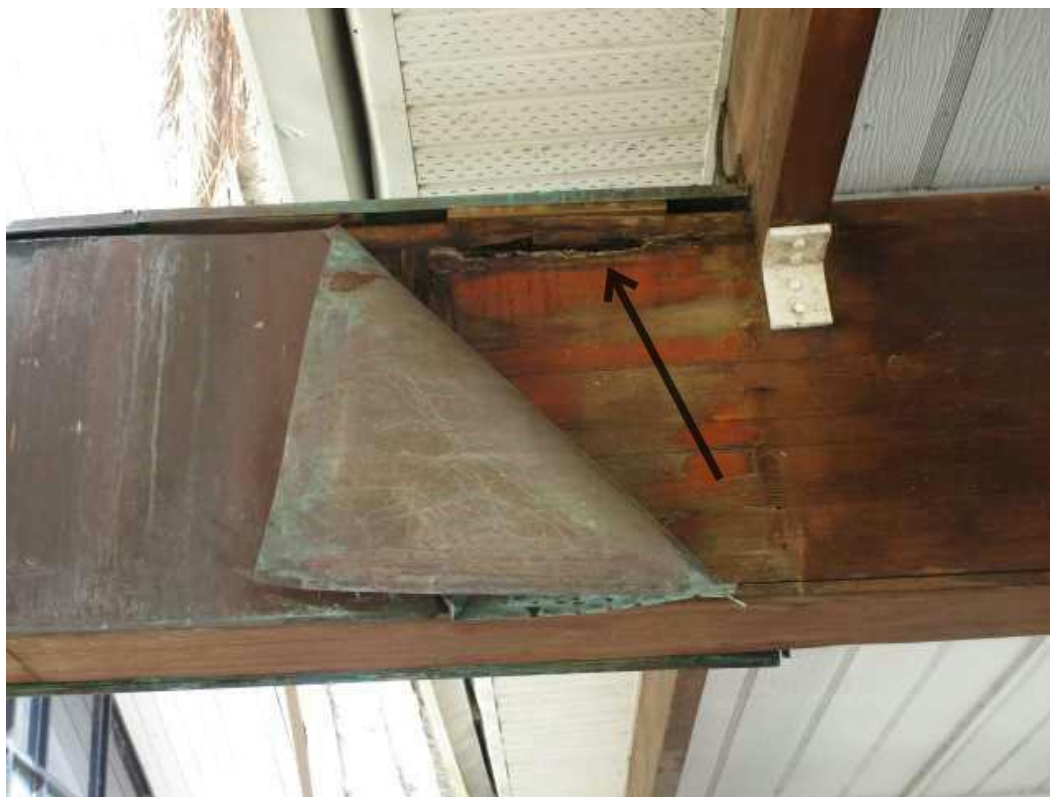
50

Deterioration to wood beam from age
and moisture
