RE: **MEMBER** **City of Cape Coral**
CLAIM NUMBER: **GC2022106844**
DATE OF LOSS: **09/28/2022**
LOCATION # - DESCRIPTION: **048024 - Yacht Club House Building**
ORIGINAL P&C DEDUCTIBLE: **\$25,000.00**

Report Number	:	FIRST AND FINAL
Named Insured / Member	:	CITY OF CAPE CORAL
FMIT Number	:	0074
FLC Claim Number	:	GC2022106844
Date of Loss	:	9/28/2022
Loss Location	:	048024 - Yacht Club House Building 5819 Driftwood Parkway Cape Coral, FL, 33904
Description of Loss	:	Hurricane
Sedgwick File Number	:	TMP22110700

We inspected this loss with the insured on 10/27/2022. The scope of damages includes wind damage to the metal roof fascia, and roof edge on the main Yacht Club House. The main roof had tarping in place from a previous wind event and the tarping needs re-installation in some places due to Hurricane Ian. There is also wind damage to wood fence that surrounds the Air Conditioner outside back left of the main building. There is also damage on gutters on the attached Locker room building which is directly behind the main building from a tree falling on the roof edge.

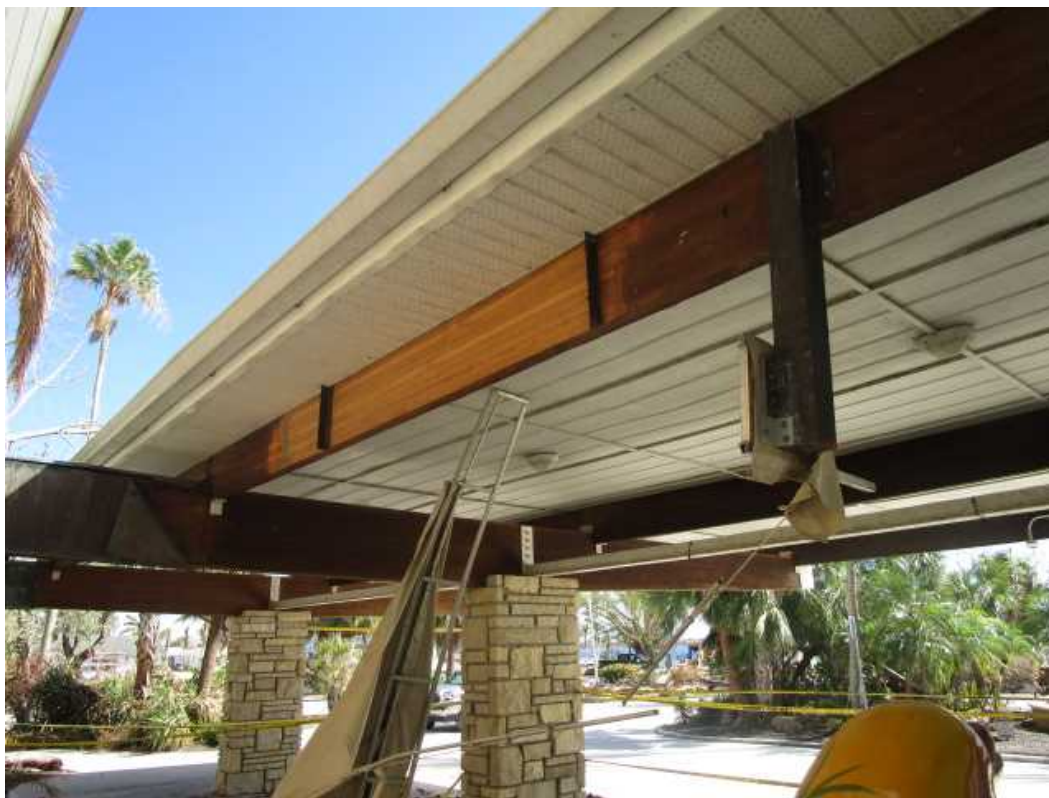
51

Metal siding on beam blown off

DESCRIPTION	QUANTITY	UNIT PRICE	TAX	O&P	RCV	DEPREC.	ACV
7. R&R Soffit - metal	24.00 SF	6.94	0.00	33.32	199.88	(46.58)	153.30
8. R&R Gutter / downspout - aluminum - up to 5" Across back side near main building	75.00 LF	9.10	0.00	136.52	819.02	(374.85)	444.17
9. R&R Siding - steel - Commercial - High grade Cross beams under roof	96.00 SF	11.56	0.00	221.94	1,331.70	(104.06)	1,227.64
10. R&R Siding - steel - Commercial - High grade Around beams attached to main building	144.00 SF	11.56	0.00	332.94	1,997.58	(156.10)	1,841.48
Totals: Portico			0.00	724.72	4,348.18	681.59	3,666.59
Total: Main Level			0.00	2,143.42	12,860.44	1,264.57	11,595.87
Total: Roof			0.00	2,143.42	12,860.44	1,264.57	11,595.87

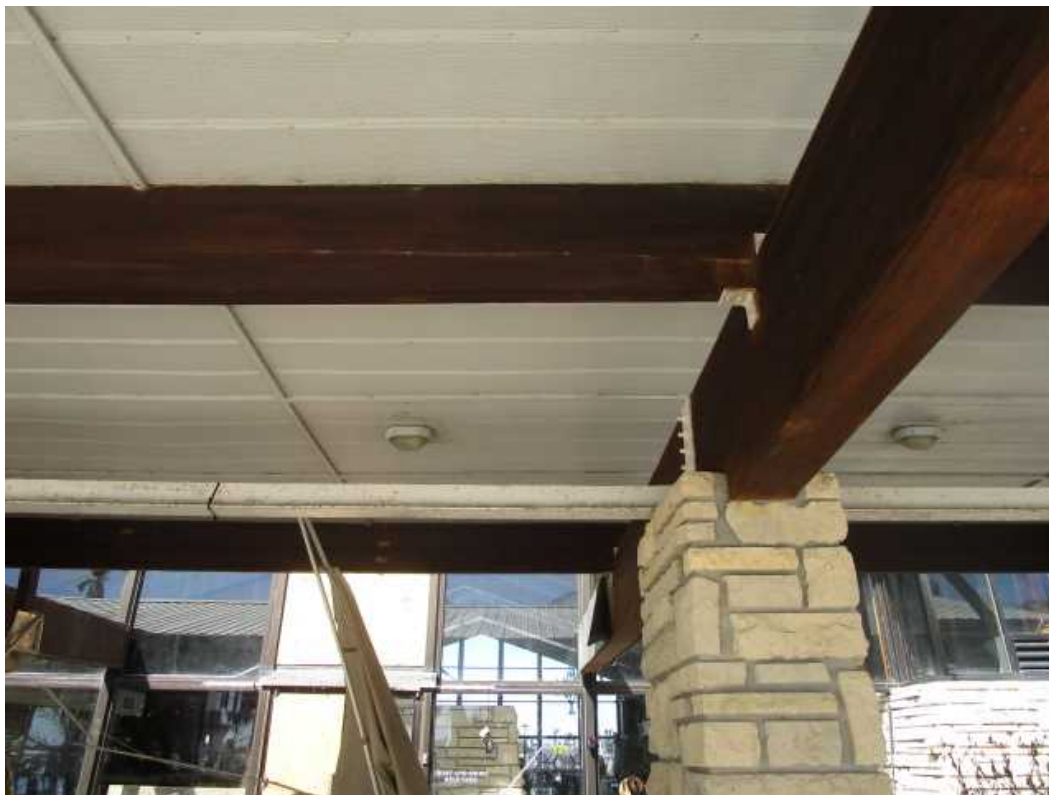
52

Stress crack in beam

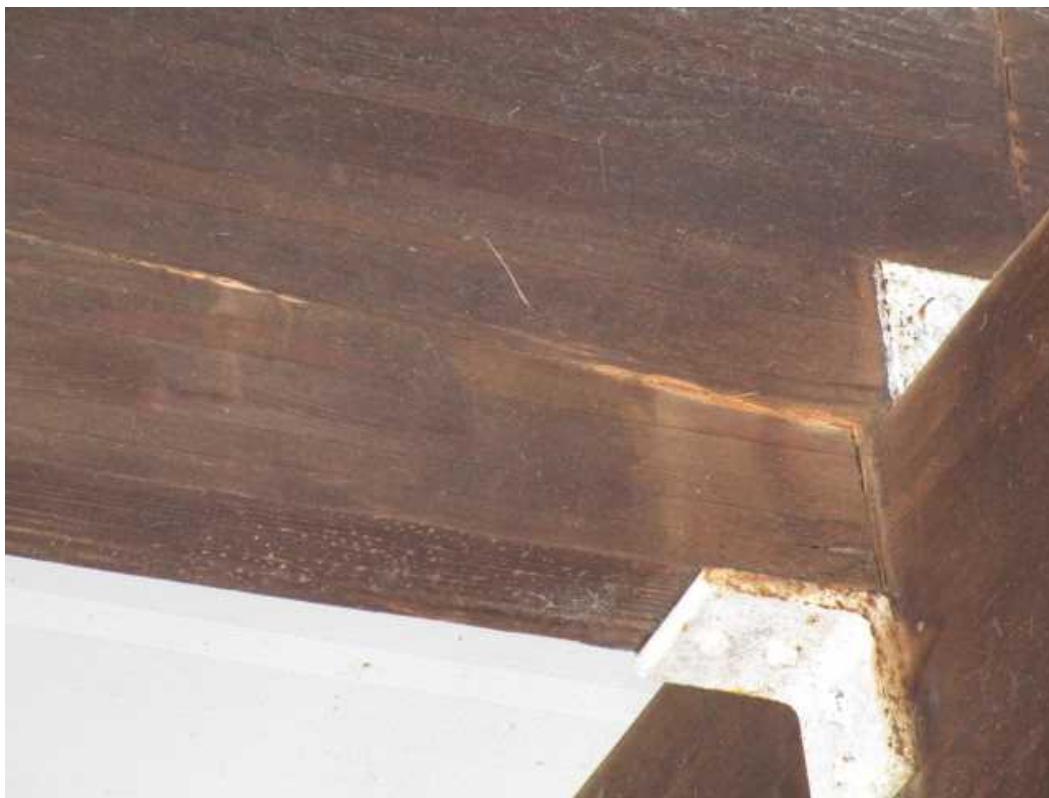
53

Slight separation of stress crack

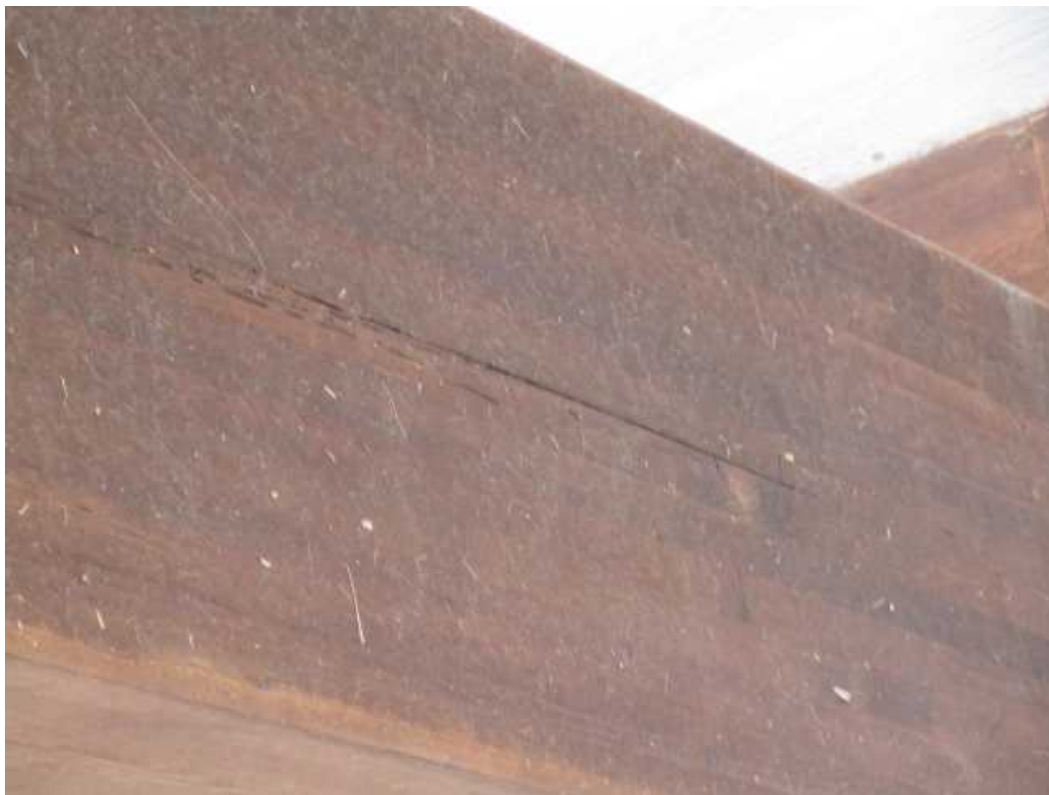
54

Crack in beam from age
