Yacht Club Condition Assessment and Discussion

Winter Retreat
January 26, 2023

Yacht Club Complex

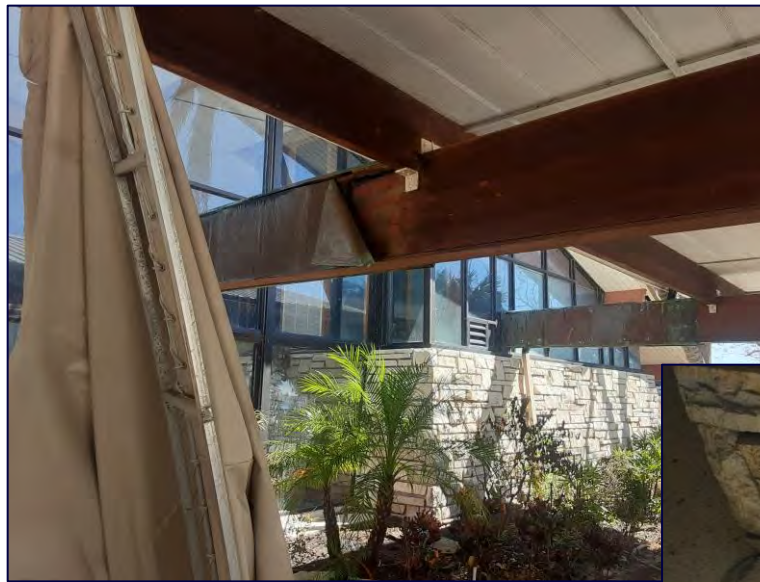
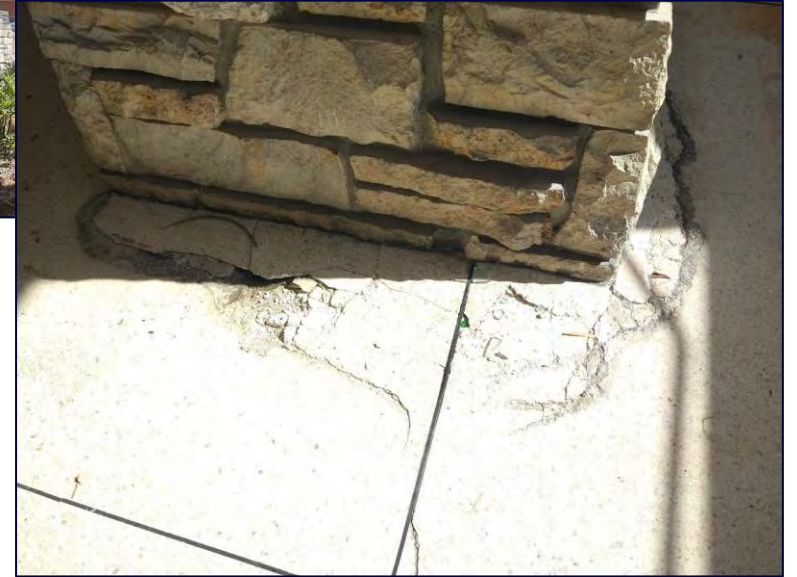
A. Foundation

- Exterior structural wall components (beam/thrust blocks) damaged due to flooding
- Beam/Column cap plates damaged and/or torn off
- Glued laminated timbers damaged
- Slab upheaval in the immediate vicinity of the chimney
 - Suspect upheaval transferred through the roof

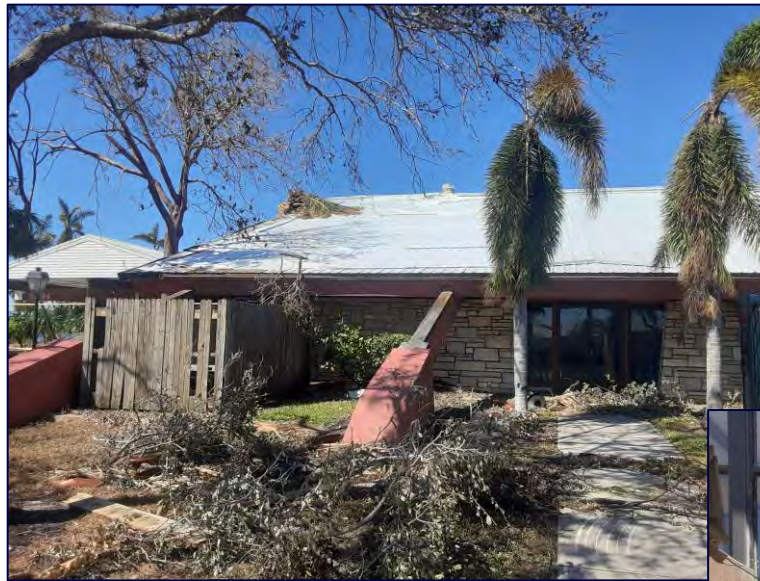
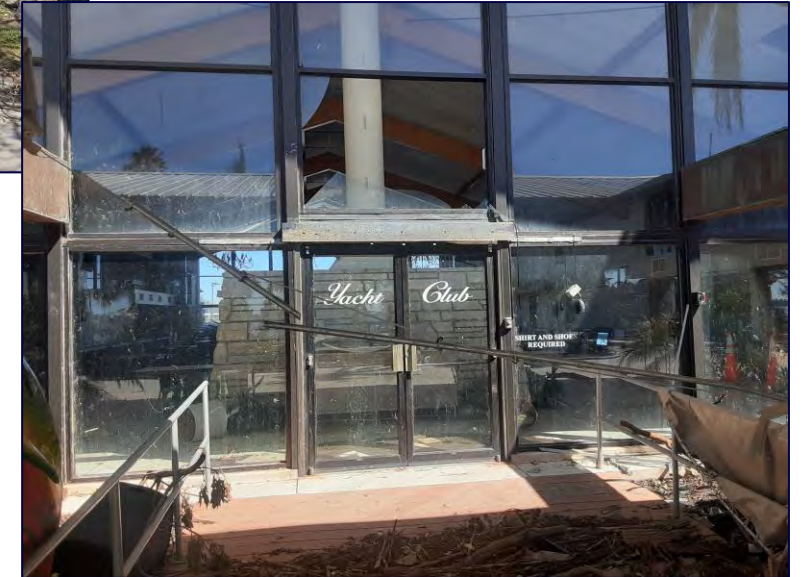
- Roof overlay (metal over shingle) ~1999
 - Roof decking failure causing leaks in East meeting room
 - Soffit damaged
- Storefront (windows/doors) original, single 1/4" plate glass damaged
- Awning damaged beyond repair

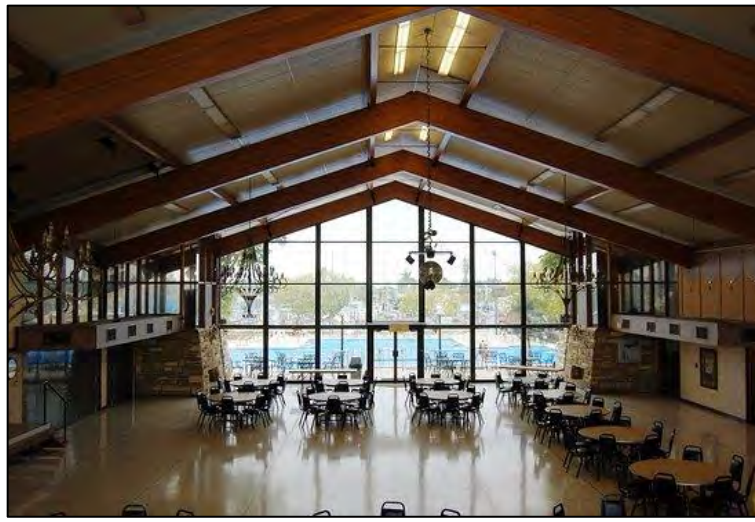
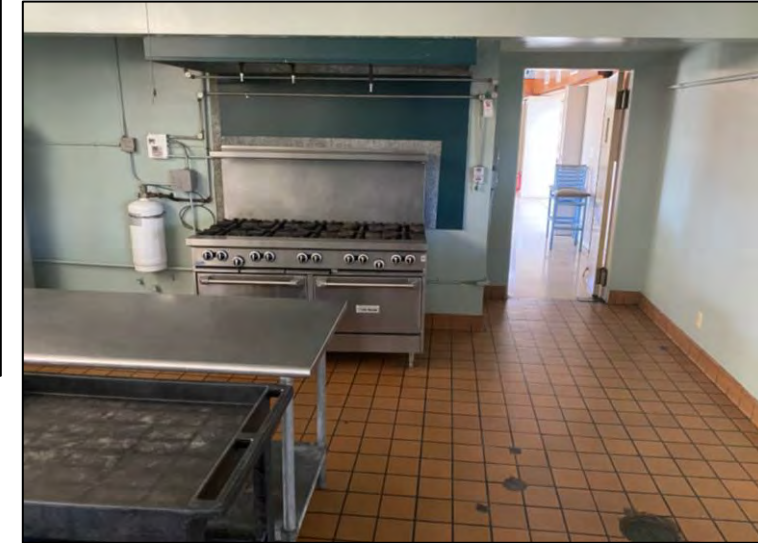
- Interior walls in office cause access problems with mechanical system (Air Handler Unit-AHU) maintenance
- Folding walls outdated and need to be replaced
- Stage is functional; however, front and rear stairs are not ADA-compliant
- East Hall (original tongue-and-groove) ceiling needs to be replaced
- Kitchen originally designed as “Service Pantry” and not “Commercial Kitchen” as currently used
- Non-Uniform finishes throughout the structure
 - Knock-down, popcorn, tongue-and-groove, acoustical tiling, drywall, flooring mixes, plaster, etc.

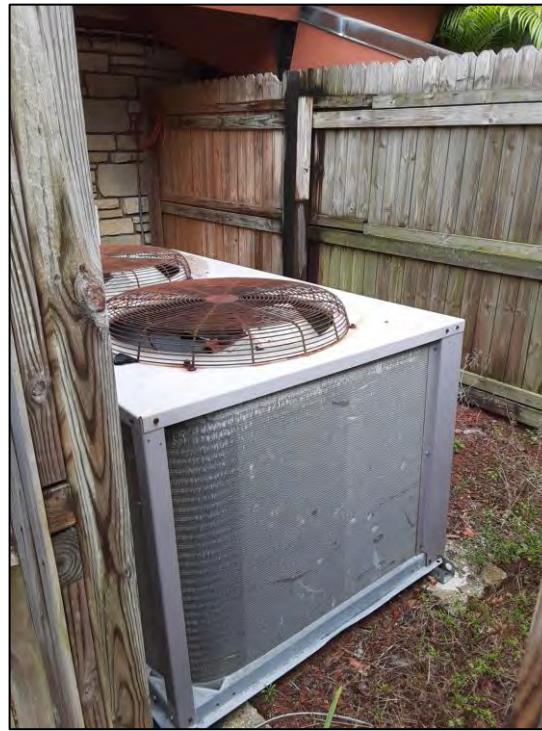
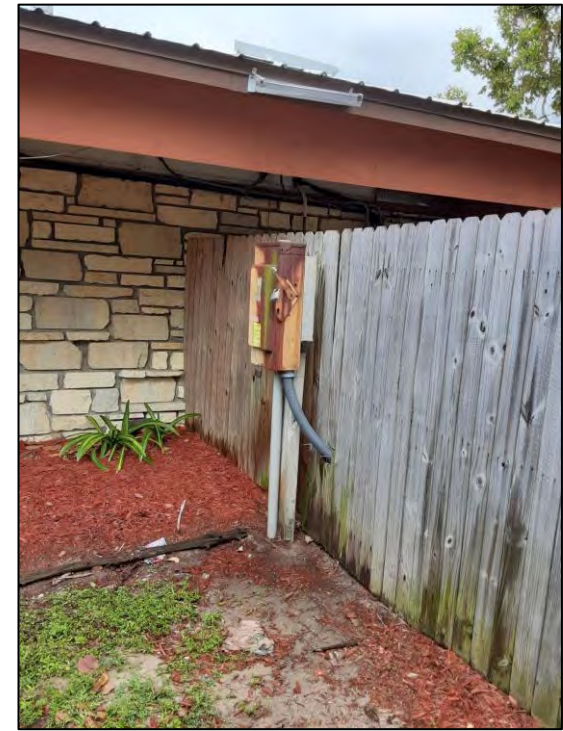
- Two of four HVAC systems have exceeded life expectancy, requiring frequent repairs
 - Systems do not have heat
 - Disconnect panels rusted
- AHU's (installed in various years) are in under-sized closets and will require modifications for replacement equipment
 - Original ductwork needs to be replaced
 - Mismatched units
- Chimney not known to have ever been used and chimney stack never serviced

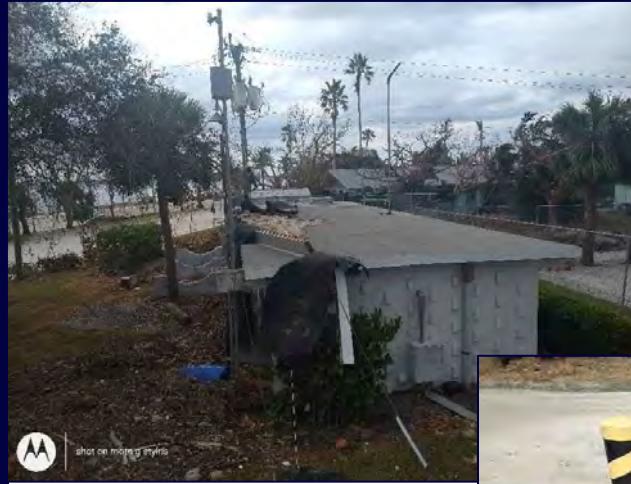
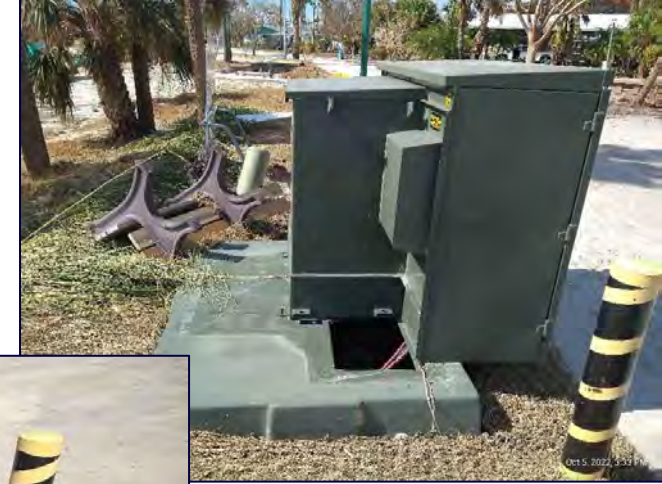
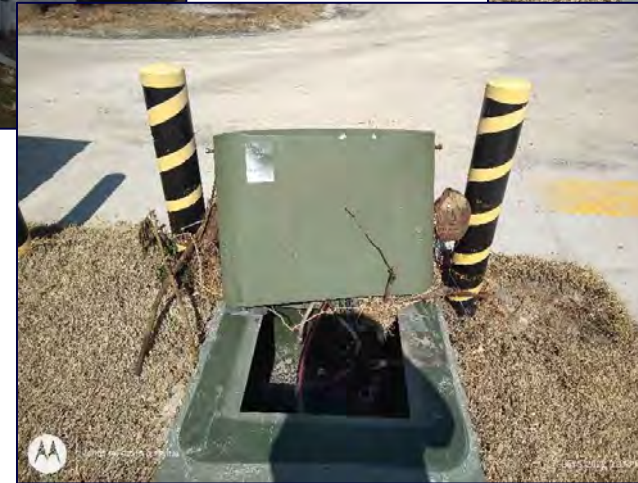
- Mechanical/Electrical building flooded, and salt-water compromised electrical system
 - High voltage distribution and relay transformers pushed forward and completely fell off foundation, exposing wires
 - Electrical Building sustained roof damage
 - Electrical system feeds Ballroom (2/3) and Senior Center (1/3)
- Ballroom electrical panels original with few spares; service panel work arounds ineffective (kitchen)
- Security system needs upgrade

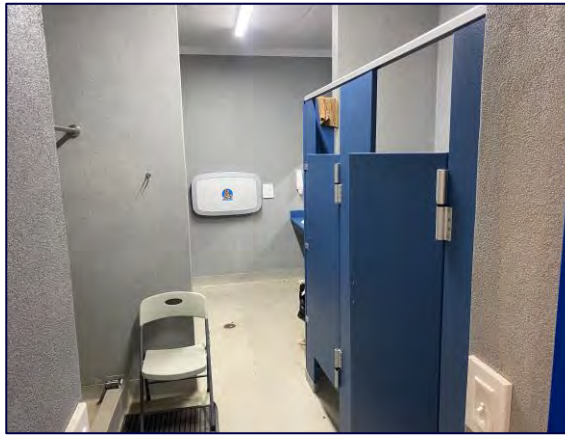
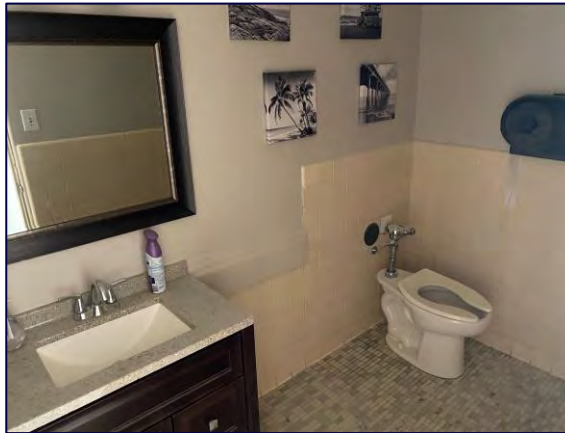
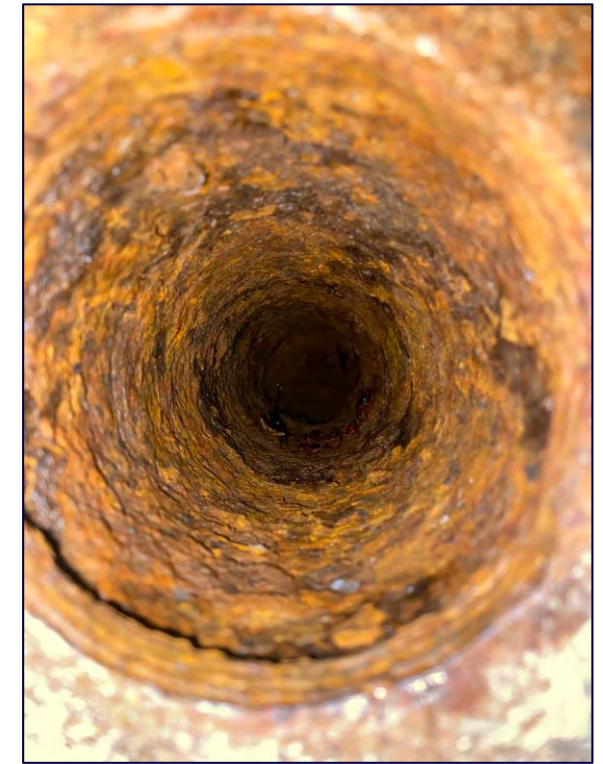
- Original plumbing lines well past useful life, requiring frequent repairs
 - Original Cast-Iron sewer drains deteriorating under slab
 - Copper (majority) pressurizes pipe with some CPVC replumb
- East Hall bathrooms renovated (2017-2022); however, staff restrooms need to be replaced and address ADA deficiencies
- Grease trap and lines (Kitchen) clogged and need replacement

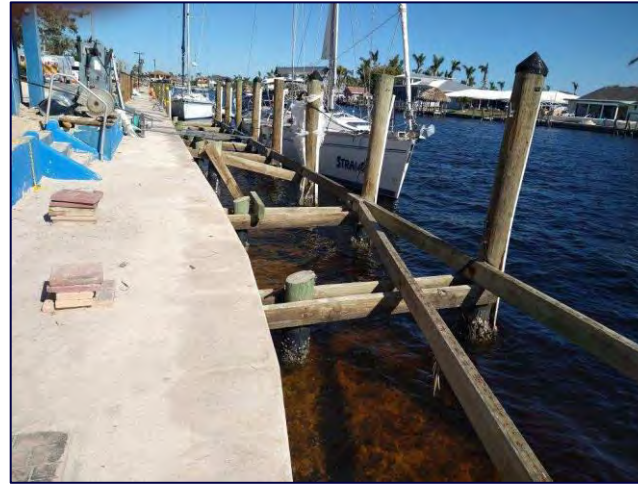
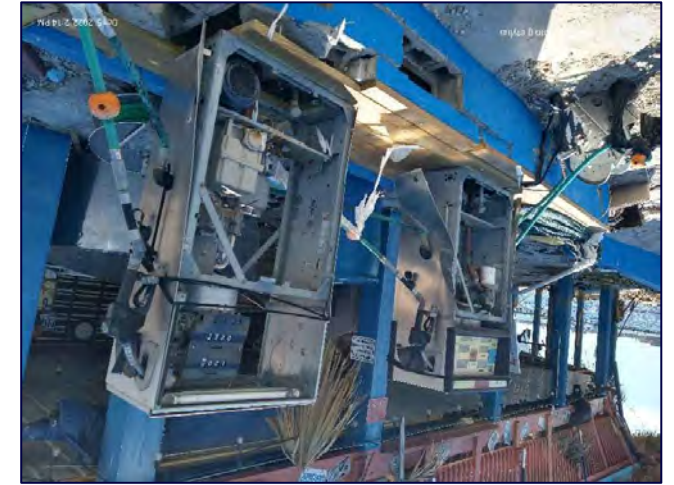
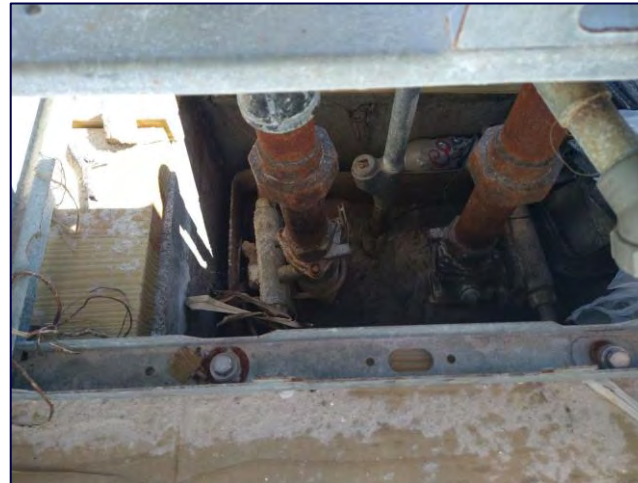
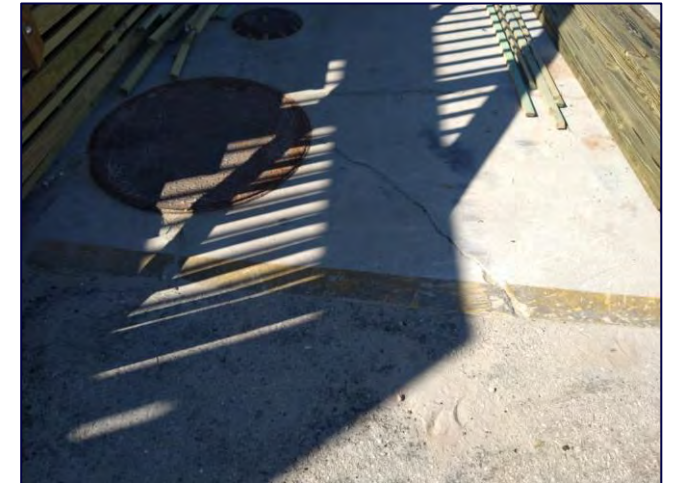
- FUEL OPERATIONS -

- Fuel Dispensers and associated electrical and piping damaged
- Fuel dock destroyed
- Fuel concrete pad cracked and requires further investigation
- Temporary repairs underway as required under Boathouse lease

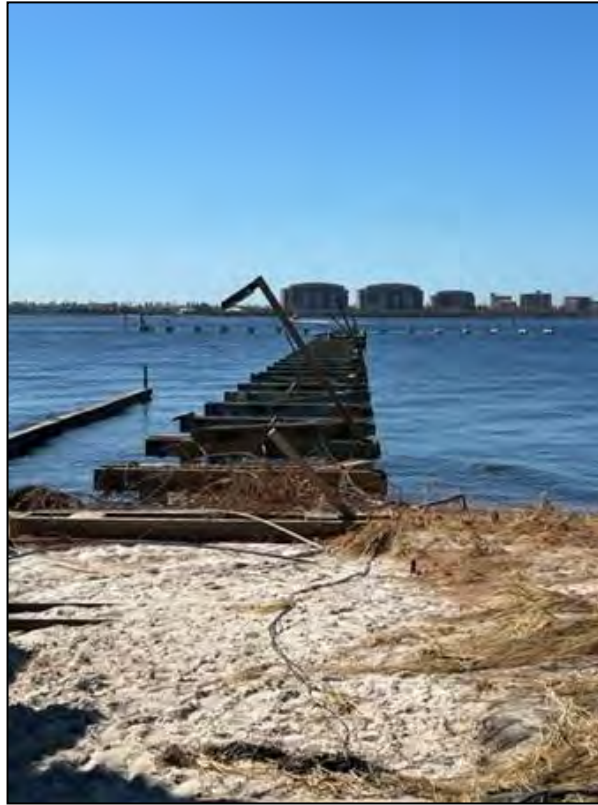
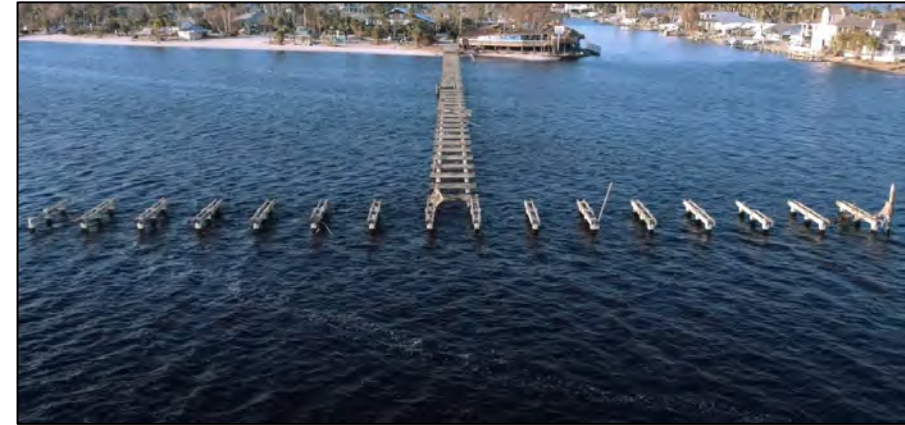
- PIER -

**Estimated cost to
repair: \$1,500,000**

- 800' pier (stem and 'T') severely damaged
 - Driven concrete piles remain – complete structural integrity unknown but compromised
 - Gazebo destroyed
 - Electrical and Plumbing destroyed
 - Decking and railing destroyed
 - Fish cleaning stations not found
 - Benches not found

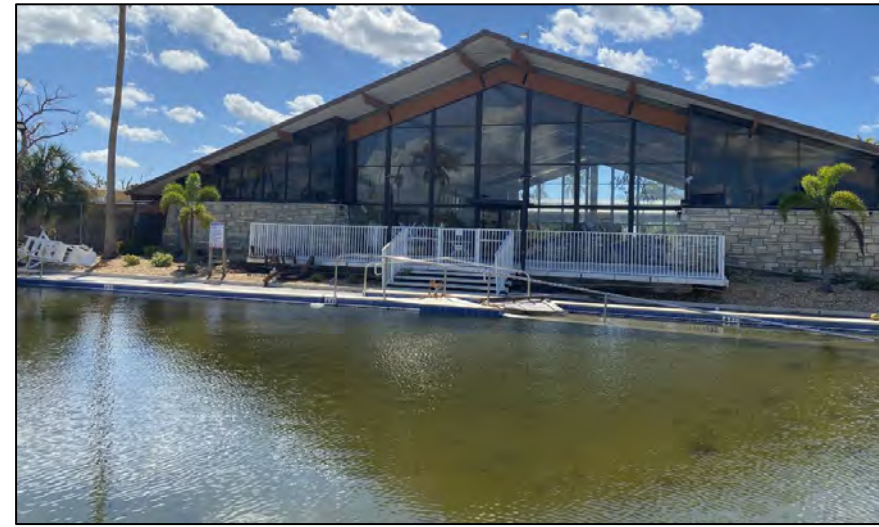
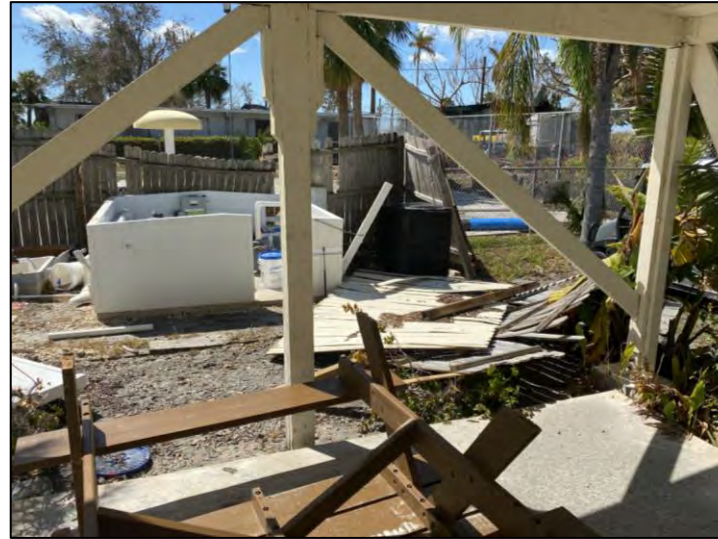
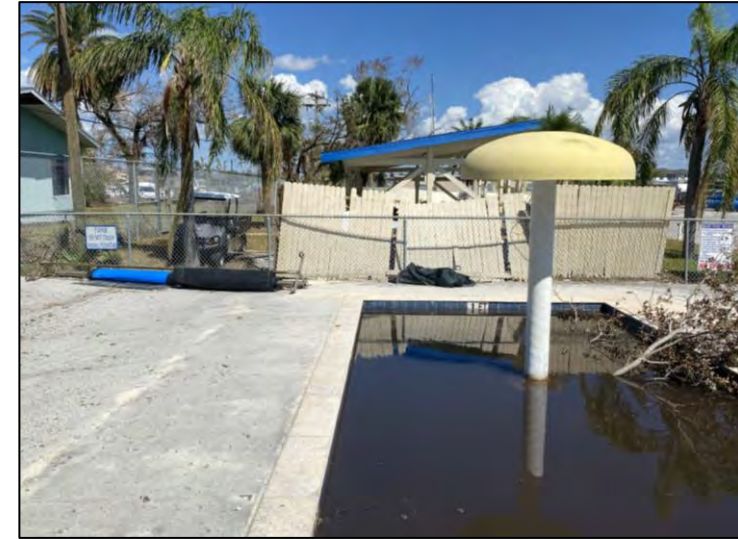
- POOL -

- Pools (main and kiddie) damaged
 - Coping, shell, tile, weir
- Filtration system damaged
 - Pumps, filters, drain lines
 - Chloring Injection and Tanks systems under evaluation

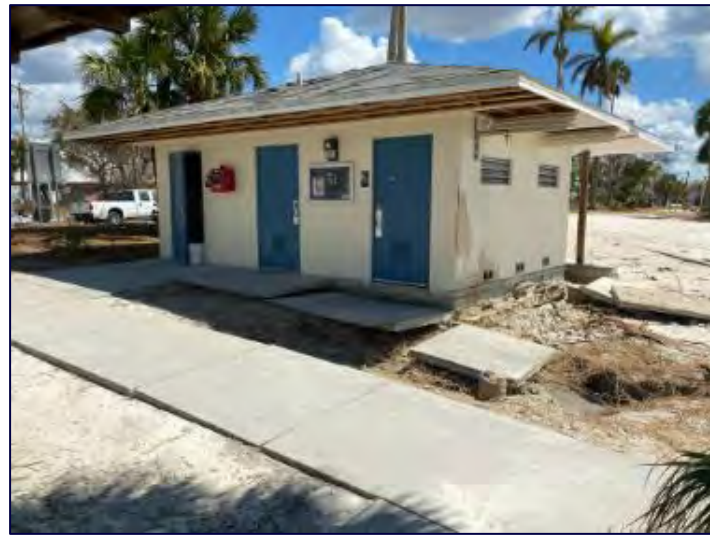
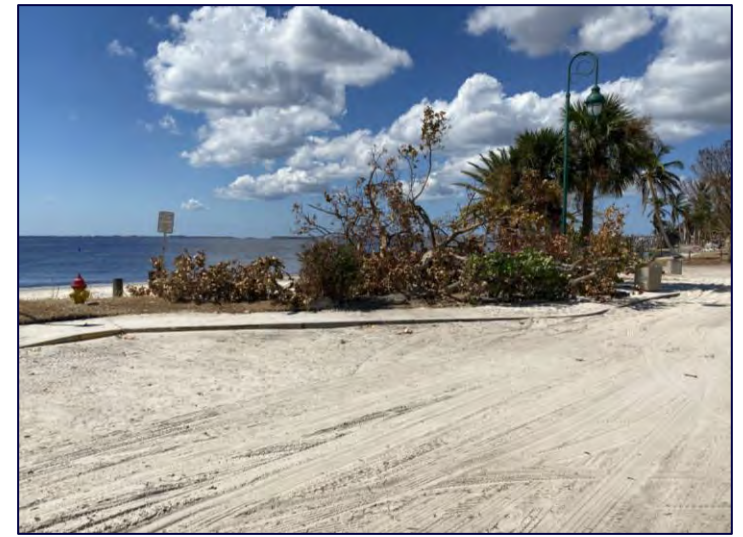
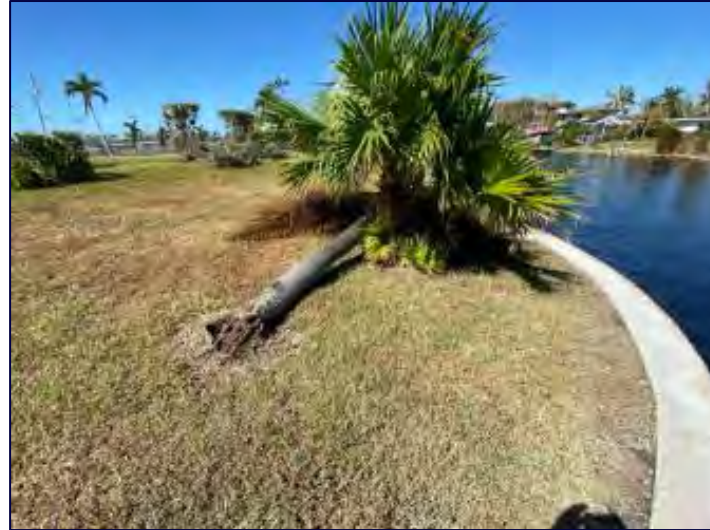
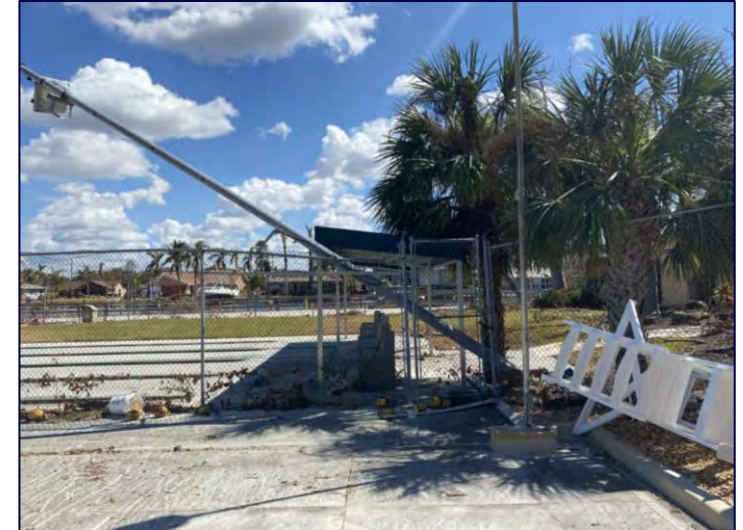
- SITE AMENITIES -

- Building foundations damaged at beach bathrooms and pavilions
- Numerous fallen trees throughout the park
- Fencing destroyed or damaged throughout the park
- Several traffic and informational signs damaged
- 1"-2" of sand throughout parking lots

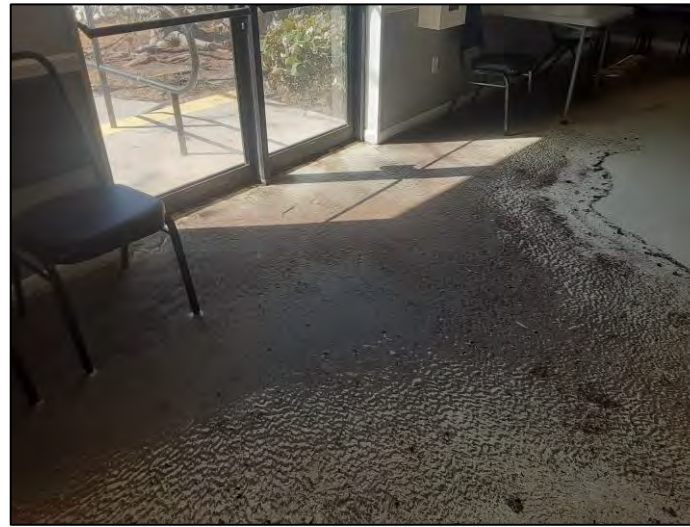
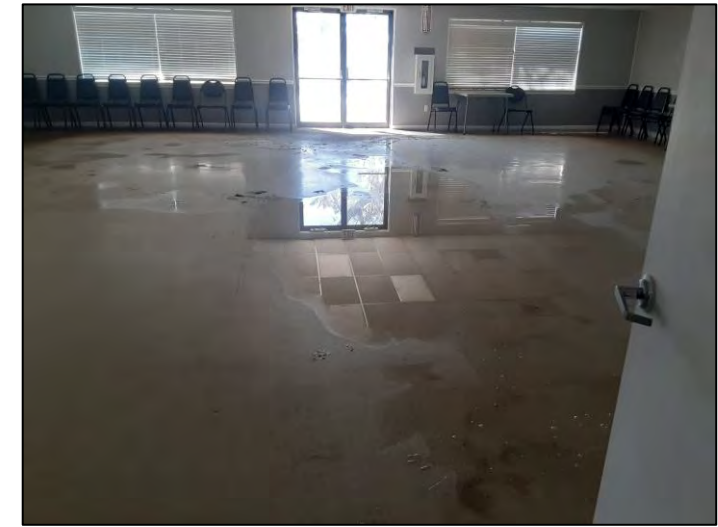
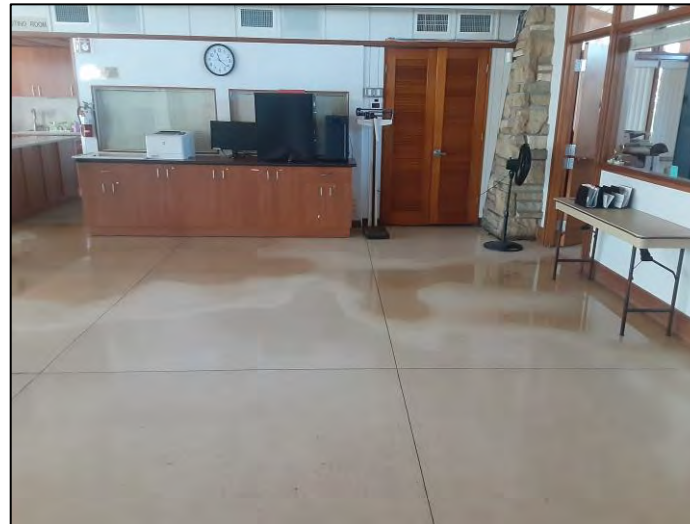
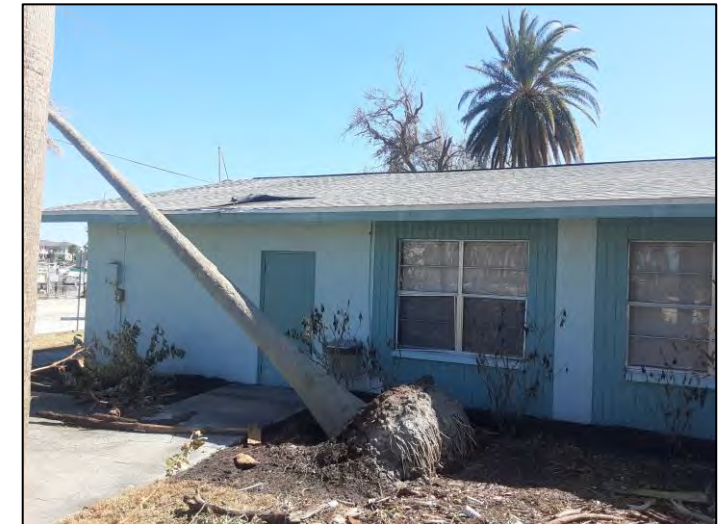
- ROTINO CENTER -

- Roof damage (re-roof 2020)
- Wind-driven rain damaged flooring
 - Thresholds and weatherstrips deteriorated
- Landscaping damaged and/or uprooted throughout

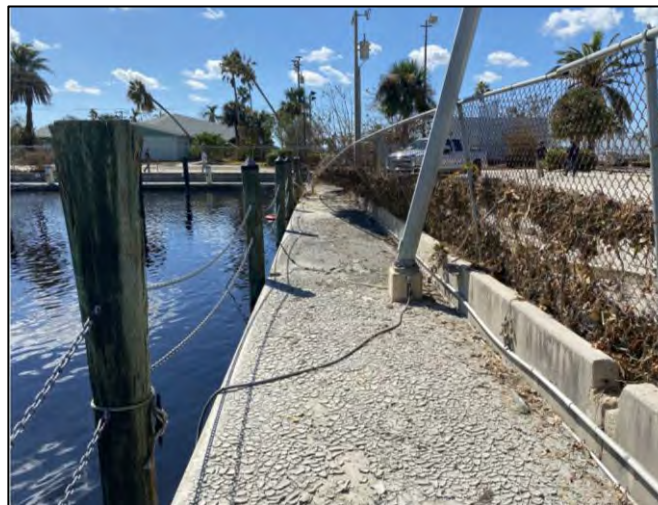
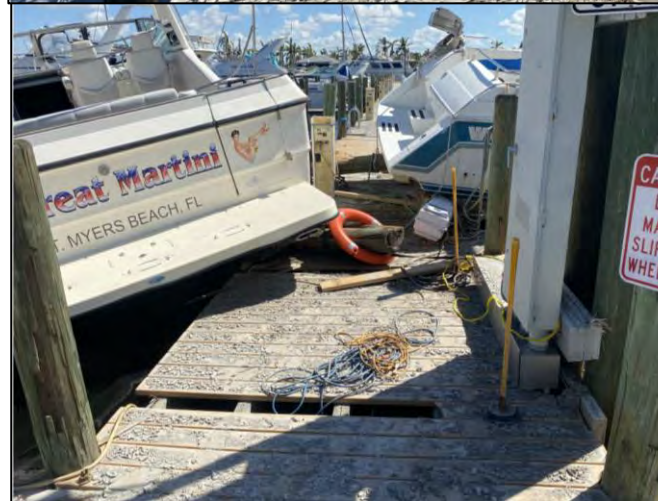
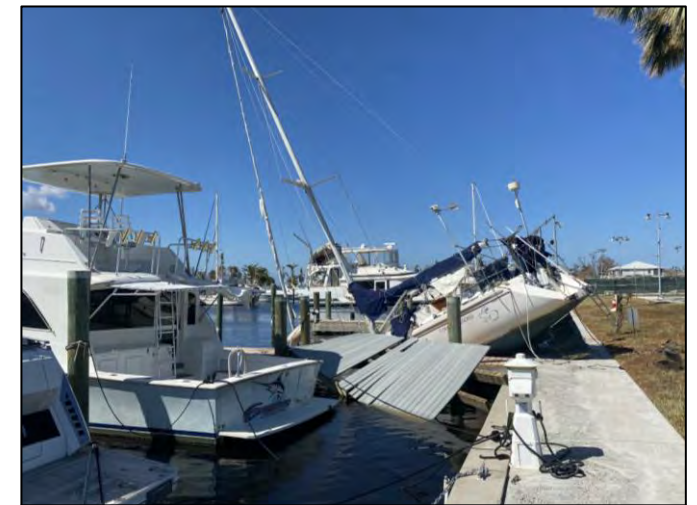
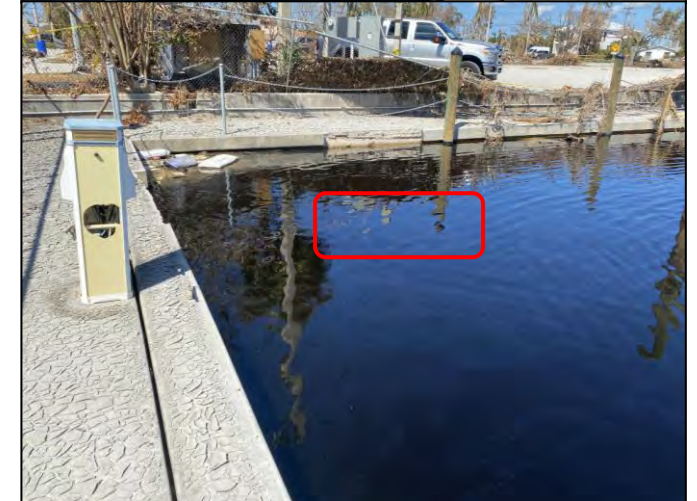
- YACHT BASIN -

- Boat docks damaged/destroyed
 - Boat slips without power and water
 - Decking Damaged
- Area lighting destroyed; electrical system compromised
- Seawall damaged
- Fencing damaged

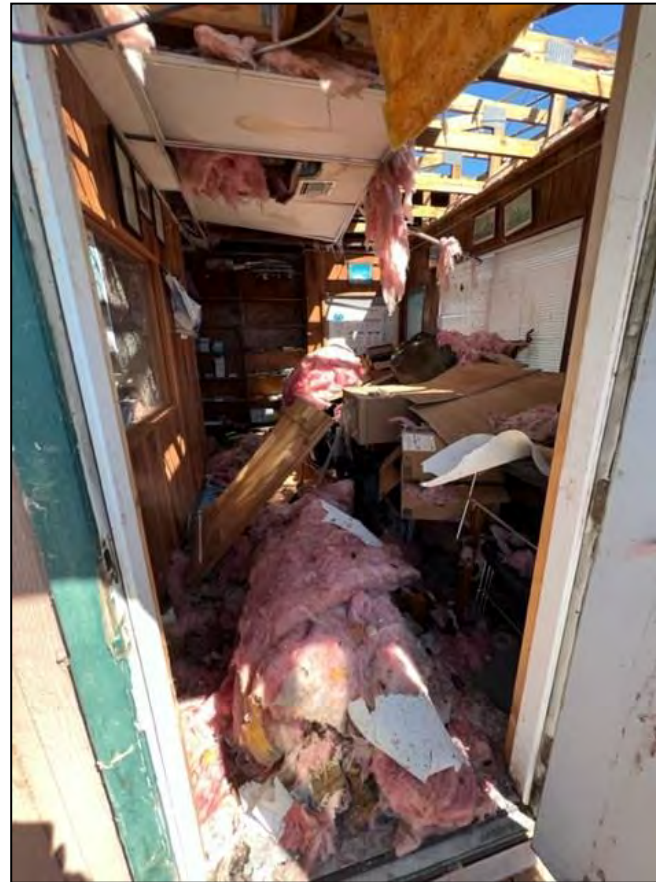
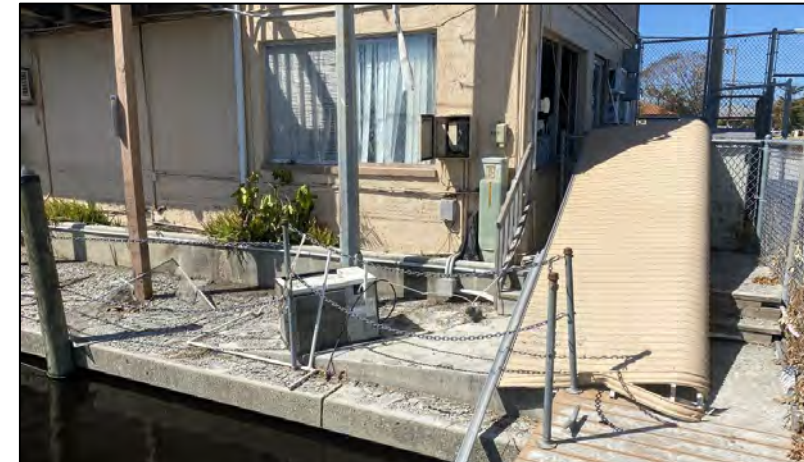
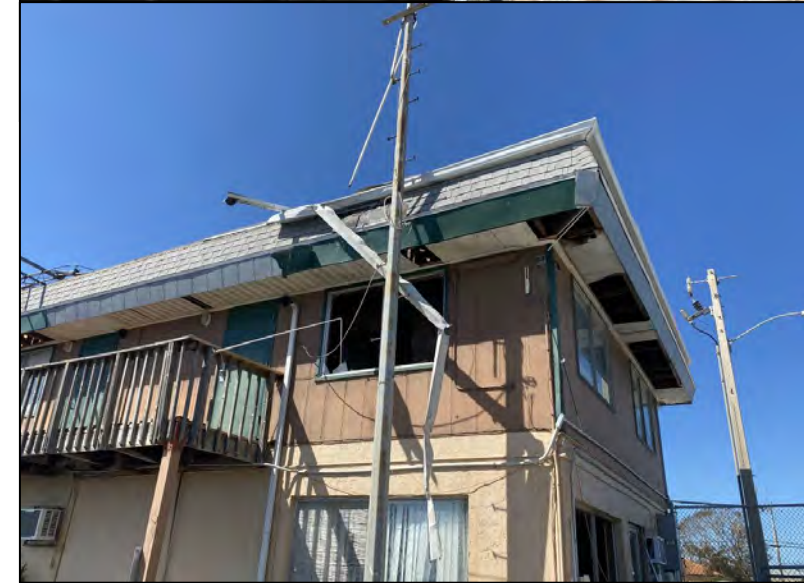
- HARBOR MASTER -

- Building destroyed
 - Roof collapsed
 - Windows broken causing wind-driven rain and flooding
 - Antenna/Radio communications destroyed
 - Area lighting destroyed

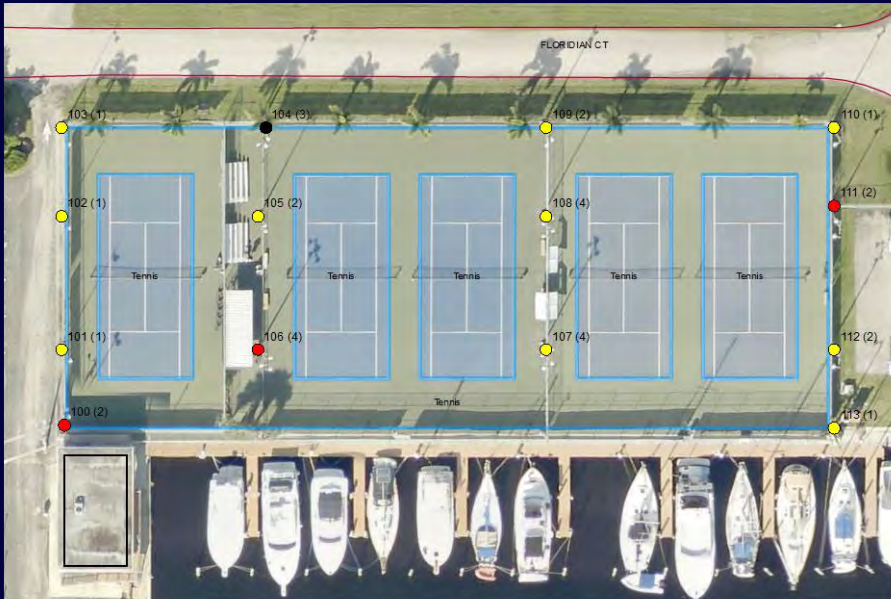
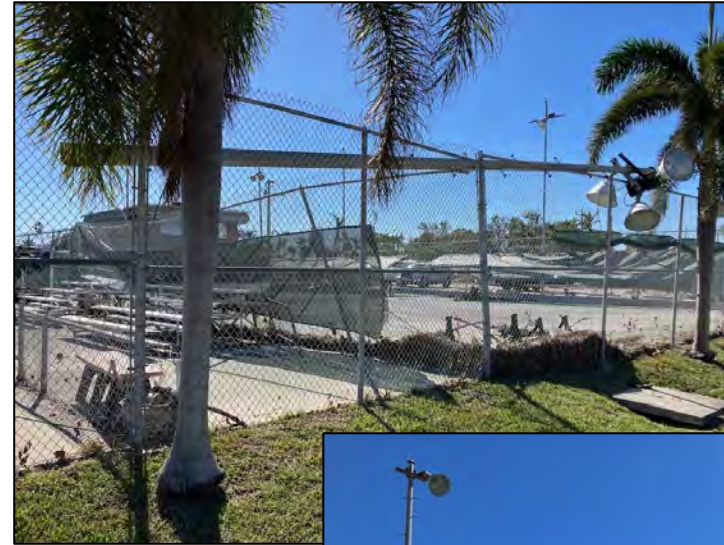
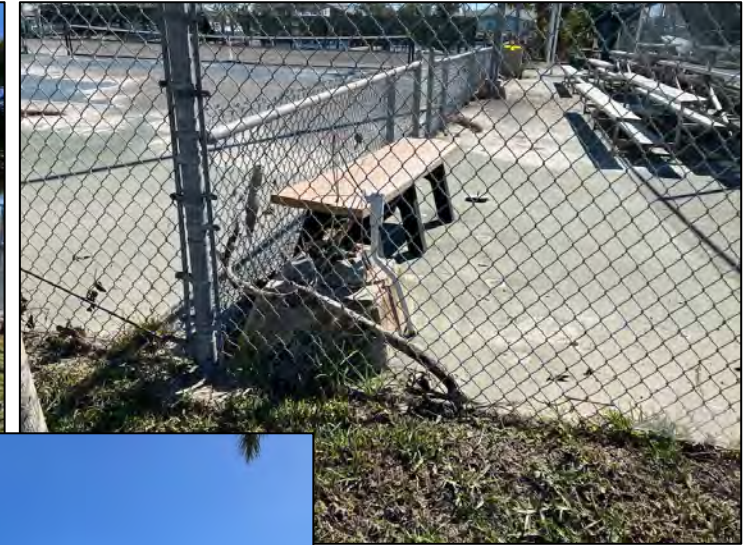
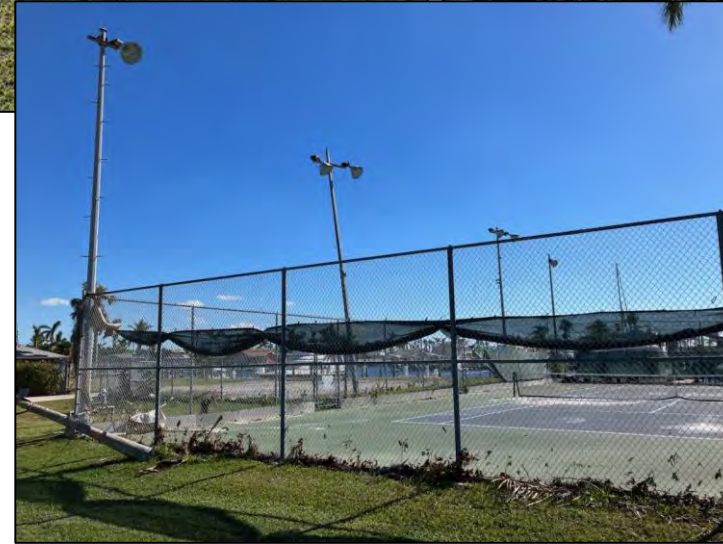
- TENNIS COURTS -

- Tennis court surface flooded, with significant sand deposits, requiring repair and resurfacing
- Tennis court (athletic) lighting damaged
 - One pole destroyed (black dot); three poles bent (red dots)
 - Missing area lighting
- Tennis court fencing damaged

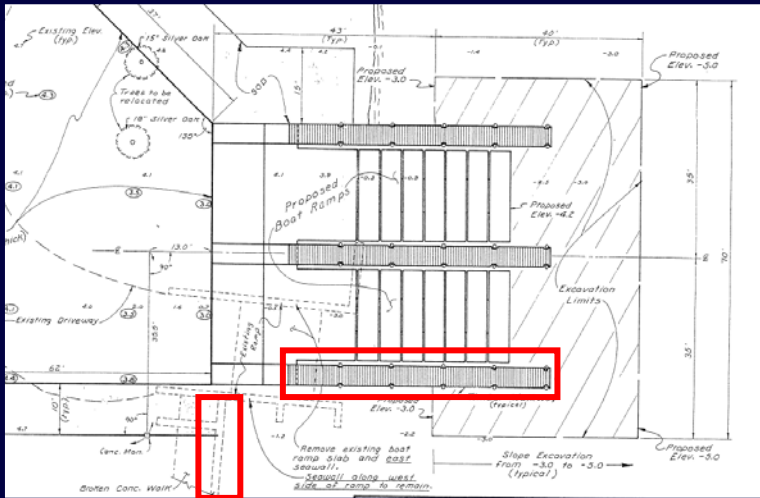
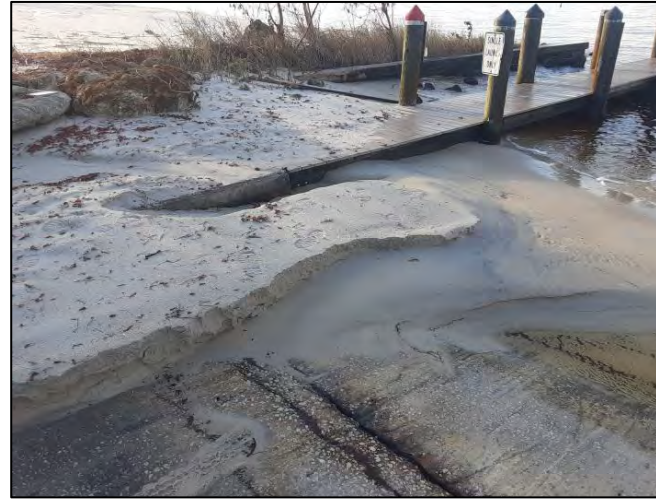
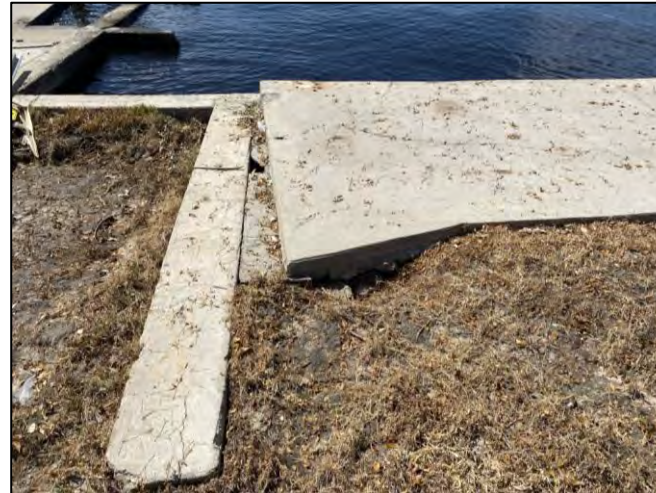
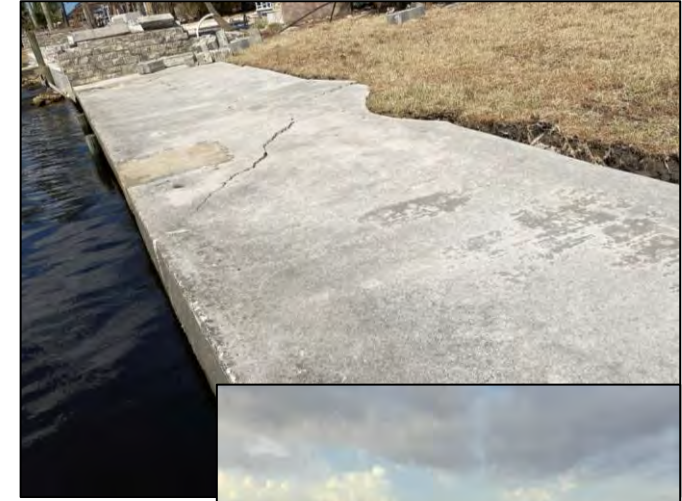
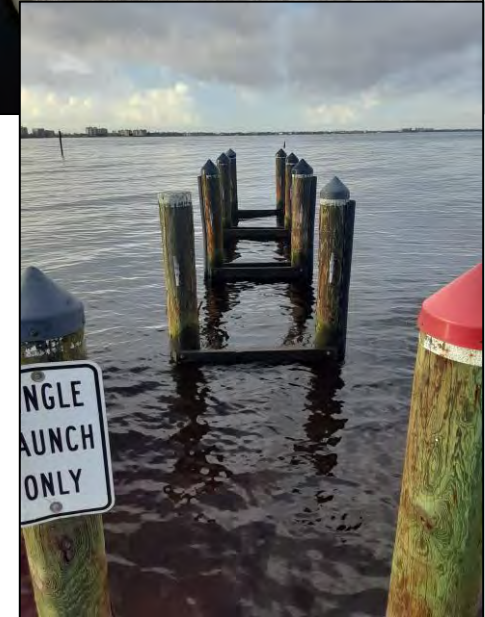
- BOAT RAMP -

- Boat Ramp finger docks damaged - fenders, piling caps, cleats
 - West dock destroyed
- Sidewalk destroyed – upheaved and cracked
- 6"-8" sand cleared from ramp

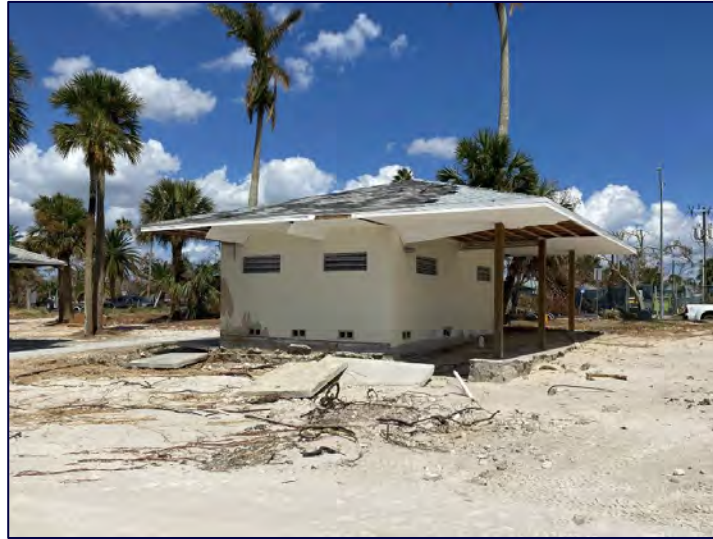
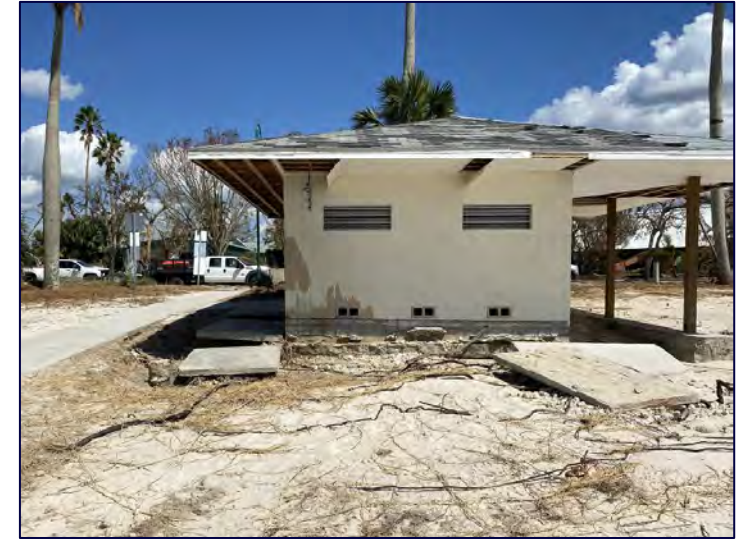
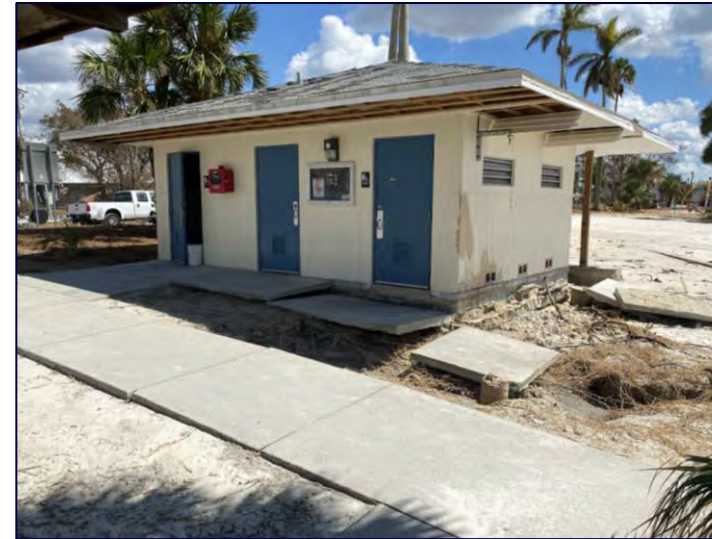
- BEACH RESTROOM -

- Roof/soffit damaged
- Foundation compromised
- Sidewalk/walkway collapsed

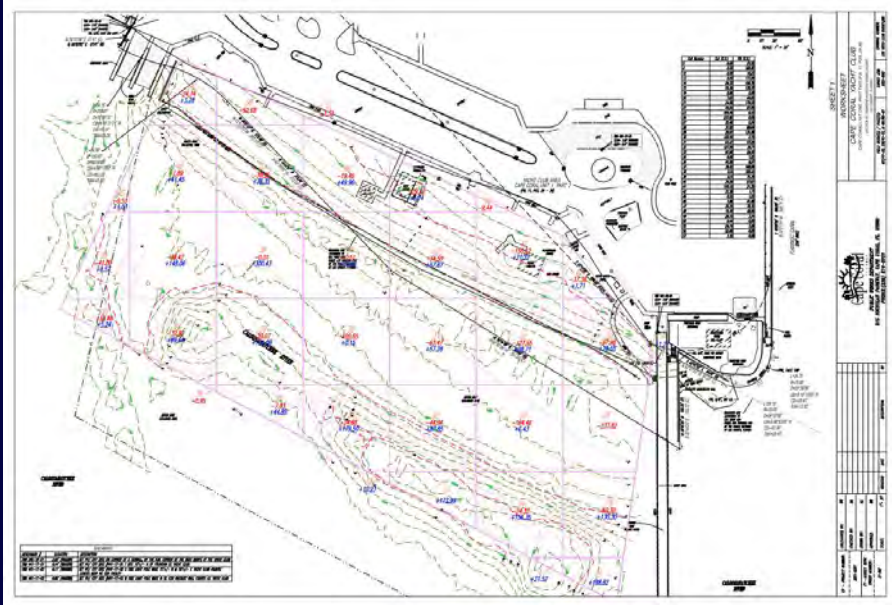
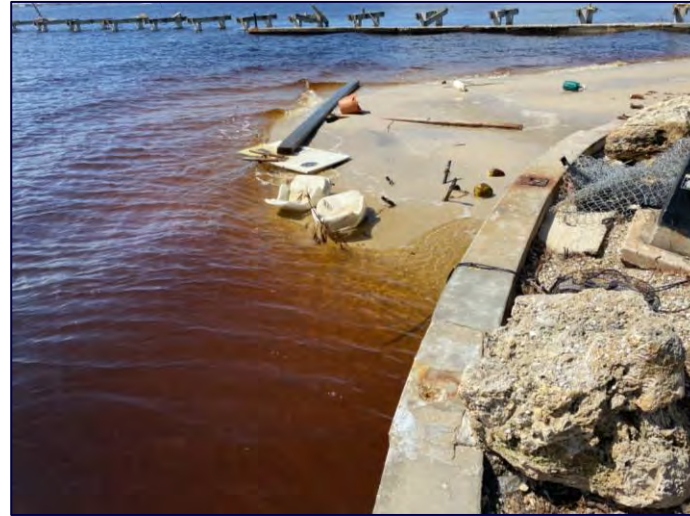
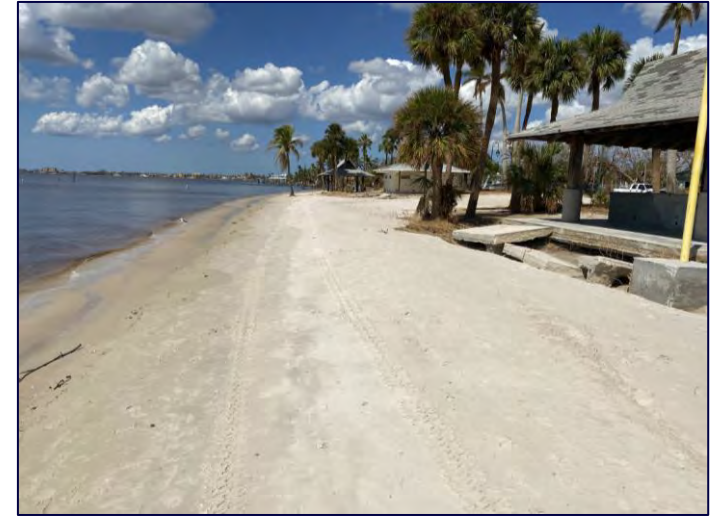
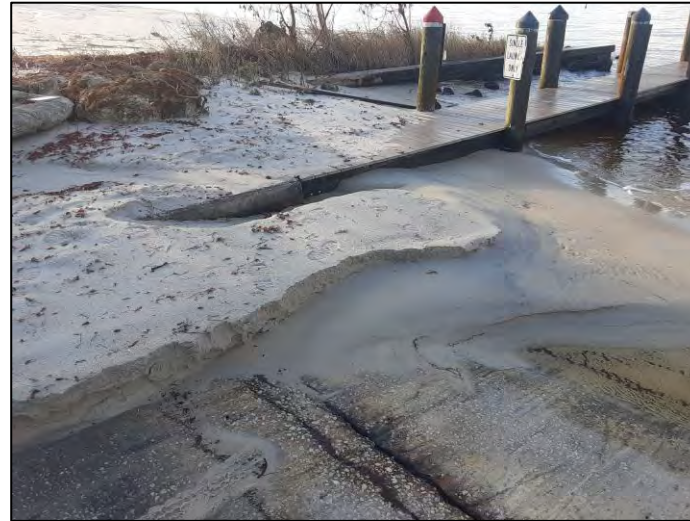
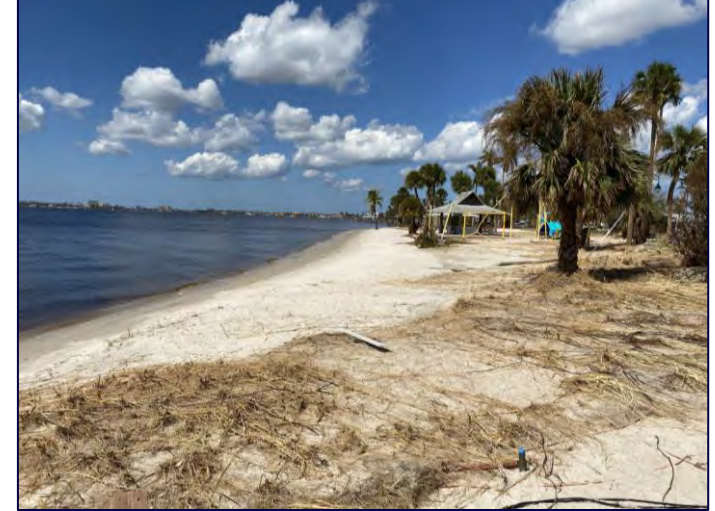
- BEACH -

- 3,646 cubic yards of beach displaced
 - NFL football field at two-foot (2') depth
- Beach structure foundations compromised (bathroom/pavilion)
