**BURNS FIELD
WARMING SHELTER / FIELD HOUSE
HINSDALE, ILLINOIS**

September, 2009

Completed by:
Anne T. Sullivan, AIA

BURNS FIELD WARMING SHELTER

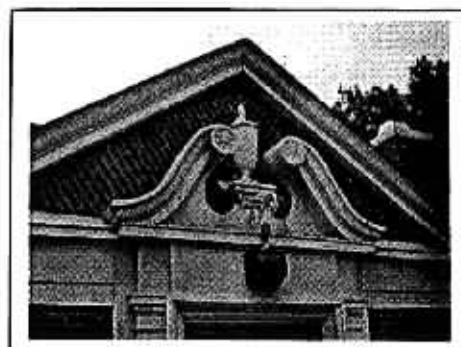
Image 6: Pediment over entry

- Decorative wood scrollwork flanking an engaged urn are positioned over the entry doors on the east and west elevations, within triangular pendentives. (Image 6) These are generally in very good condition; the wood appears well maintained and regularly painted. No obvious deterioration or rot was observed. The curved scroll elements are covered on their top surfaces with painted metal flashing. The original drawings show "copper flashing" in these areas; this may still be the original flashing, now painted. This is an excellent way to protect these surfaces from water damage. The wood elements are very stable, but should be both watched and maintained regularly.

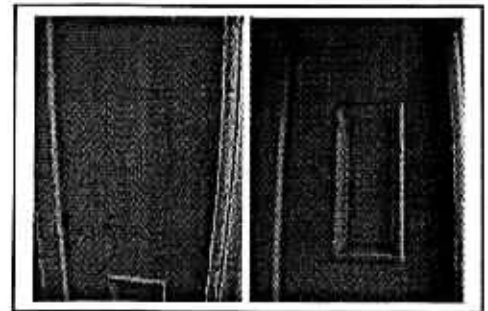
Image 10a & b: Missing and original jamb panels

- The east and west doors are deeply inset, framed by paneled door jambs. One of the inset panels at the west entry door has been replaced with flush wood. (Image 10a) Restoration should include replacing the solid panel with an inset panel and raised trim to match adjacent. (Image 10b)

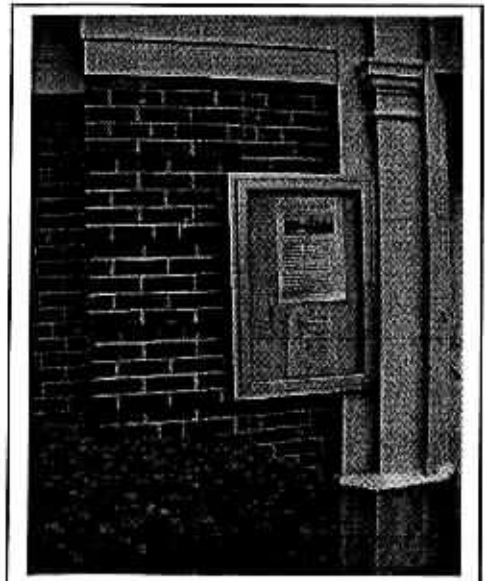
Image 11: Board at west entry

- An aluminum framed bulletin board is positioned to left of the west entry door. It is modern in style, and should be replaced with one more compatible with design of building.

possibly integrating a painted wood frame.(Image 11) The new unit should be centered within the brick field to the left of the door.

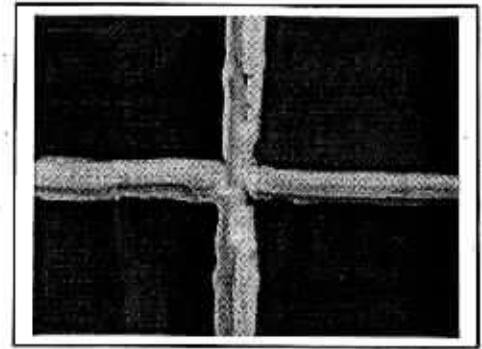
- The windows in the central pavilion are in worse condition than the other windows, probably due to greater use and possibly to vandalism. These windows area in poor condition but not irretrievable. Window sills are deteriorated by UV light; and in need of replacement or epoxy consolidation and repair. The wood sash can also be restored with an epoxy repair system. Some of the muntins will need to be re-milled and replaced. (Image 15) Holes remain in the window surrounds from where metal screens were once fastened, and should be filled. (Image 16)

Image 15: Detail of deteriorated muntins

- We recommend that the original wood double hung windows be retained, restored and re-used. We think they should remain operable, and that traditional wire screens be fabricated to allow for them to be opened during the summer months to provide greater cross-ventilation (in

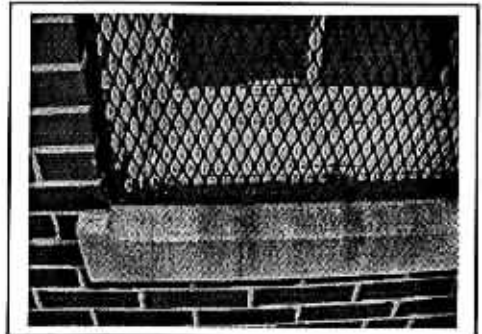
- Protective grates were installed over the windows in the one-story wings. (Image 17) These remain over windows leading to the mechanical room and bathrooms. They are not present over windows leading to the warming shelter. Rust staining was observed on the limestone window sills, resulting from the window grates. If there is no longer a security issue at these windows, the grates should be removed. If security continues to be necessary, remove the existing and replace with stainless steel or galvanized grillwork; preferably in a design compatible with the historic building, or at least less institutional than what exists.

Image 17: Corrosion at screen over window

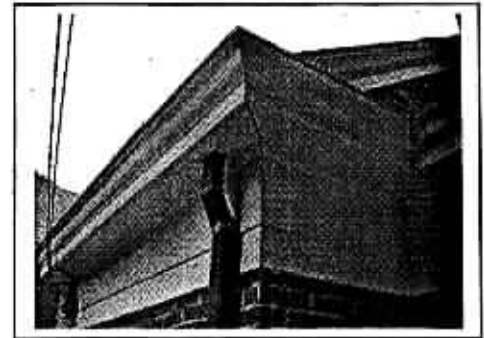
Image 20: Cornice with integral gutter

- Some wood deterioration was noted at the joints where the soffit trim meets or changes direction. (see Image 20). This is not unusual, as wood is most susceptible at the end grain; but these areas should be regularly monitored and maintained. The joints should be painted only - caulk should not be utilized at open joints, as it can trap moisture and make the deterioration accelerate.

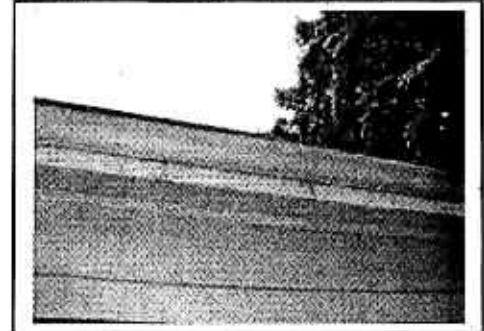
- The fascia and cornice are in very good condition; except for several small areas of staining and possible wood deterioration due to gutter leaking. (Image 21) Our discussions with Mr. Piontkowski indicate that these leaks were alleviated when flashing repairs were made last year (2008).

Image 21: Stains from past leaking at gutter.

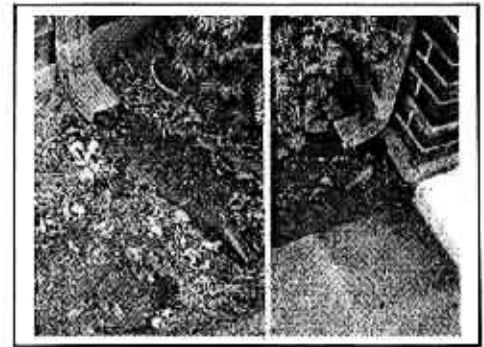
Image 23a & b: Existing and missing splashblocks

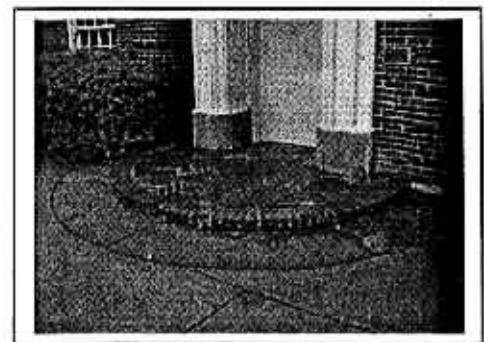
Image 24: Entry stoop at east entry

- Brick semi-circular stoops once lead to the entry doors on the east and west elevations. The stoop on the east elevation remains (Image 24), but that on the west entry has been either removed and replaced with concrete or

- If handicapped accessible entry is required to this building, the concrete walkway should be sloped up to meet the semi-circular brick entry stoop. The semi-circular stoop on the west elevation should be restored / recreated based on historic drawings.
- The east entry stoop appears in fair condition; there are some missing bricks that have been patched with concrete; others with a somewhat compatible matching brick. The stoops should be repaired and reset as part of a larger restoration campaign. An excellent matching brick should be obtained.
- The concrete sidewalk around the east entry stoop was carefully scored to compliment the design of the semi-circular brick pattern. This paving pattern should be replicated on the west elevation in the new paving which will be sloped up to the stoop.

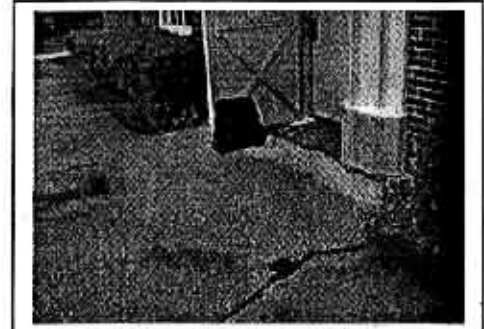
Image 25: Paved stoop at west entry

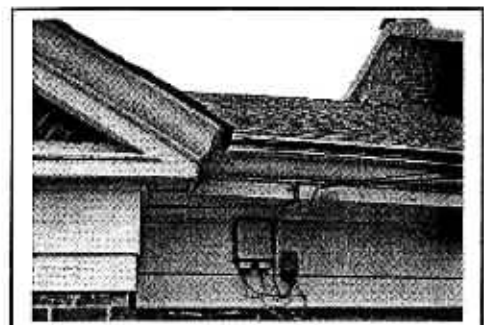
Image 26: Obsolete telephone wiring

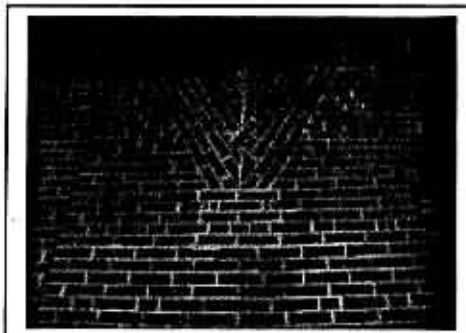
Image 33: Detail over north fireplace

- Brick repair work has been undertaken on the interior which was not as masterfully done as on the exterior. The iron firebox linings were replaced about 10 years ago, necessitating disassembly of the lower half of the fireplace wall. The replacement brick is a fair match, although it does not have the variation in colors that the original brick has. Some detailing near the top of the north wall chimney was poorly patched, and should be re-constructed in a restoration effort. (Image 33).

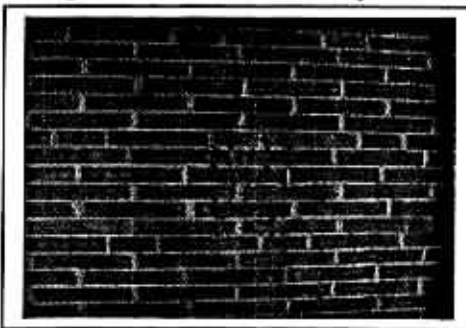
- Miscellaneous brick cleaning, replacement and patching should be undertaken in a restoration program. Hazy areas appear on the brick, pointing to the need for interior cleaning, and previous masonry anchors have left holes in the brick and mortar. (Image 34)

Image 34: Detail stained and deteriorated brick

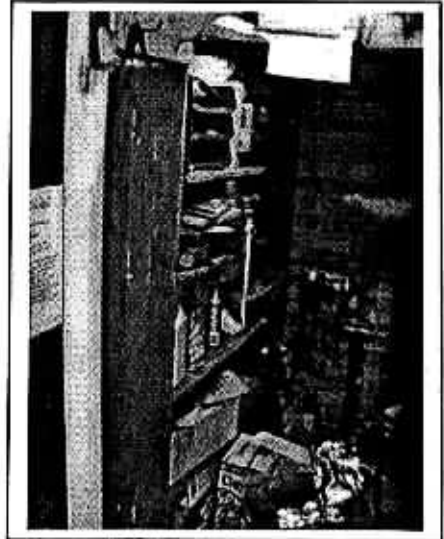
Image 40: View into storage

- The small storage space houses a variety of things pertaining to maintenance of the building, the concessions, and the daycare. (Image 40). The existing wood shelving should be removed and new stainless steel shelving installed to provide as much storage as possible within the small space.

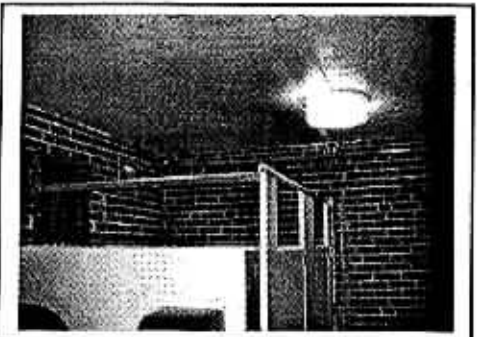
Image 42: Partitions in Rest Room

- The concrete floors should be stripped and coated with a non-slip coating as recommended for the field house.
- The plaster ceiling in the restrooms appears to have had a number of coats of paint or other skim coating. (see Image 42) It is patchy in areas. Either the existing should be replaced with a new Keene's cement plaster coating, or blueboard with a plaster skim coat should be applied over the existing.

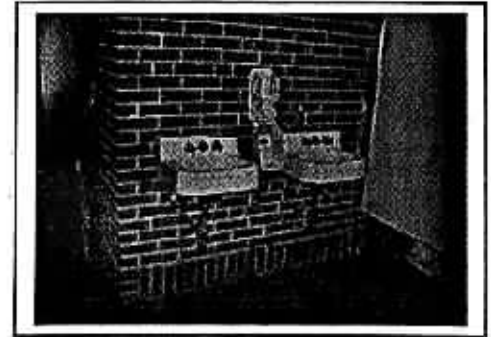
Image 44: Sinks in Rest Room

- The porcelain-enamel steel sinks are nearing the end of their serviceable life, and one or more of them are spalled and corroded. (Image 44) These should be replaced with similarly designed wall-hung sinks and outfitted with water-conserving faucets.
