**Notice of Demolition
Request for Bids**

**# 2 Iris Ave.
Pontoon Beach, IL 62040**

ASBESTOS INSPECTION SURVEY

2 Iris Avenue Pontoon Beach, IL 62040
--

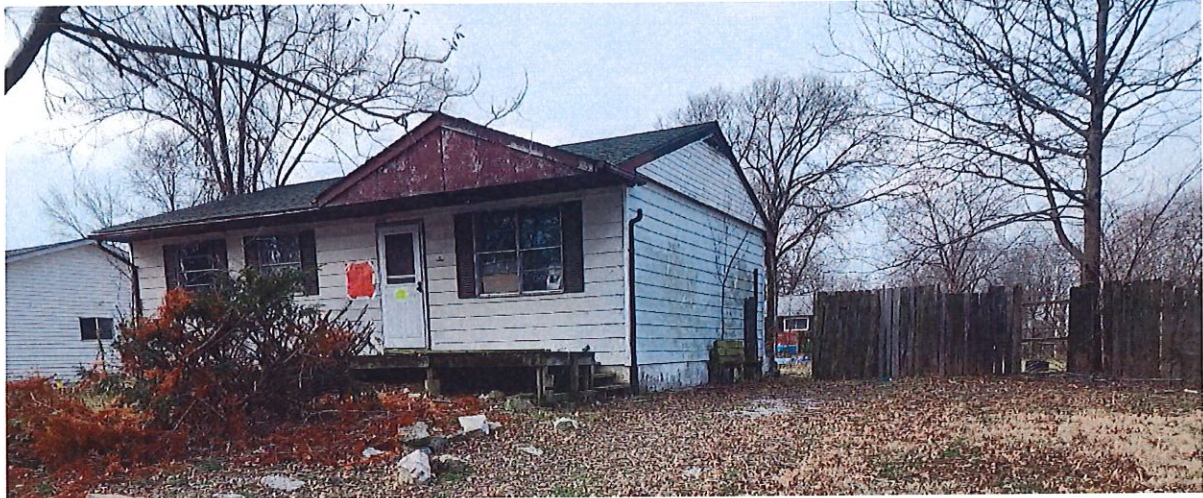
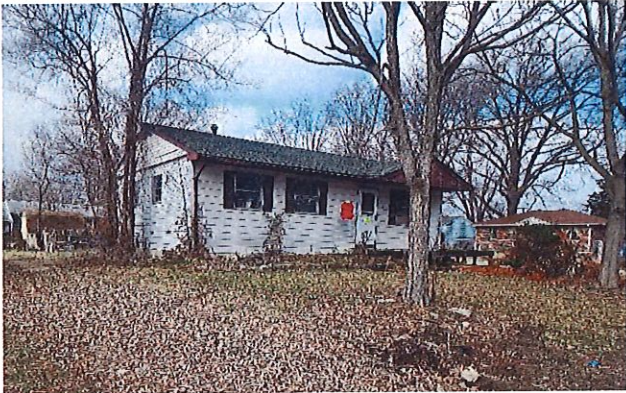
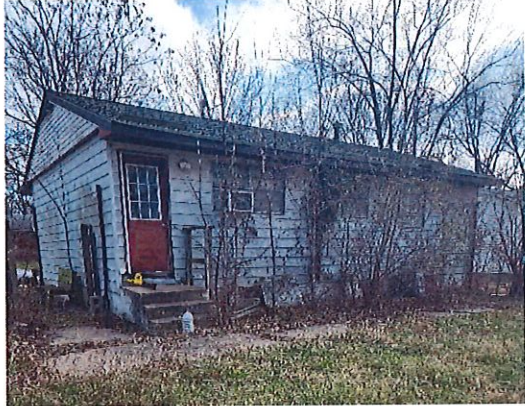
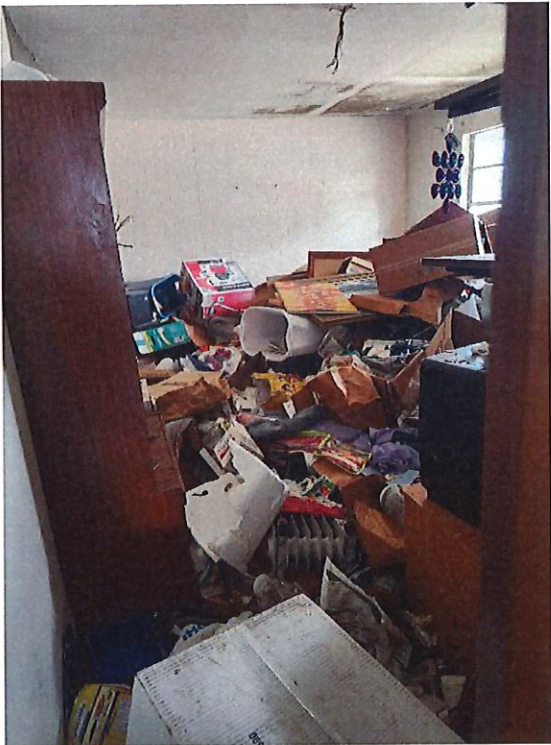
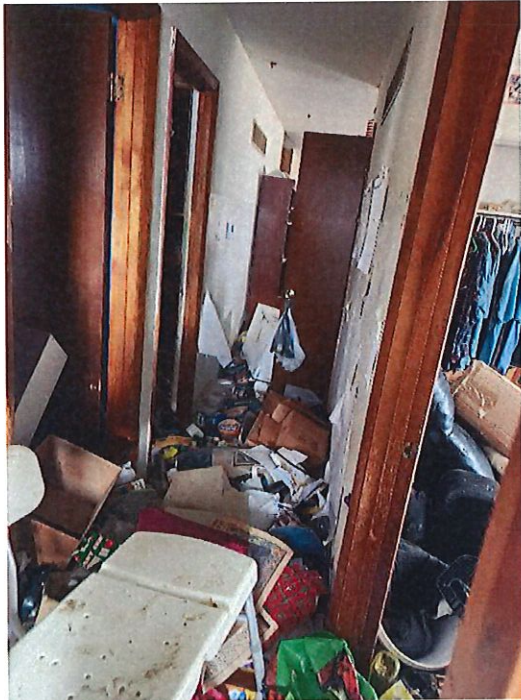
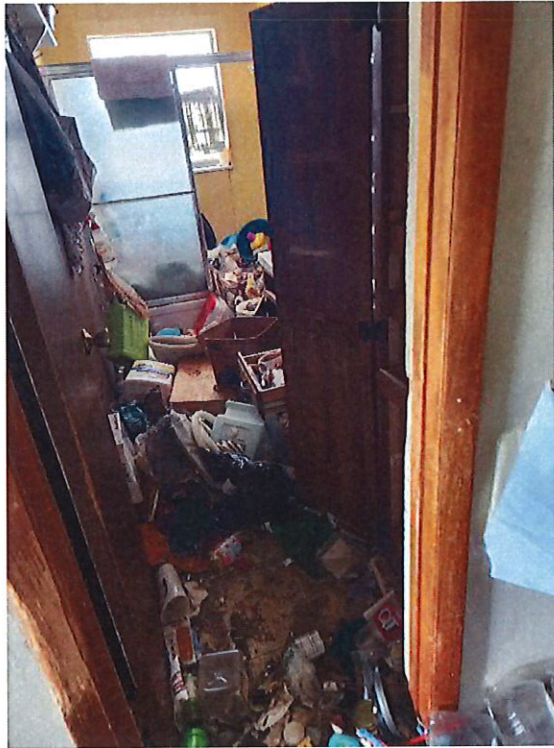
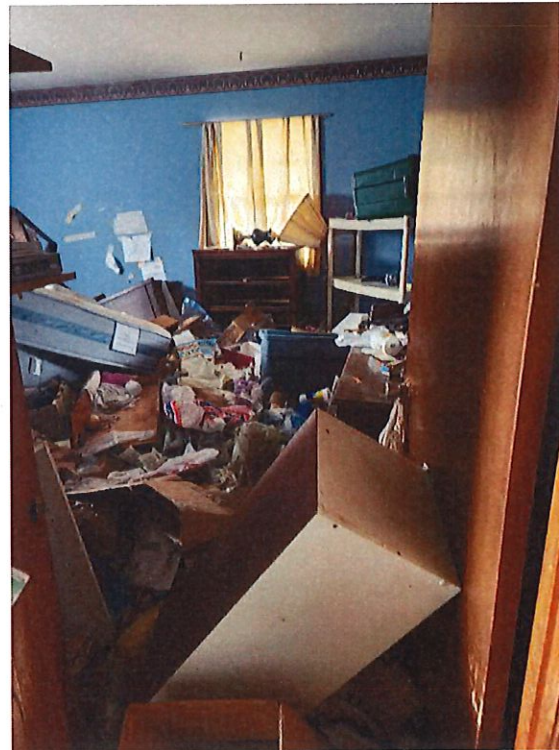
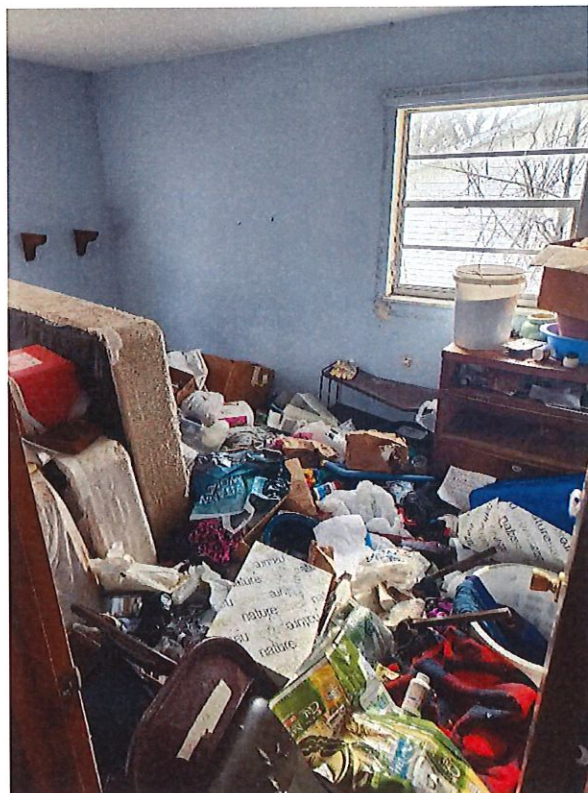
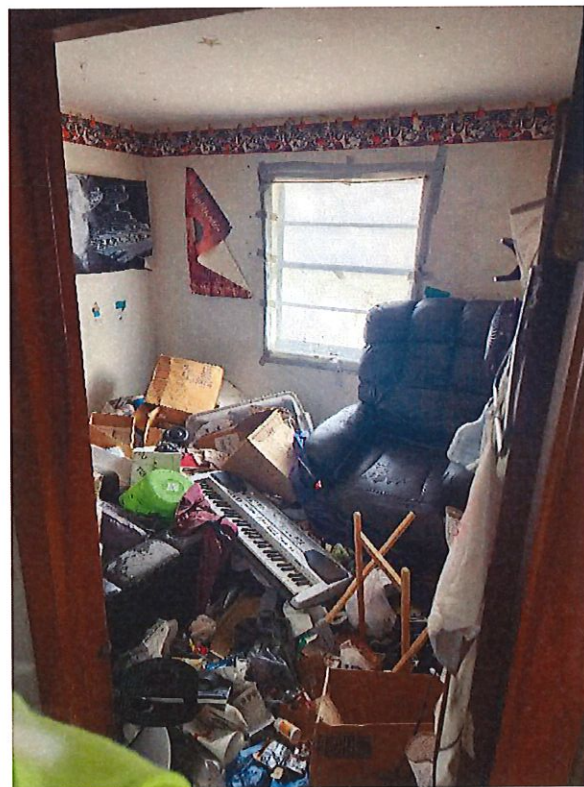
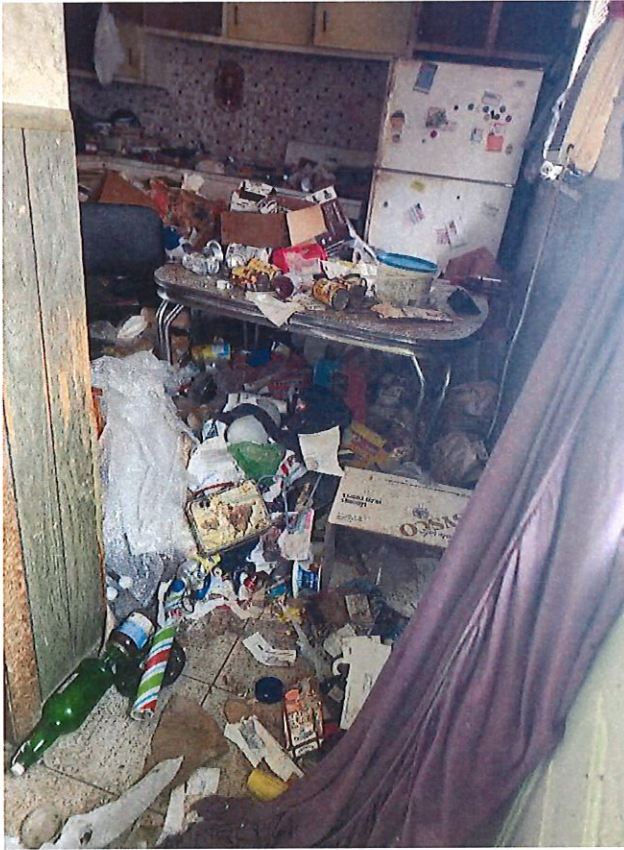
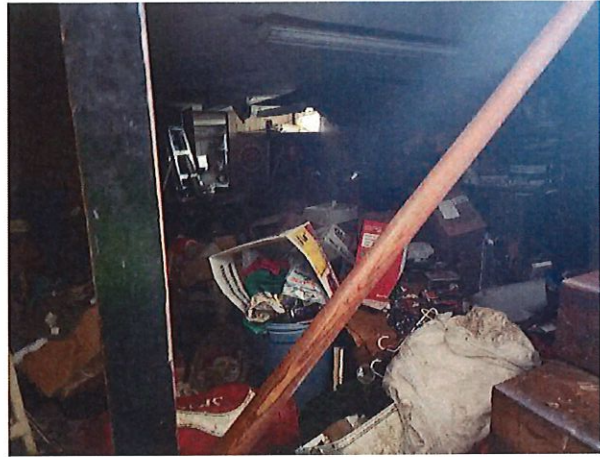
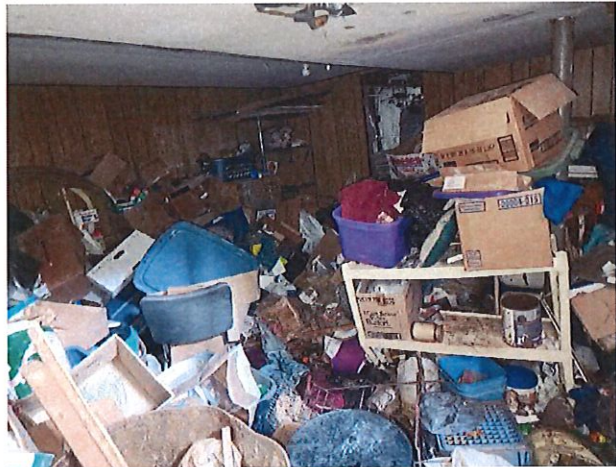
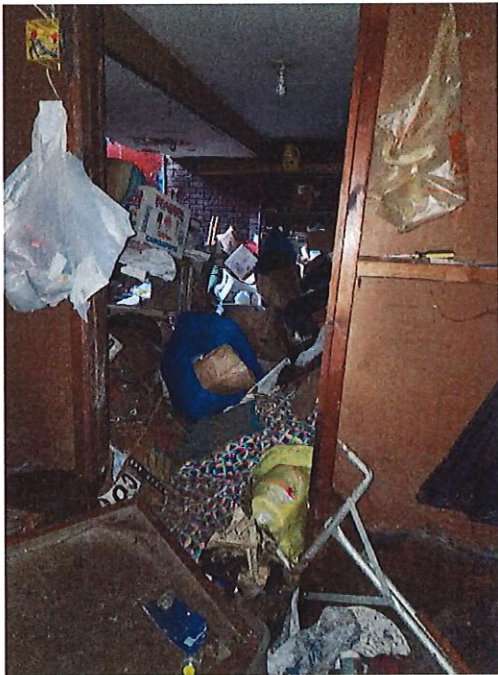
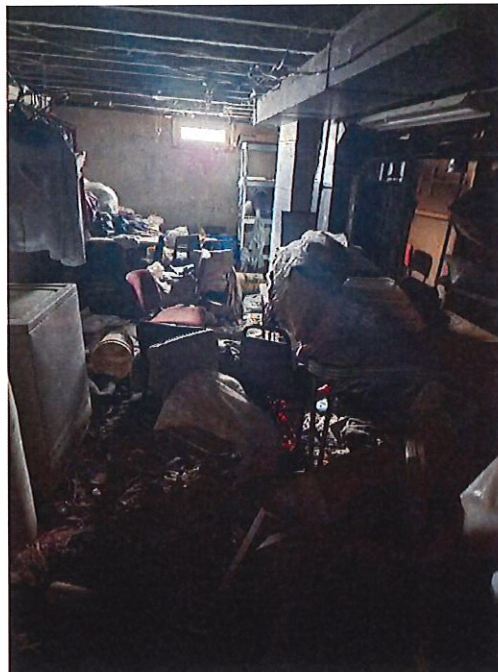
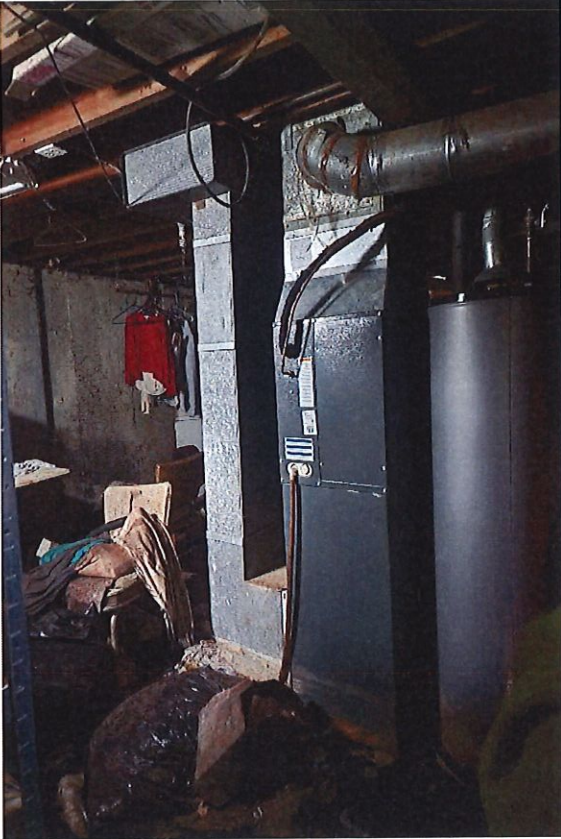
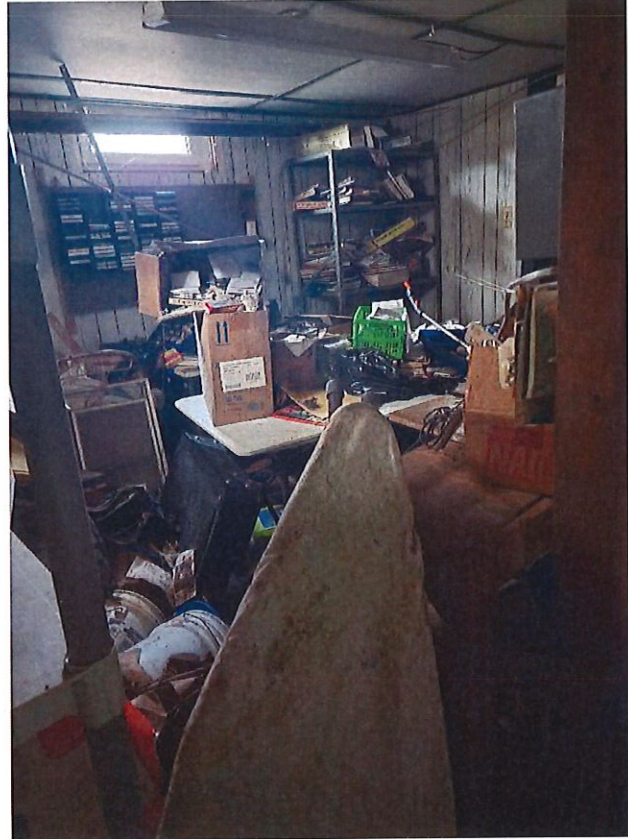
Please be aware throughout the whole structure there is roughly 2-3 foot of trash and debris. See attached photos for condition.
