CITY OF McBAIN
MISSAUKEE COUNTY, MICHIGAN

USDA – Rural Development
Preliminary Engineering Report
Water System Improvements

January 2020

WATER SYSTEM REVIEW

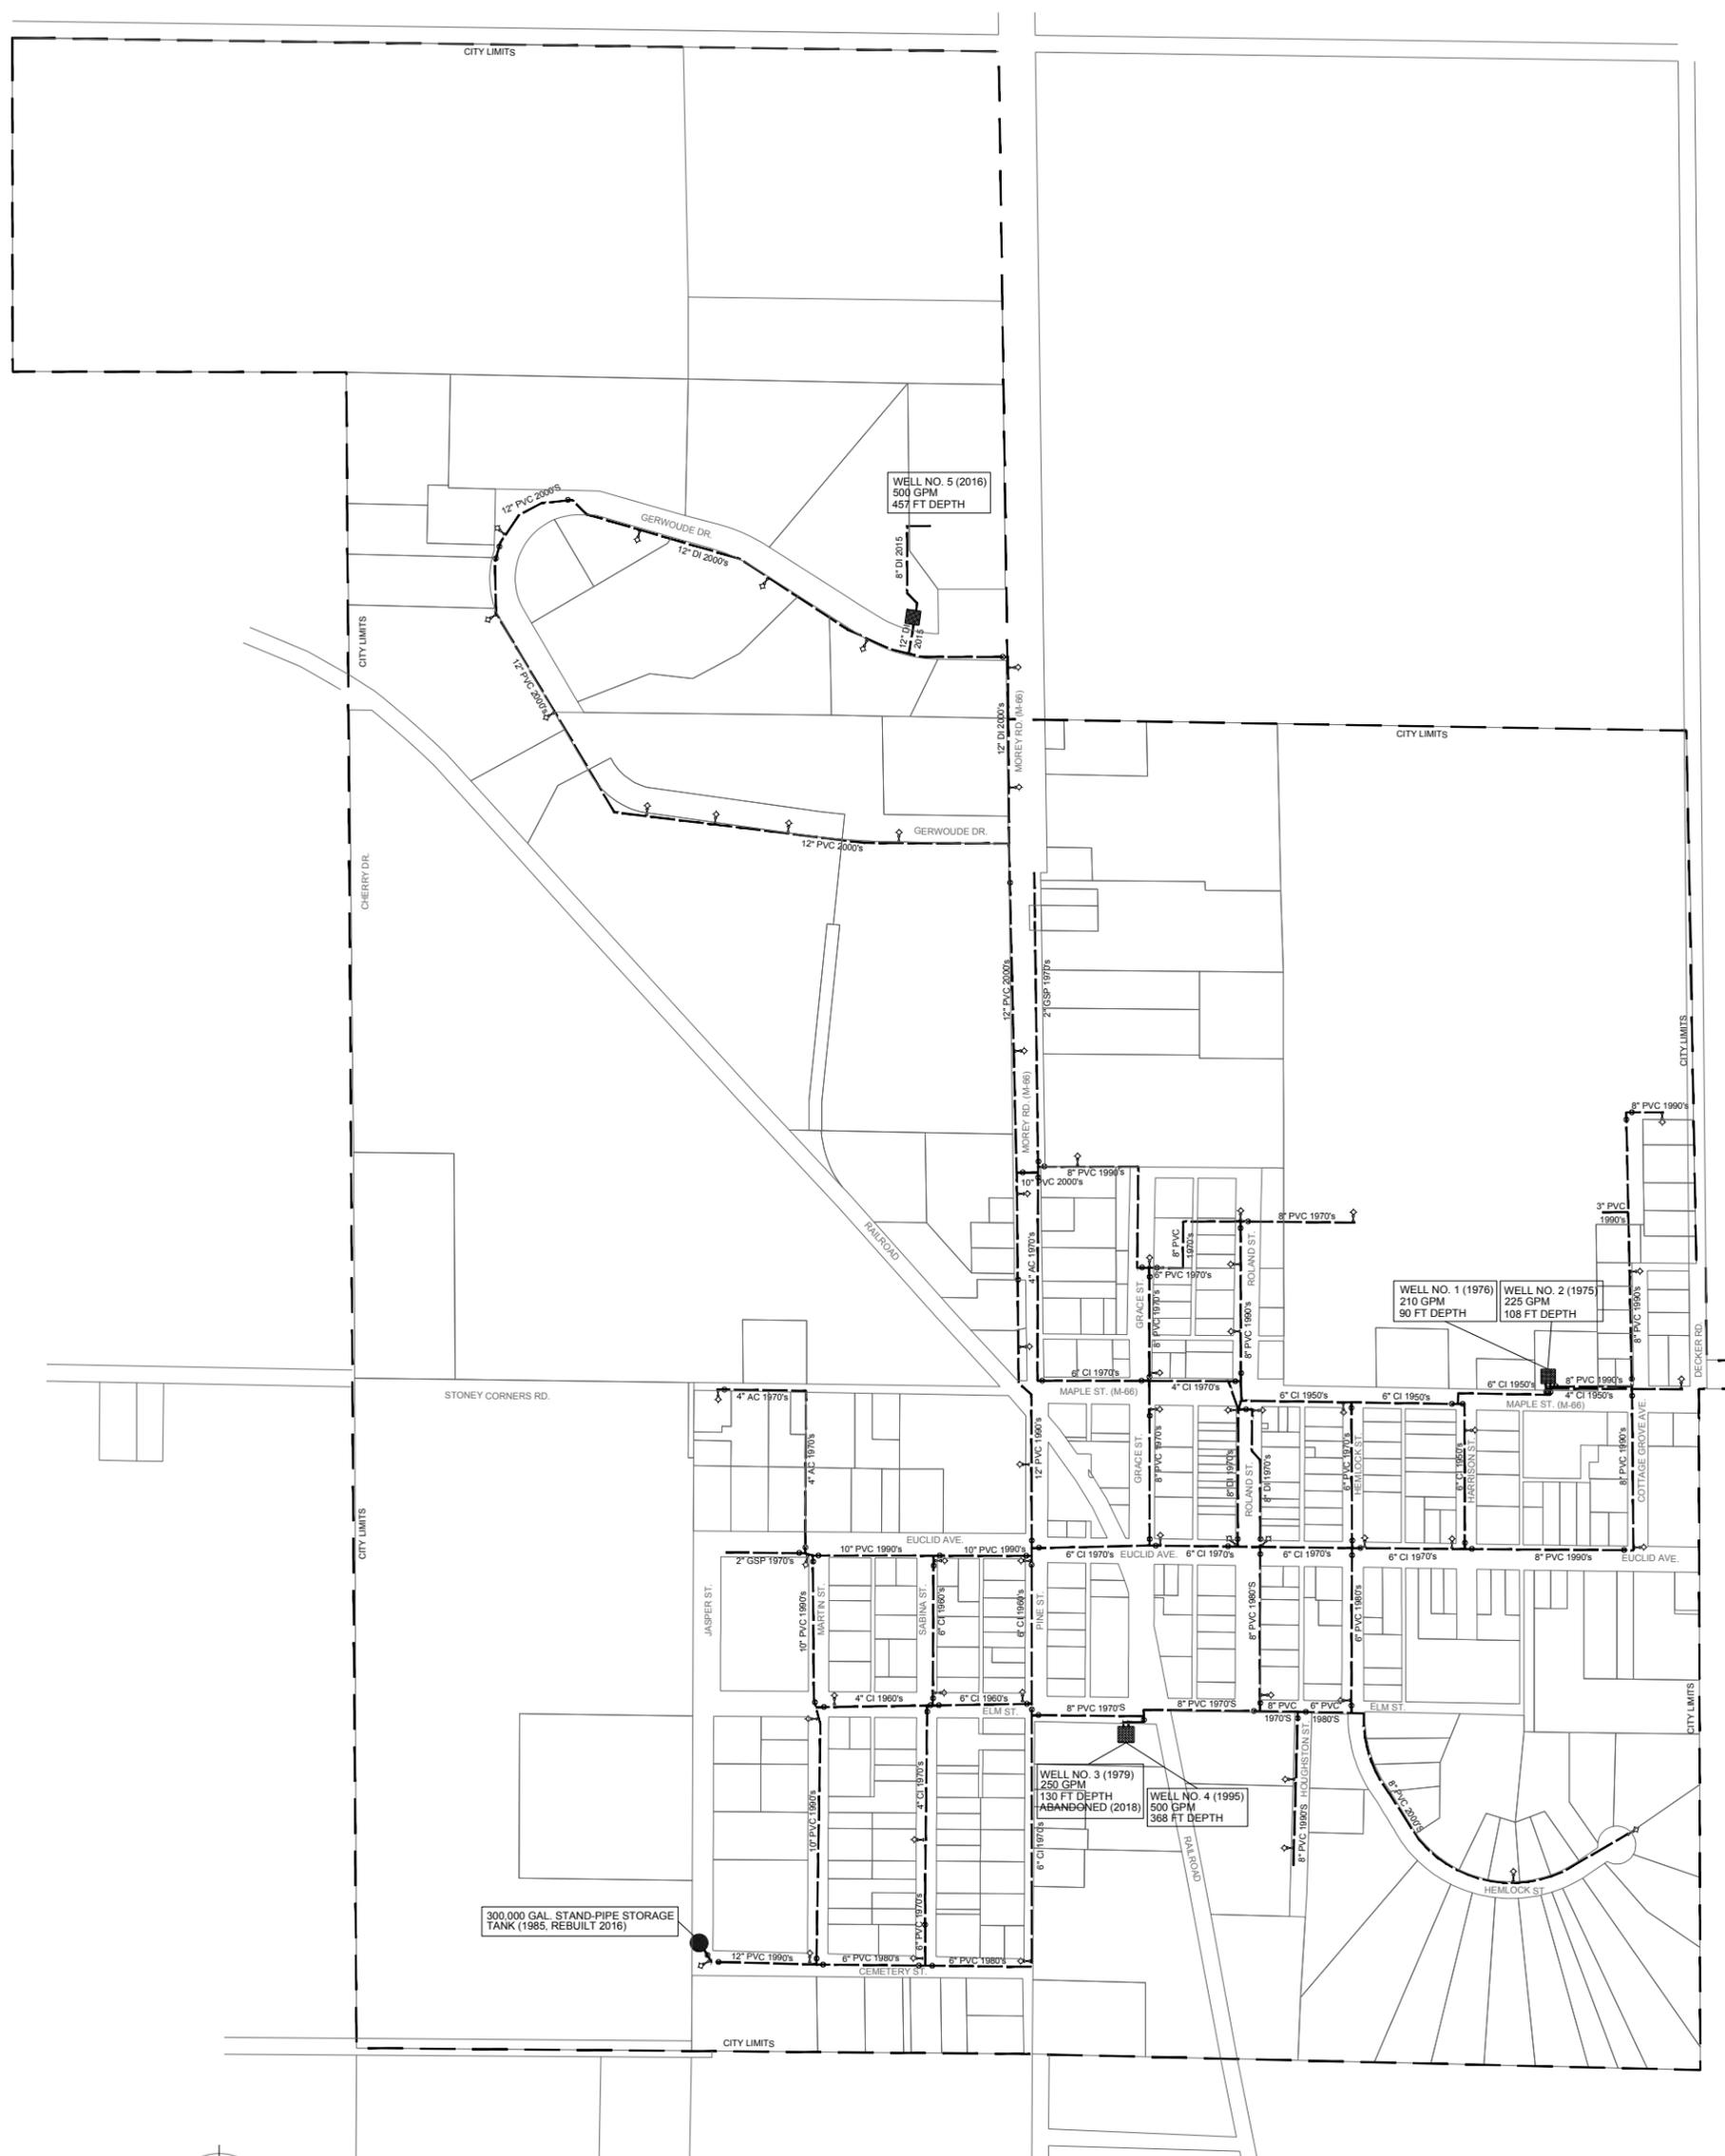
FIGURE 1 - EXISTING SYSTEM

**CITY OF McBAIN
MISSAUKEE COUNTY, MI
EXISTING WATER SYSTEM**

The project planning area is the current water distribution service area in the City of McBain. The City currently serves municipal water to 224 customers. The median household income for the City is \$31,875. See attached map of the existing water distribution area (Figure 1).

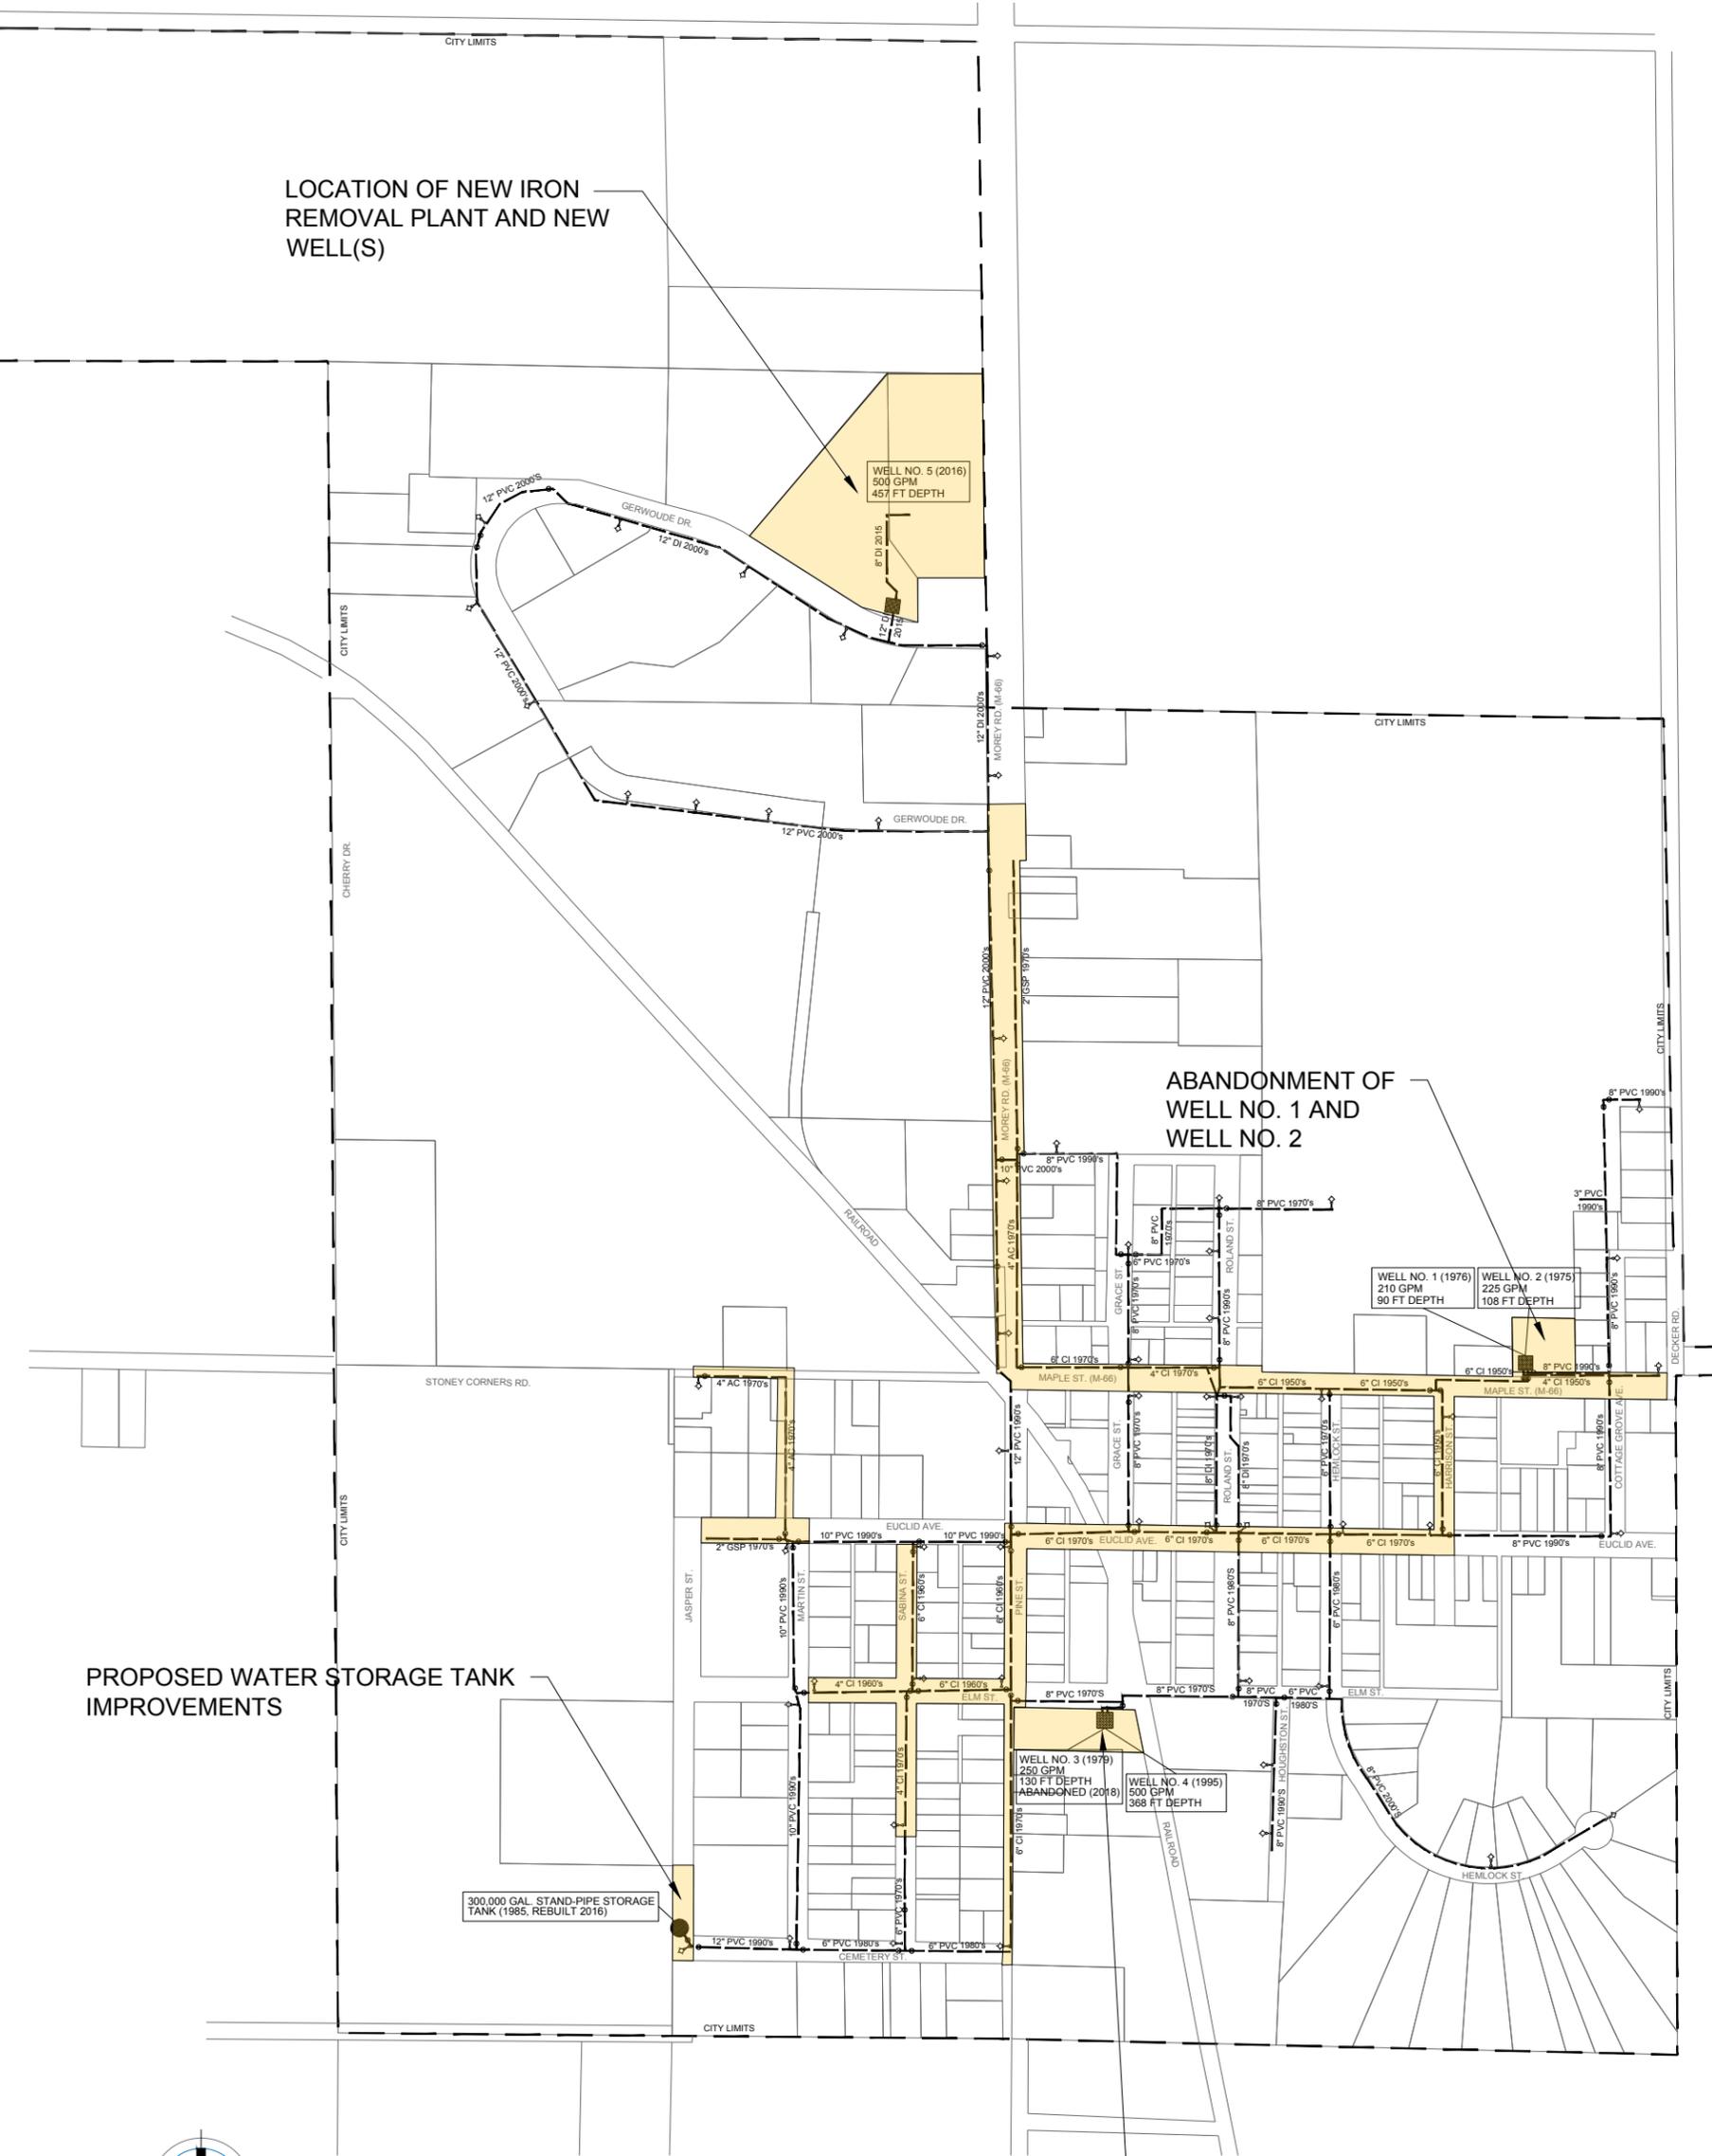
LOCATION OF NEW IRON REMOVAL PLANT AND NEW WELL(S)

ABANDONMENT OF WELL NO. 1 AND WELL NO. 2

WELL NO. 1 (1976)
210 GPM
90 FT DEPTH

A copy of the water system map showing the recommended improvements can be found at the end of this section (Figure 2 – Selected Alternative).

The proposed project will consist of existing watermain replacement, Modifications to the existing water storage tank, a new 800 gpm iron removal plant, a new well(s), improvements at Well No. 4, abandonment of Well No.1 and Well No. 2, and installation of water meters and remote reading system. The scope of the watermain improvements can be seen on Figure No. 2 (Selected Alternative) attached to the previous section of this report.

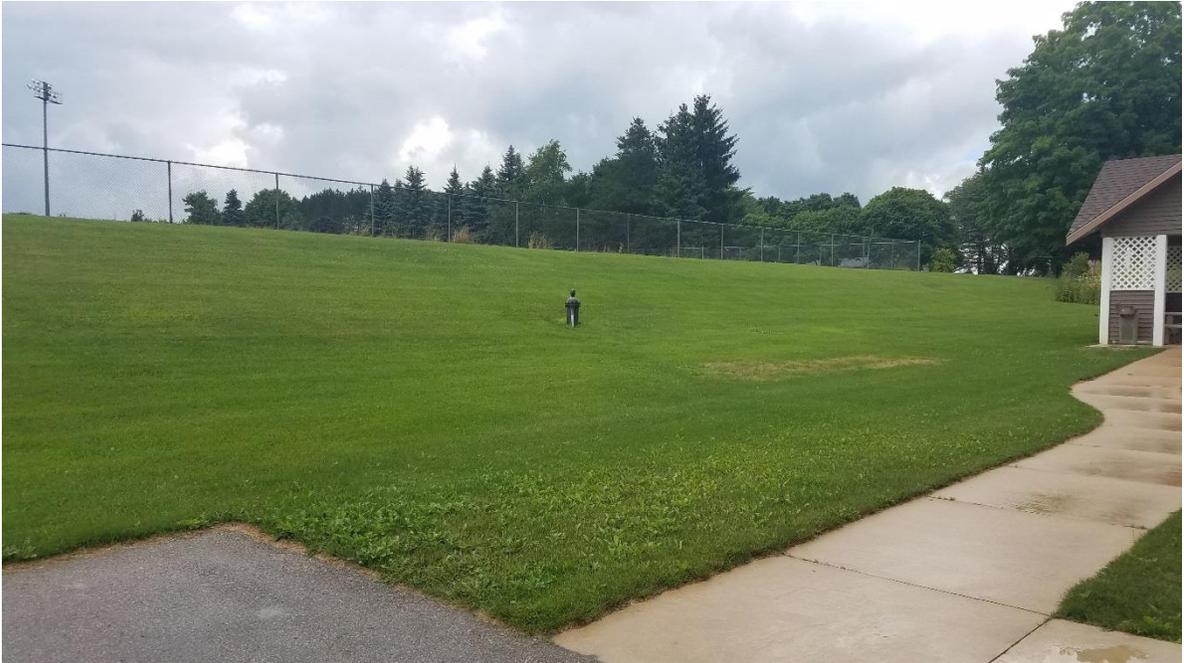
Location of Well No. 1 south of McBain High School's football field.

Well No.1 was installed in 1938. New well pipe, casing and pump were installed in 1976. The well was cleaned in 2010 and another new pump was installed. Well No. 1 is currently active. MDEQ has noted that the well is near the end of its life and has requested annual inspection by a professional to ascertain capacity and operational condition of the well.

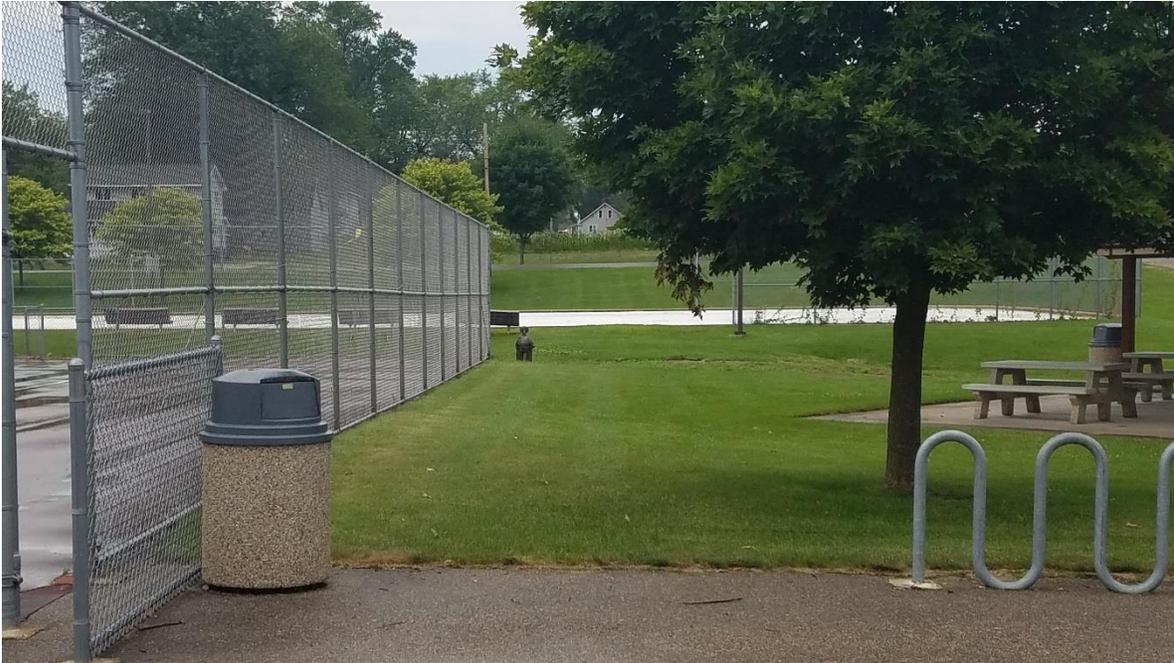
Location of Well No. 4 at the City park north of the tennis courts.

Well No. 4 is a 12" diameter well installed in 1995 at 375 feet deep. It was cleaned and rebuilt in 2017. Well No. 4 is currently active. MDEQ has requested annual inspection by a professional to ascertain capacity and operational condition of the well.

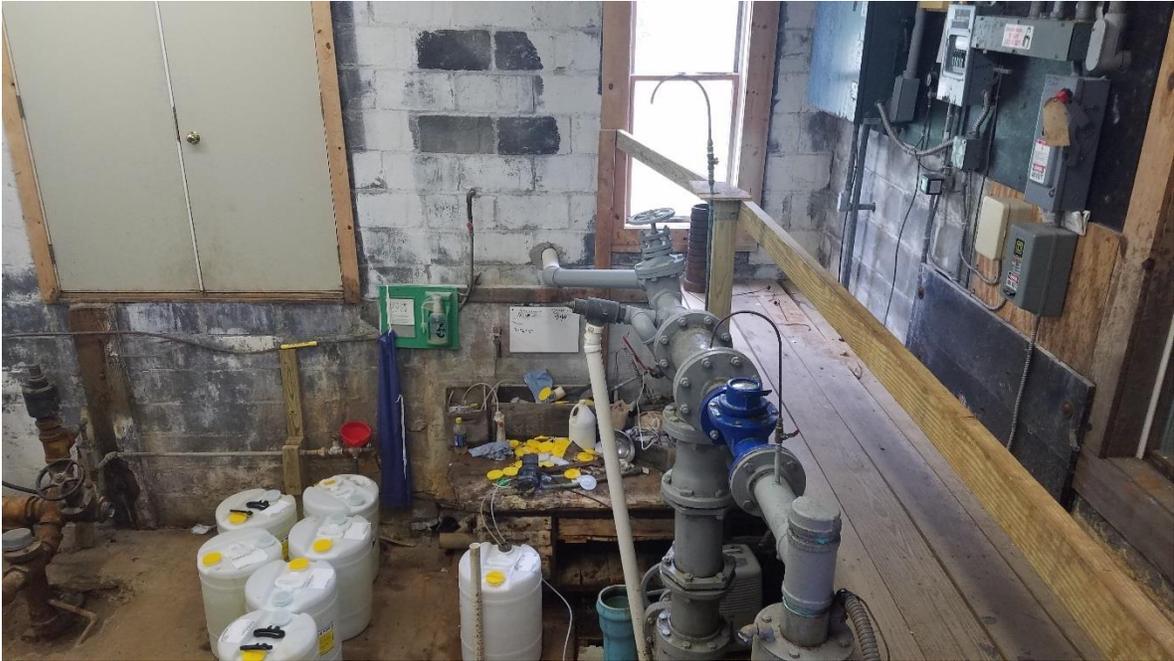
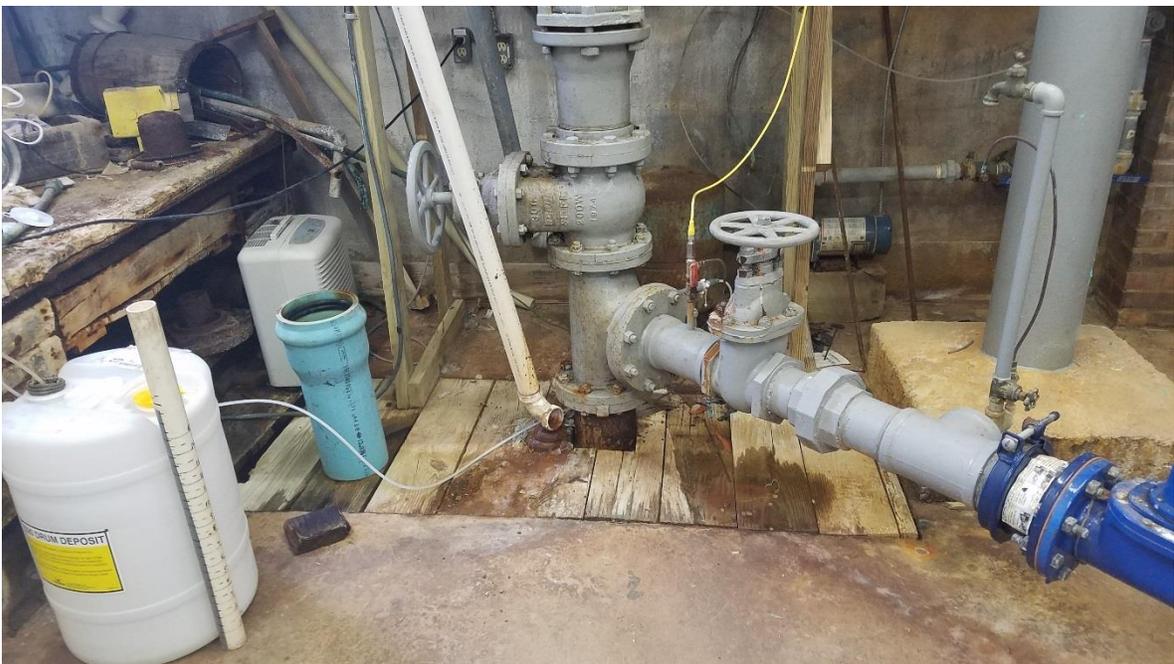
Inside well house for wells no. 1 & 2.

The Well House that serves wells No. 1 & 2 is masonry block construction and is very old. To access the piping and chemical feed areas, the operator must descend into a lower level. Electrical equipment is accessed via a narrow walkway. As both well 1 and 2 are located outside the building, this wellhouse only contains electrical, controls, and piping. MDEQ has recommended the City begin active planning to replace or rehabilitate the wellhouse, as the safety and conditions for the operators are less than optimal.

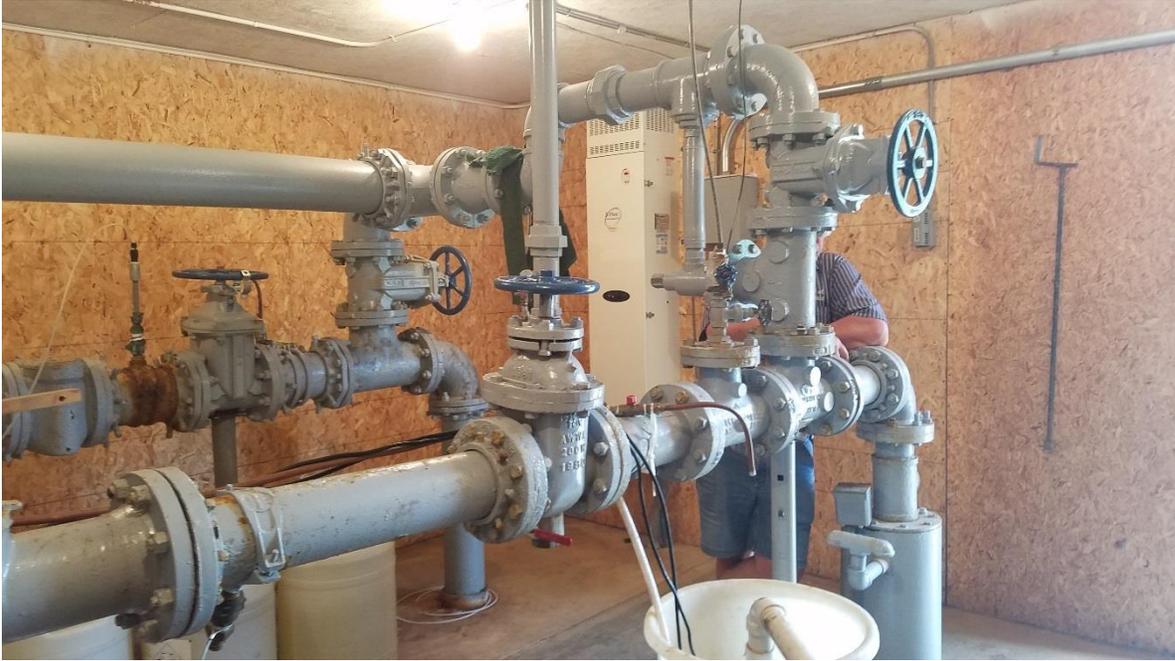
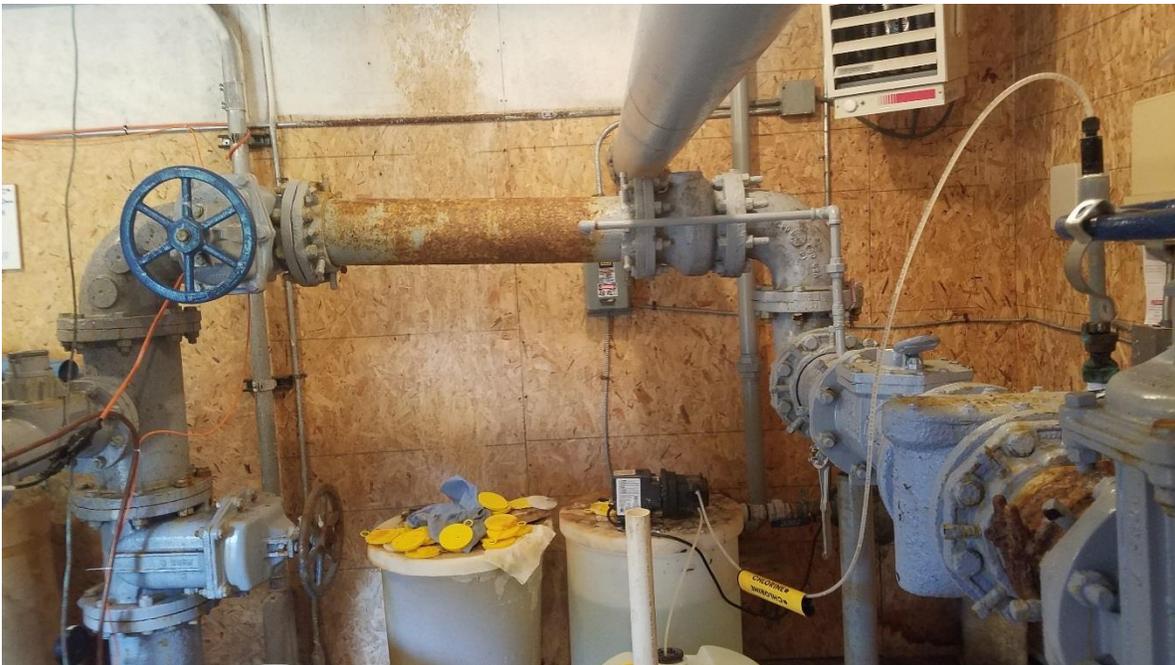
Piping located in well house for wells no. 3 & 4.

The masonry block well house for Well No. 4 is in good condition. The process piping inside the wellhouse is showing corrosion, especially around the chlorine injection quills. Since Well No. 3 has been abandoned, the City should consider investing in removing its associated piping and equipment, and cleaning and repainting the well 4 piping. Another consideration would be whether a new well at the site could be served by the wellhouse and the piping for Well No. 3 could be reused for this new well.

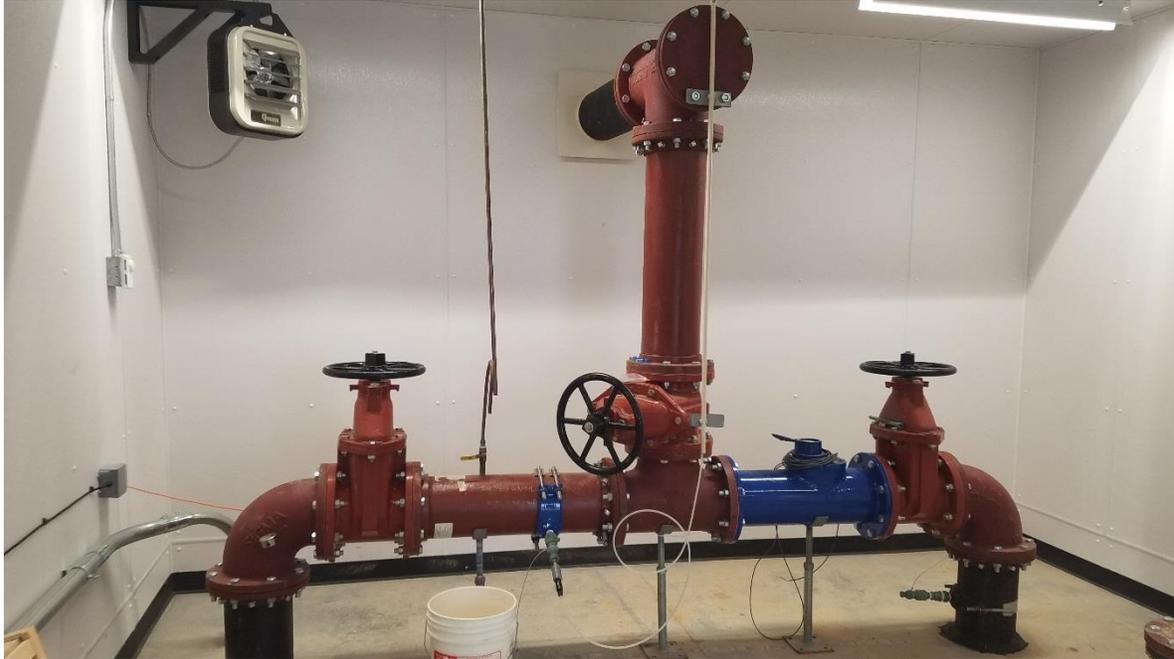
Piping located in new well house for well no. 5.

The wellhouse for well 5 is very new and in excellent condition. The building contains space and pipe penetrations to allow an additional well to be served through the wellhouse.

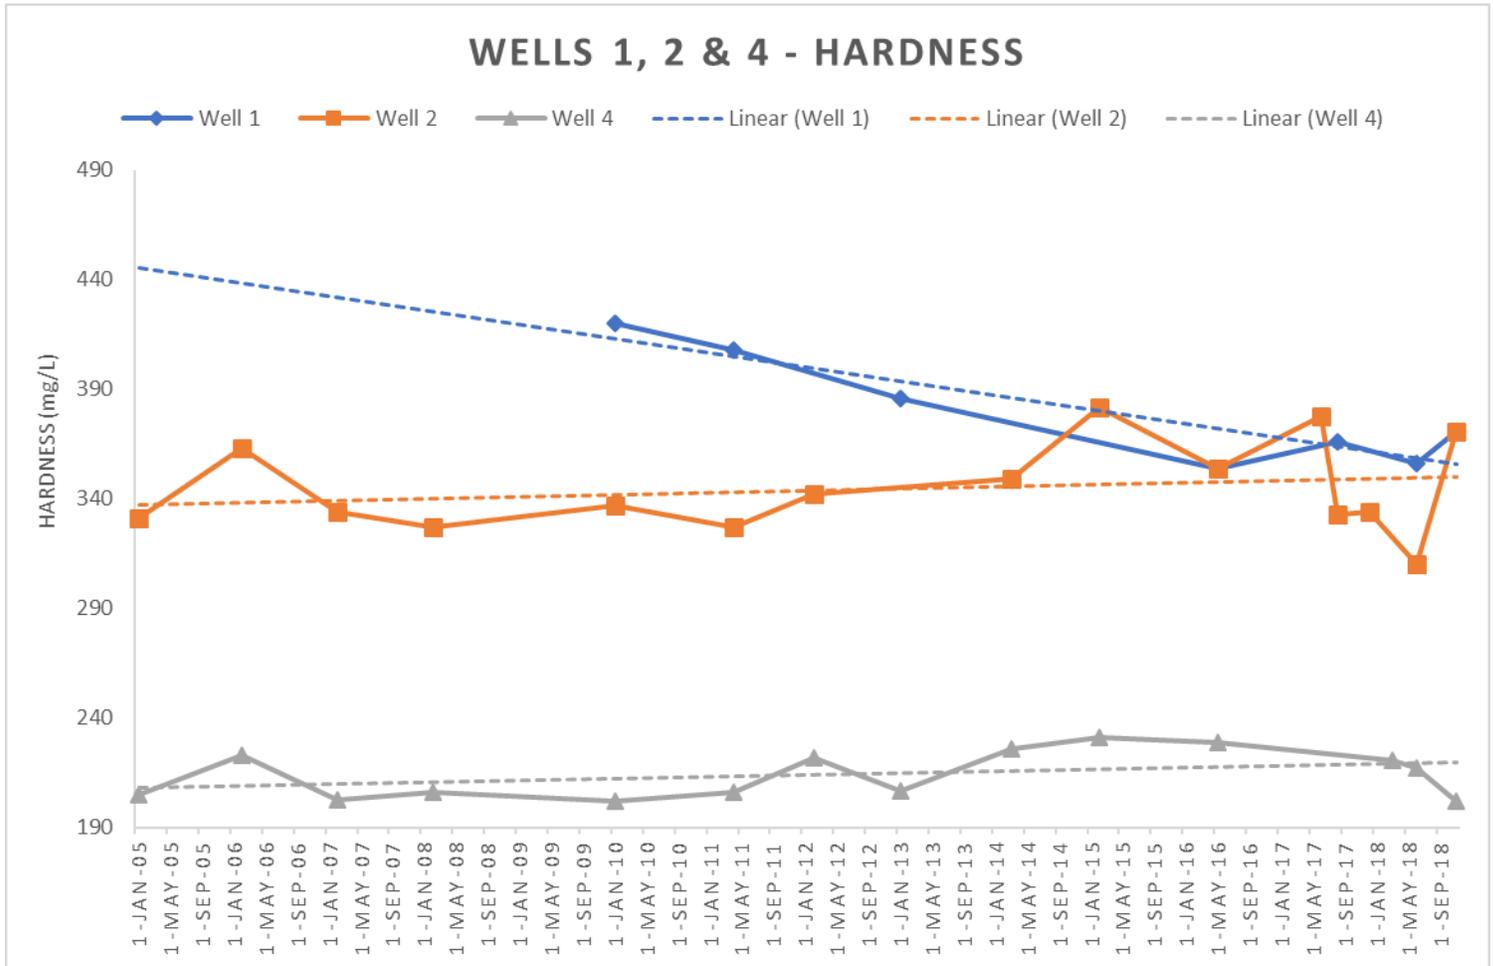
**FIGURE 1
HARDNESS COMPARISON – WELLS 1, 2 & 4**

Above you can see the hardness levels of the City’s water. Hardness is typically a function of the geology of the ground where the wells are drilled. Environmental factors and aquifer use and strain can cause hardness values to change over time. Wells 1 & 2 are at levels notably higher in hardness than well 4 or 5. Interestingly, well 1 is trending downward, while well 2 has trended upward since 2010.

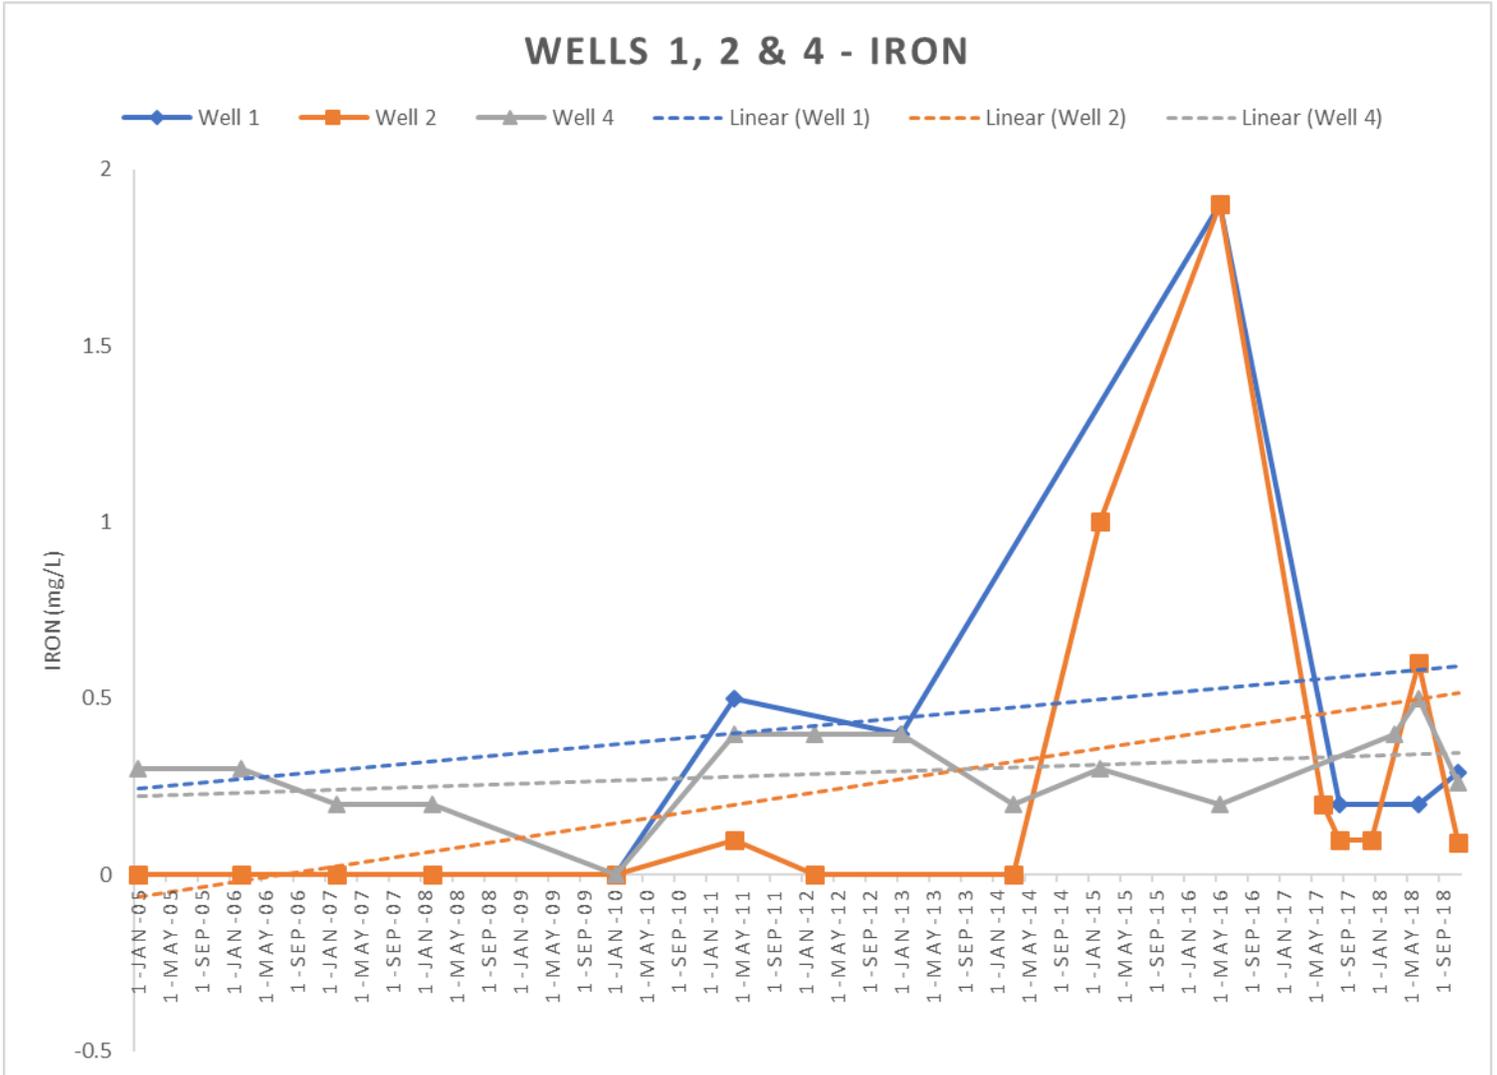
**FIGURE 2
IRON COMPARISON – WELLS 1, 2 & 4**

There are several tests for iron that deviate from historical averages for the City wells. In 2015, well 2 showed a very high iron test and in 2016, both wells 1 and 2 showed high iron tests. In 2017, the levels for both wells came back down to historical averages. It is impossible to know whether there was something that happened during collection of the sample, analysis at the lab, or whether the water really did exhibit very high iron at that time. All 3 of the City’s older wells are showing a trend of increasing iron levels. The EPA has set a guideline of 0.3 mg/L as a threshold where iron frequently becomes an aesthetic concern for communities. Iron within these levels are not known to cause health concerns, but can stain fixtures, discolor clothing, and have an unpleasant taste.

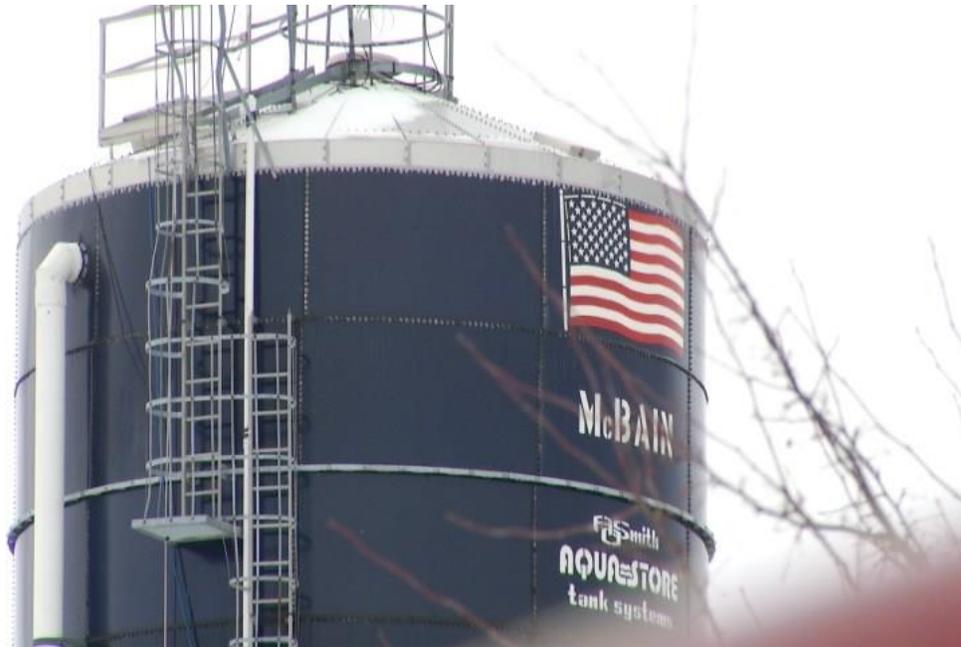
The City of McBain currently has one 300,000-gallon Aquastore stand-pipe style storage tank that supplies water storage for the system. The tank is located in the southwest part of the City at the northwest corner of the Jasper St. and Cemetery Rd. intersection. The following paragraphs address the specifications and maintenance for the tower.

City water tank.

The tank was constructed in 1985 and was rebuilt in 2016. The repairs included removing and replacing several panels that were damaged due to ice loading.

Sediment will settle out of water as it sits in a storage tank. At the time the tank was taken out of service for repairs in 2016, photographs indicate there was approximately 10" of sediment in the bottom of the tank. In many tanks, there is what is called a mud valve at the bottom of the tank that allows the operators to periodically remove this material by opening the valve and flushing the material out. The City's ground tank does not have that capability. Sediment must be vacuumed or manually removed, and the tank must be taken out of service and drained to do that.
