Canal Current

A wave of information for Cape Coral's Canalwatch volunteers

Newsletter: 4th Quarter 2019

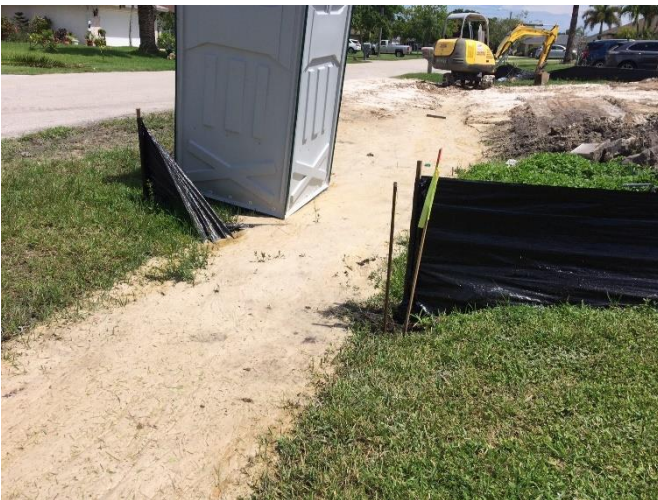
A failed silt and dirt barrier...

Water quality can just as much be a result from people's activities, as it can be from natural cycles or nature out of balance. One specific issue that causes problems within Cape Coral's waterways is construction site runoff. Excess dirt or silt that enters the canal or lake associated with stormwater runoff can create a water quality problem that is more than just unattractive.

Once construction site runoff enters a waterbody it can decrease water clarity by making the water appear milky or dirty. Although most siltation events are temporary, it can be harmful to the biology and the chemistry of the canal.

A short term decreased in available sunlight may not cause lasting harm to submerged aquatic vegetation, but the lack of sunlight can cause algae and phytoplankton to respire instead of photosynthesizing. Cell respiration uses oxygen which can decrease oxygen levels in the water. Low oxygen conditions (hypoxia) or no oxygen conditions (anoxia) can lead to fish kills or harm other aquatic or marine life. If the construction site runoff persists, the settling out of those dirt particles can create a layer of soil on top of plants that will eventually smother the plants.

Construction site runoff can directly harm fish and other gilled animals. Minute particles of silt, that create the same cloudy water condition, can clog gill structures and suffocate those that cannot avoid the area. The continued issue of construction site runoff can lead to habitat destruction and would necessitate dredging of the area to remove the material from the waterbody. However, preventing these events from happening is the best, low cost option. Alerting the Cape Coral's 311 call center if canals appear milky, or if construction site material is not staying within the protective silt barriers can help resolve these issues. Stormwater inspectors can ensure those violations are corrected, before lasting harm results.

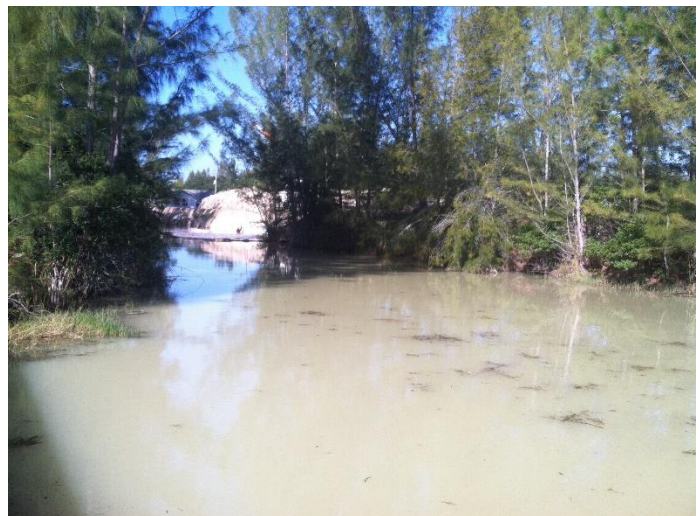
Can lead to this...
