Prepared for Dodge County
by MacDonald & Mack Architects
with Mattson Macdonald Young Structural Engineers &
10,000 Lakes Archaeology, Inc.

July 29, 2016

THE WASIOJA SEMINARY RUINS HISTORY

CONDITION ASSESSMENT AND TREATMENT PLAN

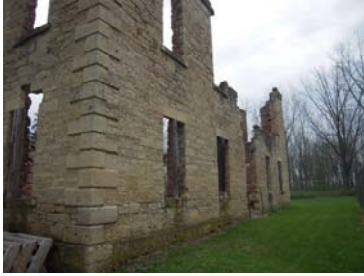
*Wasioja Seminary Ruins
(5/20/2014)*

Overall, the ruins are in fair but precarious condition. This assessment is, of course, relative to the fact that we are looking at the ruins, not at the building they once were. Because of the precarious nature of the ruins, it is not possible to assume personal safety around the walls. Our inspection of the ruins was limited to what we could see from the ground and with minimal disturbance to the walls.

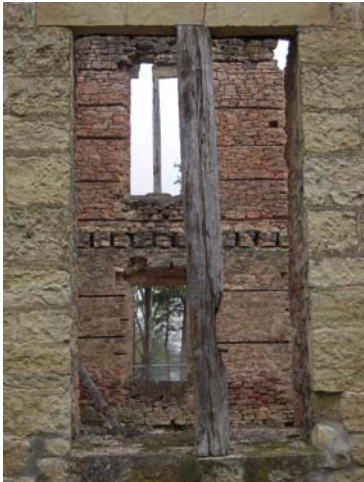
*Window Opening at Wasioja
Seminary Ruins (5/20/2014)*

- New lintel members will be needed under the stone wall, behind the existing stone veneer lintels. The new lintels could be 8” or 6” steel tube members placed in the cavity that remains from the wood lintel that was at the inside face of the wall. A plate or angle, welded to the tube would extend under the stone veneer member and be grouted tight to the underside of the stone.

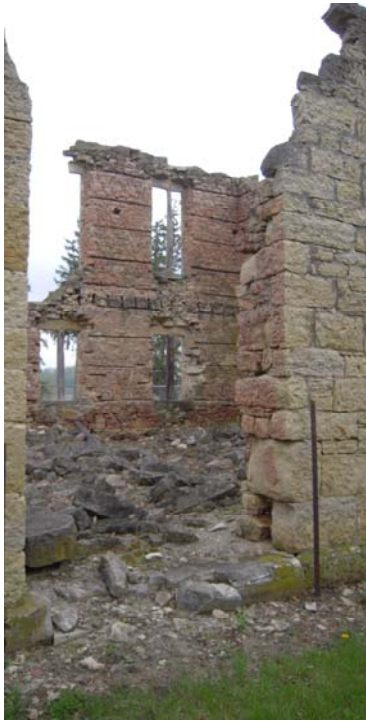
View of interior of ruins through back door opening (5/20/2014)

It will be necessary to have the construction phase of the preservation be overseen by both an architect and a structural engineer who have experience with historic masonry structures. An archaeologist should provide guidance on conduction stabilization-related construction activities to avoid disturbance to archaeological evidence, in addition to conducting archaeological investigations inside the ruins prior to removal of debris.

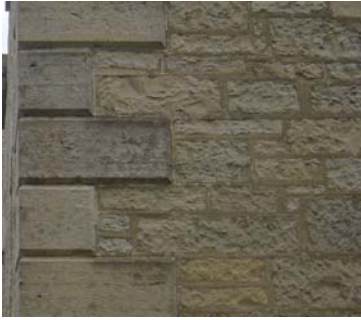
Quoins at corner (left) and square beaded joint in facing stone (right). (5/20/2014)

We recommend that the exterior face of the wall be completely repointed. The joint for the majority of the exterior face is a square, beaded joint. It is an interesting one that should be replicated. It is uncommon and will require a masonry contractor with experience working on historic buildings. The joint between the quoins at the corners of the building have a narrower, simpler joint. That joint should be replicated as well.

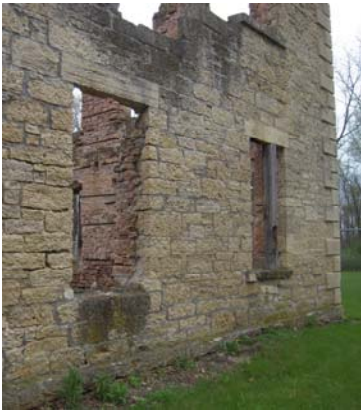
Biological growth on ruins (seen at window sills and top of wall in this image). (5/20/2014)

We recommend using the gentlest means possible to clean the walls. There are a variety of stains on the structure. Most of which are not a serious cause for concern. There are both atmospheric staining and biological staining on the ruins. Biological staining or growth is damaging to masonry walls, but at an incredibly slow rate. That type of growth shows the passage of time and is expected on ruins. If there was no other work being done on the ruins, we would not recommend removing the biological growth. However, we are recommending 100% repointing which will necessitate the removal and replacement of the existing (growth-covered) mortar and cleaning of the adjacent masonry. In this instance, we feel that it is advisable to remove the biological growth to avoid a patchy appearance on the stone. We

expect that, with time, the biological growth will return at which time the necessity to remove the growth should be revisited.

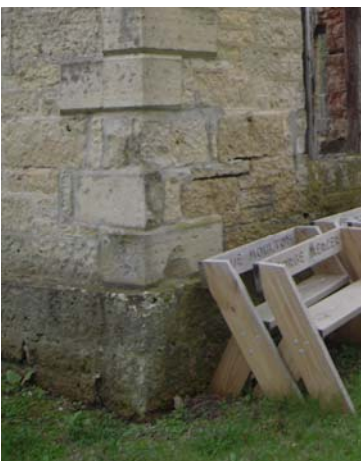
Missing quoins (bottom three stones at corner in this image). (5/20/2014)

We recommend that the existing masonry be repointed without replacing the missing quoins. There are a few missing quoins at a corner of the building, perhaps in the area where the corner stone was removed.

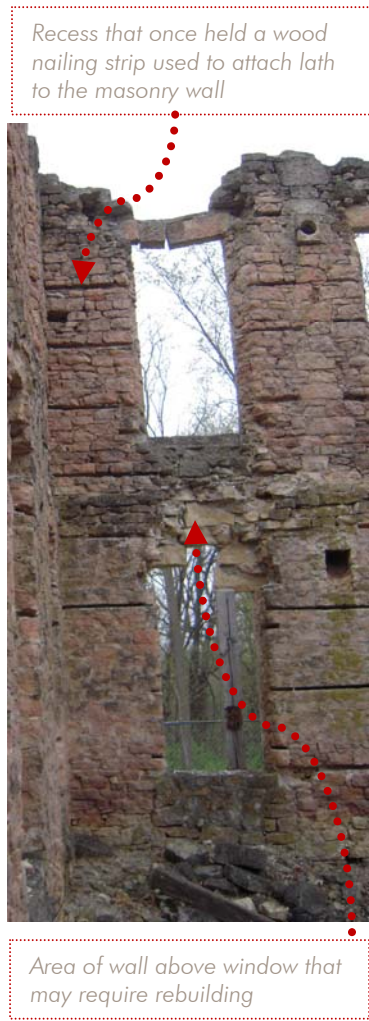
There are several areas of the interior faces of the walls that are particularly vulnerable to water infiltration including joist pockets and slits in the masonry where the nailing strips for the lath were once embedded. These details are interesting clues about the original construction and assembly. Any treatment to prevent water from infiltrating at these voids should be carefully considered so that it does not change the information they impart about how the building was originally constructed.

Interior face of wall (5/20/2014)

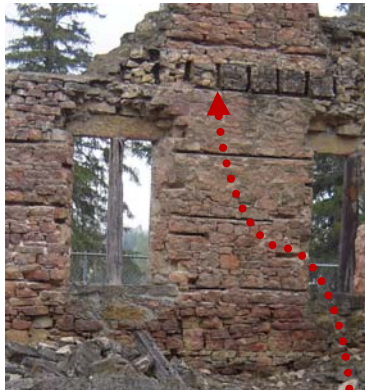
Joist pocket once held the second floor joists

We recommend installing a mortar wash in deeper openings in the walls, such as joist pockets, to encourage water to shed from the wall. This type of treatment is fairly simple. It entails mortar laid on the horizontal surface of the opening and shaped to form a wedge (with the new “top” surface being pitched to drain water away from the center of the wall). This type of treatment will eventually fail and the typical failure involves the mortar separating from the sides of the opening or the wedge of mortar itself cracking.

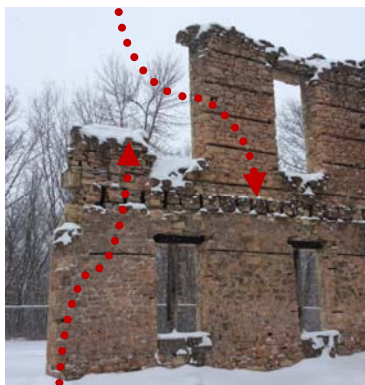
Coating/cap at top of wall

We recommend a close inspection of this current coating on the tops of the walls after the ruins are stabilized. The coating or cap looks fairly thin and perhaps cementitious. In at least one instance, the cap is

We recommend installing a similar coating type of cap (rather than a form of mechanically fastened flashing). This will allow for the most unobtrusive protection of the tops of the walls which are quite irregularly shaped. We further recommend that the final secondary, structural support be designed in a manner that will allow it to be used as a means to gain access to the tops of the walls if possible.

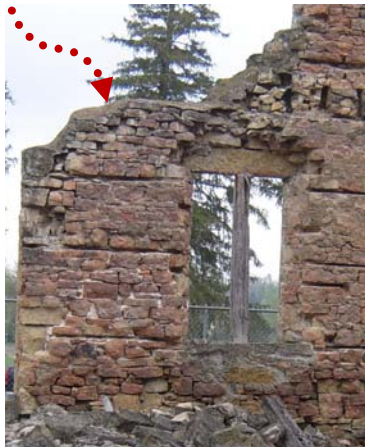
While simply filling these voids with brick or stone similar to those adjacent would be affordable, durable, and functional, it would alter the story of the ruins. It would remove information that the ruins currently tells about itself.

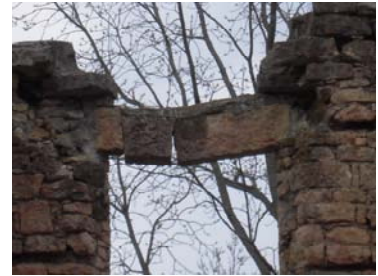
holding a broken limestone lintel in place. Caps of this nature are generally not the most durable solution but are effective, lightweight, and visually unobtrusive. They do require routine inspection and replacement.

Second floor window lintel facing stone held in place with coating/cap (5/20/2014)

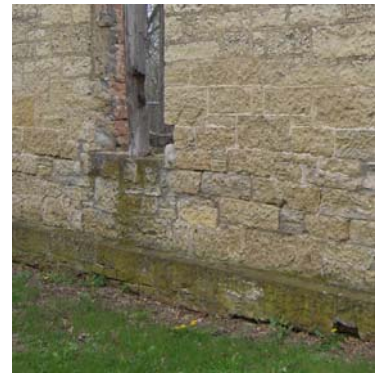
The face stones at the bottom edge of the walls of the ruins are cracked. We hypothesize that this may be caused by rising damp (which is a phrase common in historic preservation and refers to water wicking into the stone from the ground) or by snow building up against the wall during the winter. In either event, mitigation of these causes could be rather invasive. *We recommend monitoring this deterioration to see if the cause can be narrowed down or confirmed.* This will likely take several seasonal cycles. Masonry interventions at the base of the wall could take place along with the installation of the permanent secondary, structural system.

Cracks in bottom stones (at grade) (5/20/2014)

We recommend planning to address the floor and foundation walls of the ruins along with the installation of the permanent secondary, structural walls. The area is currently too unpredictable to commence an investigation or any restoration work.

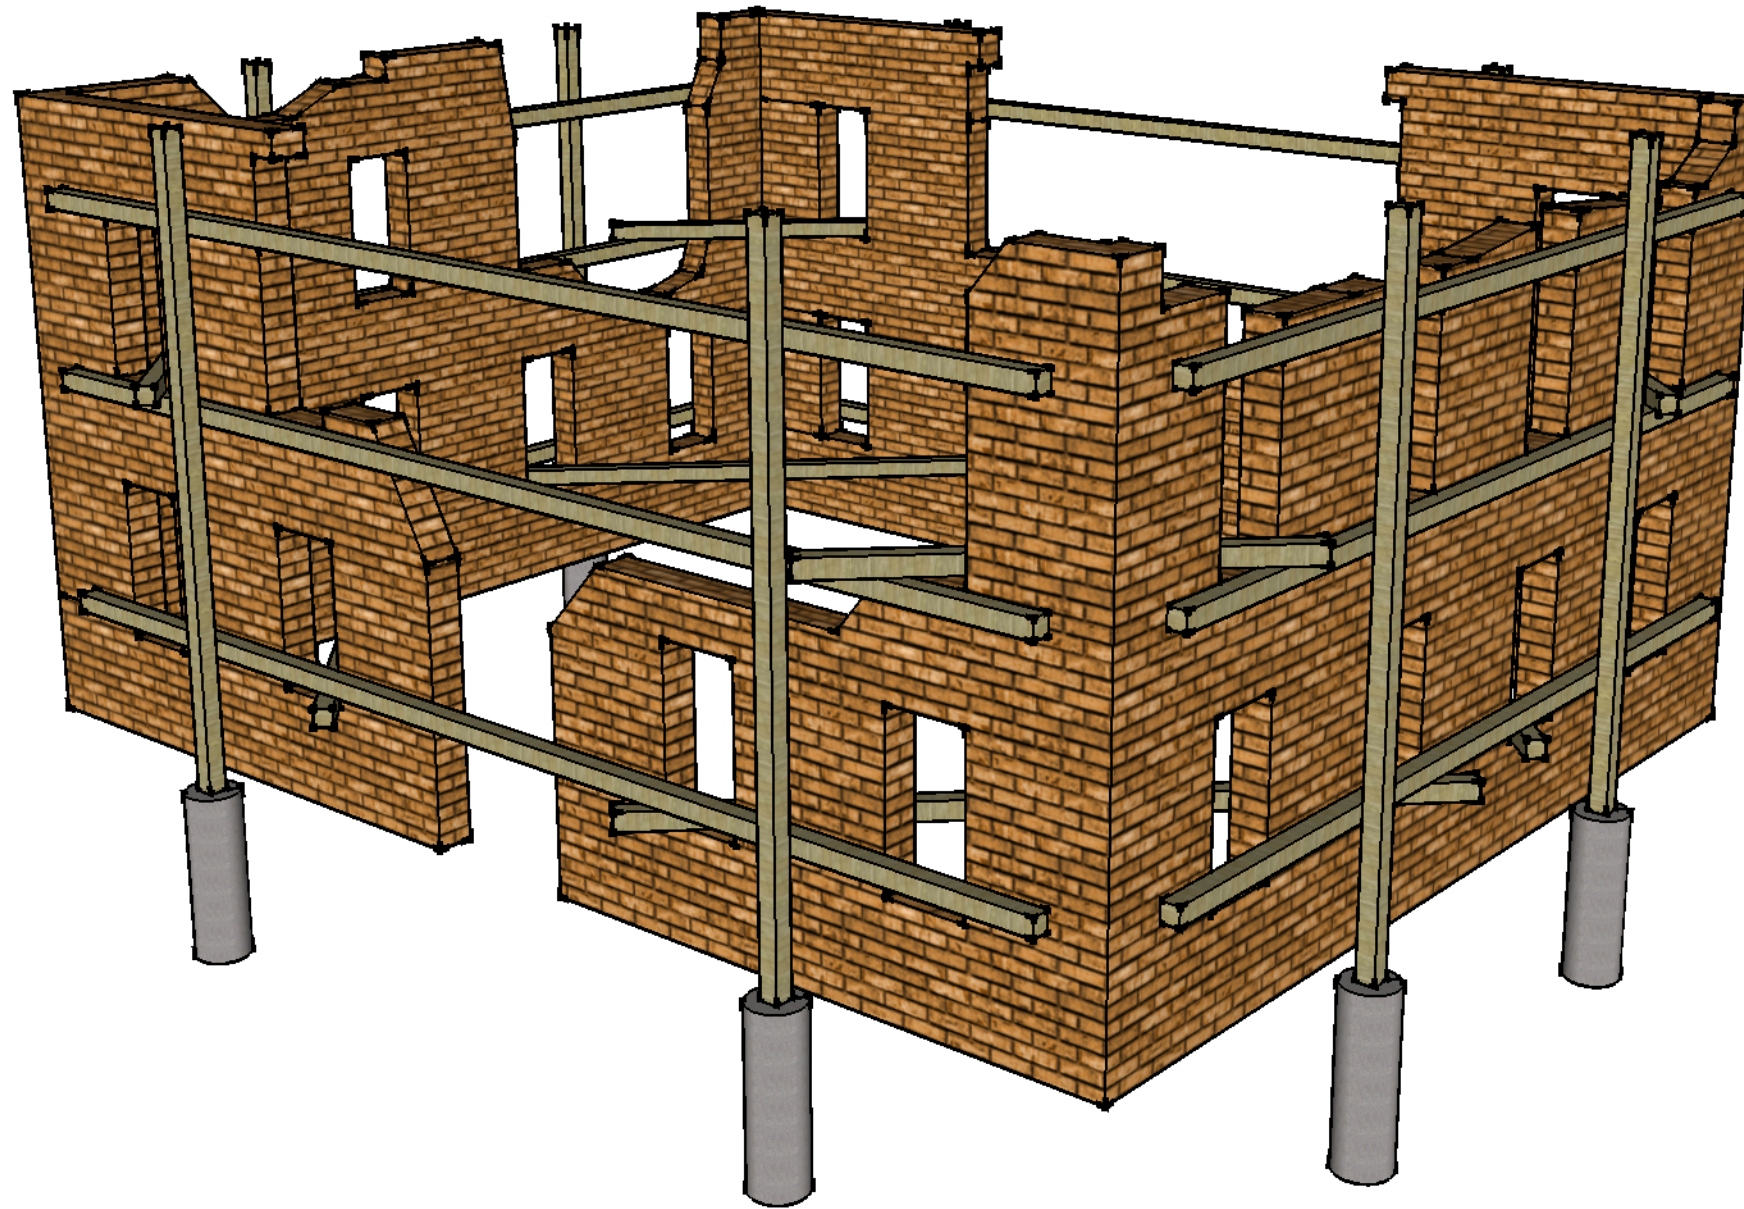
Wasioja Ruins
Temporary
Shoring Scheme
Sk-1

The following drawings Sk-1 and Sk-2 illustrate the method described above. This is by no means a final designed solution, only a schematic suggestion of one possible method for consideration.

- Install a small concrete pier at the building perimeter, approximately 2 each side of the building. The piers will serve as the base for vertical shoring columns. These piers would be installed with light equipment such as a bobcat with little adverse effect on the building. To avoid damage to archaeological evidence however, hand excavation or mechanized augering is recommended when it does not adversely impact safety.

- Thread timber shoring beams diagonally through the first floor window openings across each building corner. The shoring beams can temporarily rest on the sills of the openings.

- At the first floor opening level, place a horizontal shoring beam against the face of the wall and resting on the protruding ends of the diagonal beams. Connect the horizontal beam to the diagonal beam with thru bolts or steel angles and lag screws.

- Place a timber column over each of the piers. The column would stand away from the building perhaps 8" to 12" and would extend to the height of the top of the walls. The columns are to be mechanically anchored to the concrete piers and connected to the horizontal shoring beam at the first floor window location. Temporary bracing of the tops of the columns may be needed to keep them plumb.
