RE: Recommended Village Pool Improvement Plan

Village of Hinsdale Community Pool Facility Evaluation

May 29, 2019

VILLAGE OF HINSDALE
POOL ASSESSMENT

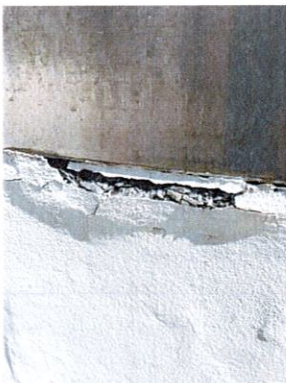
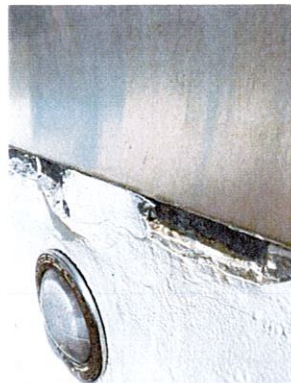
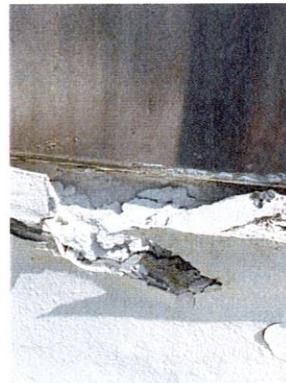
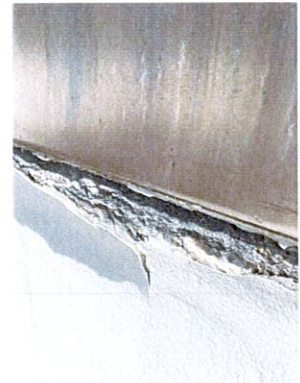
The main pool gutter does not have a continuous caulk sealant under the gutter. The grout below the pool gutter has severely deteriorated at the deep end of the pool and at the "L" portion of the pool. Additionally, the paint finish is peeling. Staff indicated that in the past,

prior to them working at the pool, maintenance used BONDO to repair these areas. This condition is a hazard to bathers and will increase the continual deterioration of the grout and pool walls unless repaired.

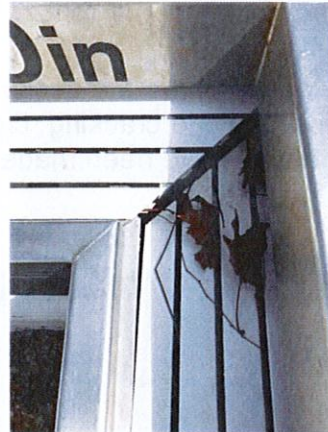
4. The gutter grating at the northeast corner of the deep end of the pool is not supported by a leveling angle. A large gap is present, which is a hazard to bathers stepping on the grating and reaching in with their hands. The grating needs to be supported so that it is level and forms a flush joint with the adjacent grating.

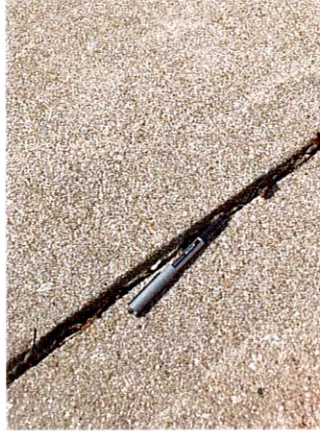
5. The decks have significant differential settlement, which has affected drainage. Additionally, the settlement creates tripping/toe stubbing hazards for patrons. Areas where there has been significant settlement have been patched or in some instance the deck was ground down to address the difference in height.

Some of the patched areas exceed 1" per foot slope. *This is a violation of current IDPH code requirements: Section 820.200.j Walkways and Deck Areas – 5) The deck shall slope at least one inch per 10 feet to deck drains or to the surrounding ground surface. The maximum slope of the pool deck shall not exceed one inch per foot.*

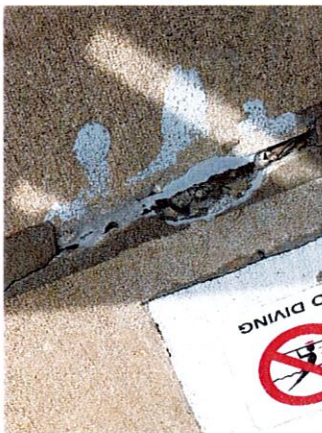
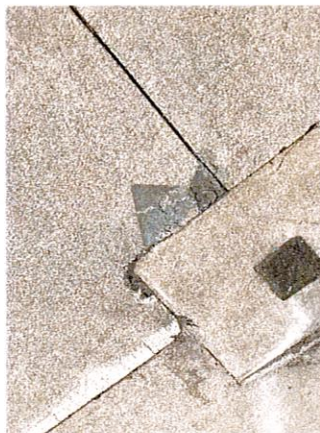
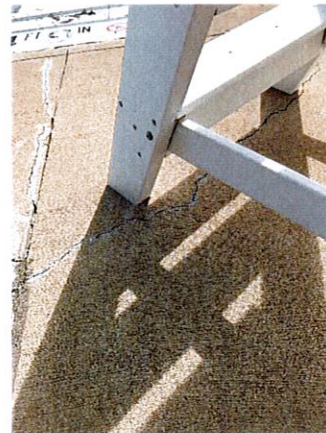
6. There are areas where the decks are deteriorating and cracking, creating hazards for patrons and affecting deck drainage. Repair attempts have been made.

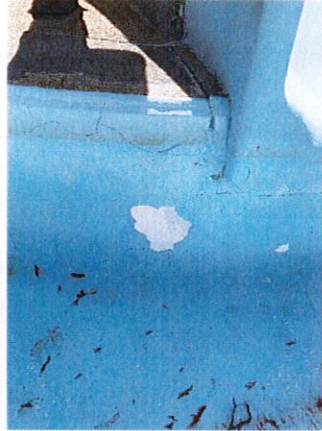
1. The wading pool concrete structure appears to be in fair condition. The wading pool paint finish is peeling and cracking in some areas. The pool should be prepped as required and repainted.

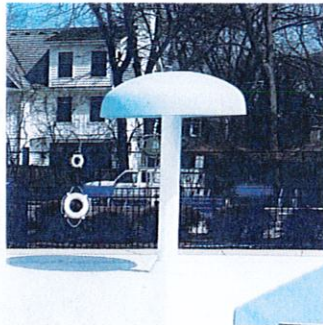
2. The Raindrop water feature is very faded and should be refinished. Additionally, the kiddie slide should be refinished.

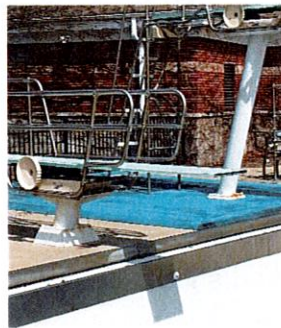
1. The dive pool structure appears to be in good condition.
2. The diving pool decks are in good condition.
3. The dive stands are in good condition. There is some rust formation on the base plates of the column supports.

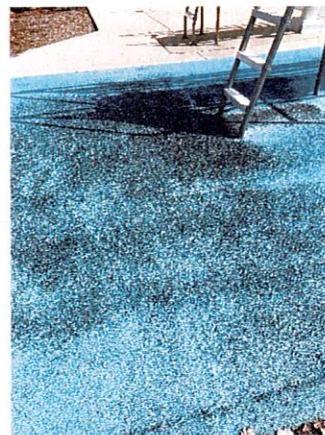
4. The safety surface under the three-meter dive stand is generally good condition. The integral color has worn in the areas of high traffic.

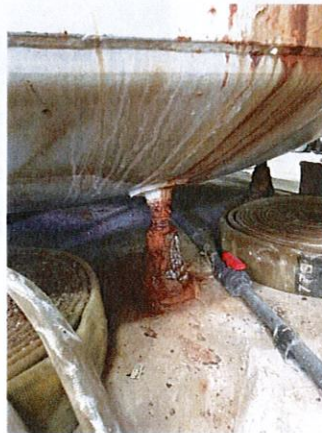
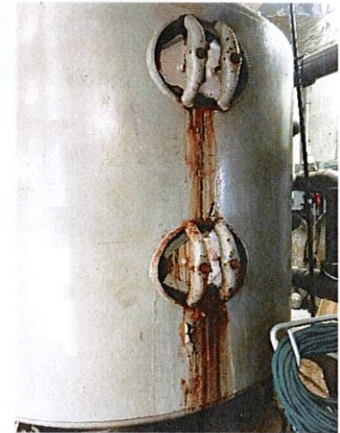
3. The main pool filter access hatch areas and hatches are rusting, in some instances very severely. Additionally, the filter support legs are also severely rusted. The dive/wading pool filters are also rusting but not as severely. Staff indicated that 10 to 12 years ago the filters were sandblasted on the inside and a new epoxy coating was applied. The access hatches no longer seal well. Staff indicated that some sand gets into the pool, which could be an indication that the filter laterals could be cracked.

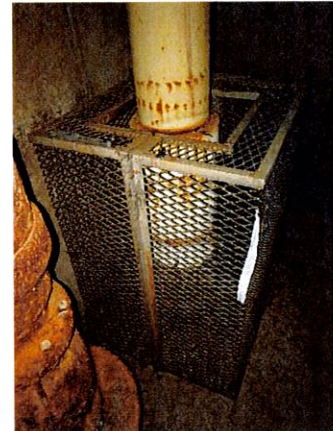
4. The dive/wading pool circulation pump utilizes a secondary strainer to capture debris. However, the openings in the stainless steel strainer sheets is $\frac{3}{4}$ " at the widest point by $1\frac{1}{2}$ " long, which will allow larger debris through, and the strainer has minimal surface area. Staff indicated that the secondary strainer gets loaded with debris quickly and requires continual cleaning throughout the season. It is recommended that a 9'-6" x 8'-0" high 11 GA stainless steel wall, with door access, be provided with $\frac{1}{8}$ " round holes on $\frac{3}{16}$ " centers. This will provide a large surface area which will capture the majority of the debris. Additionally, the strainer wall will protect the pump and extend filter runs. Facilities that have incorporated such strainer walls have experienced only having to clean them at the end of the season.

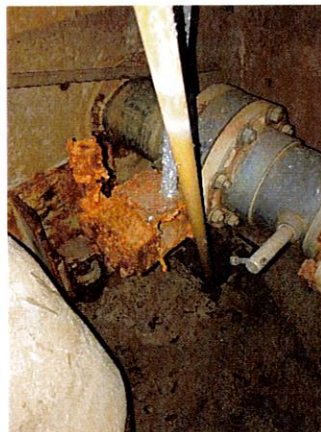
5. Both the dive pool and wading pool main drain throttling/isolation valves are in very poor condition. The wading pool main drain throttling/isolation valve is not operational and needs to be replaced.

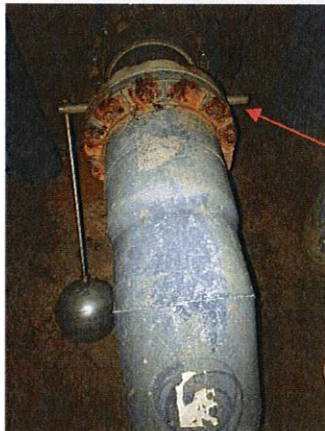
7. The dive pool 10" main drain float operated modulating valve is missing one float assembly. The float should be replaced to provide accurate operation.

Missing float assembly

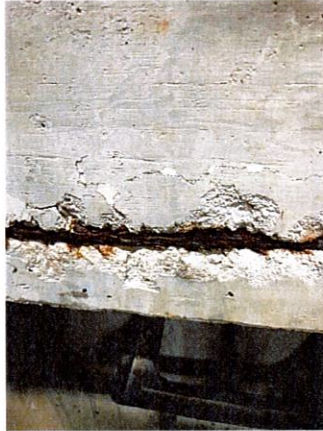
8. The dive/wading pool surge tank top at the access hatch is deteriorating. The rebar is visible and rusted.

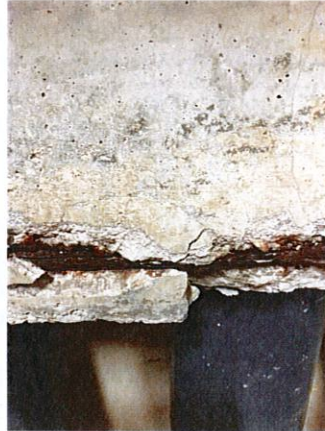
11. The main pool surge tank top at the access hatch is deteriorating. The rebar is visible and severely rusted.

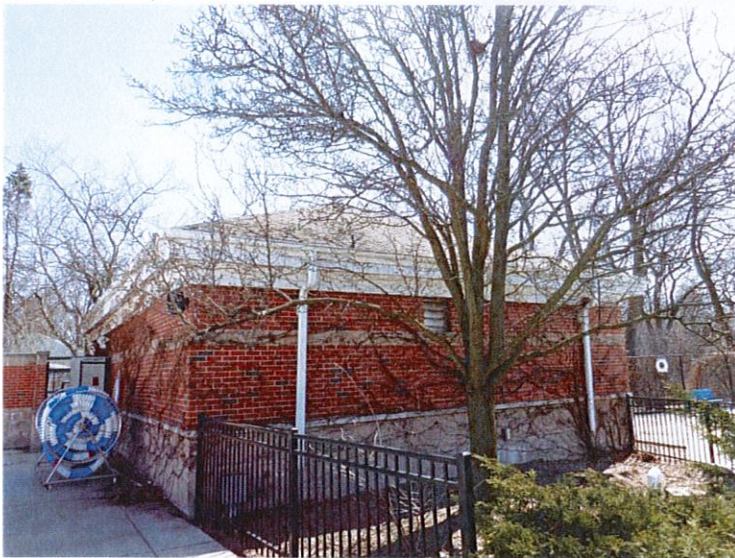
1. North West Corner of Filter Building

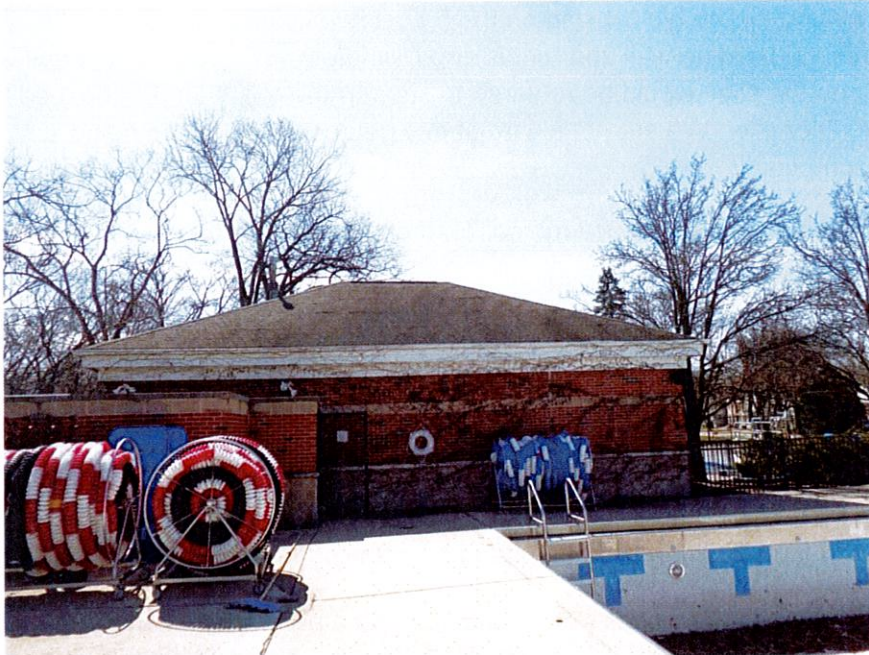
2. North Elevation of Filter Building

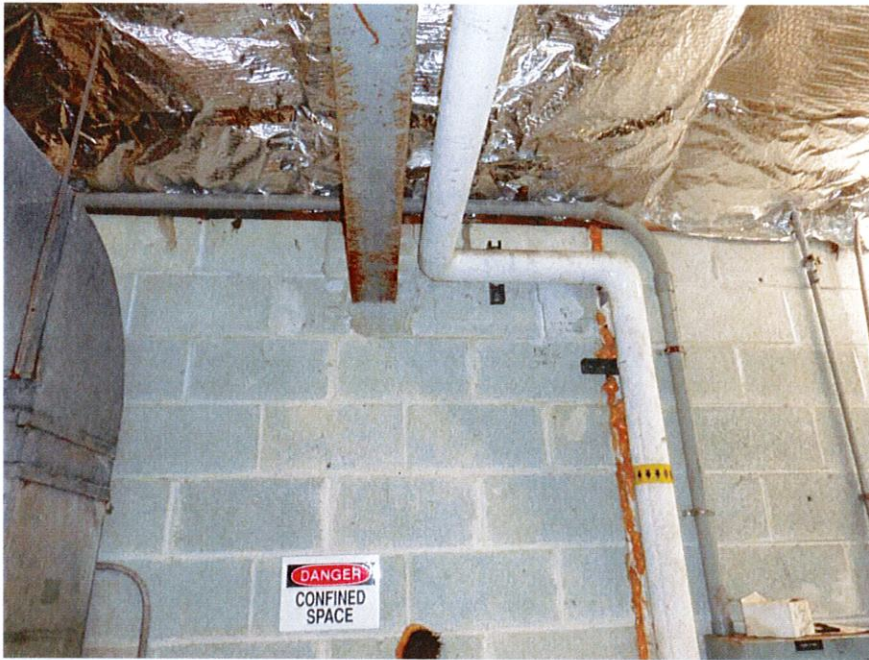
4. North Wall Control Joint (Interior view)

- CMU control joints should be cleaned out and a flexible sealant installed.

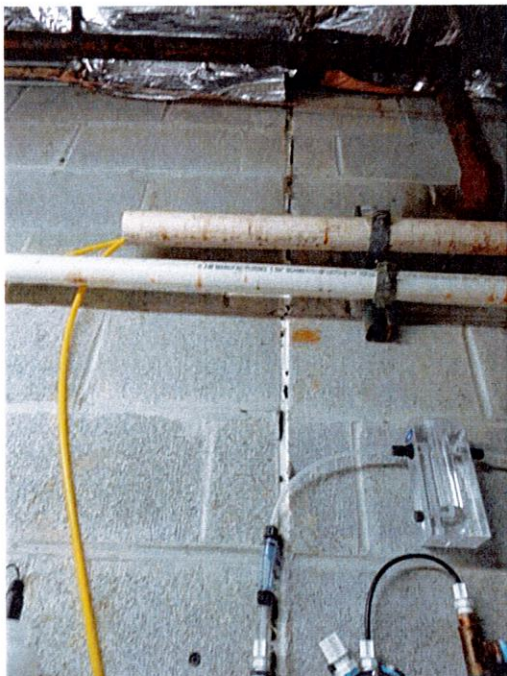
6. West Wall Control Joint

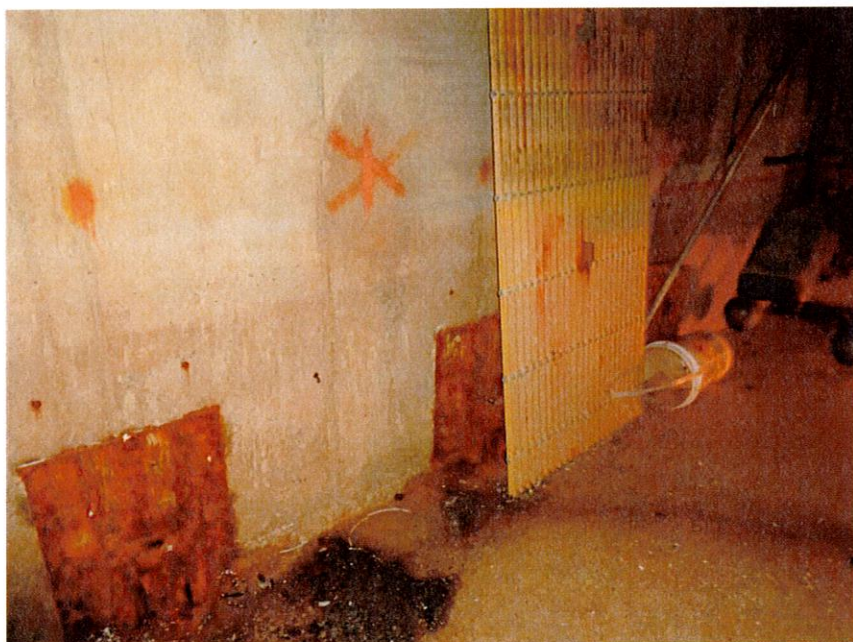
The surge tank area of the structure has settled over the years. Eight micropiles were placed within the tanks (six in the north tank and two in the south tank) based on the recommendations of the 2010 report noted above under reference documents. The micropiles were placed to control future settlement of the tanks. The owner noted that several pipes that pass thru the west wall of the tank recently sheared off and had to be repaired.

7. Micropiles in North Tank

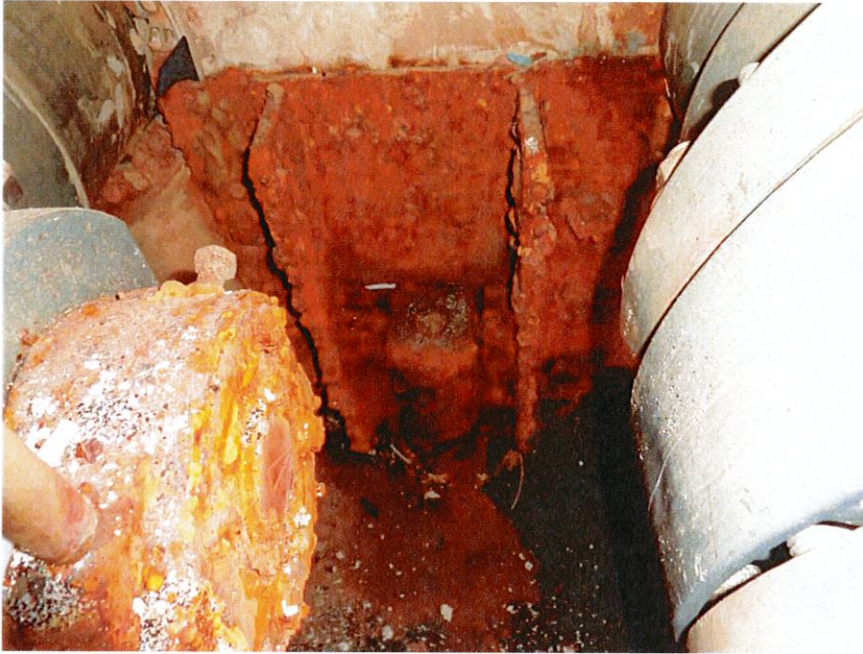
8. Micropile on North Wall of North Tank

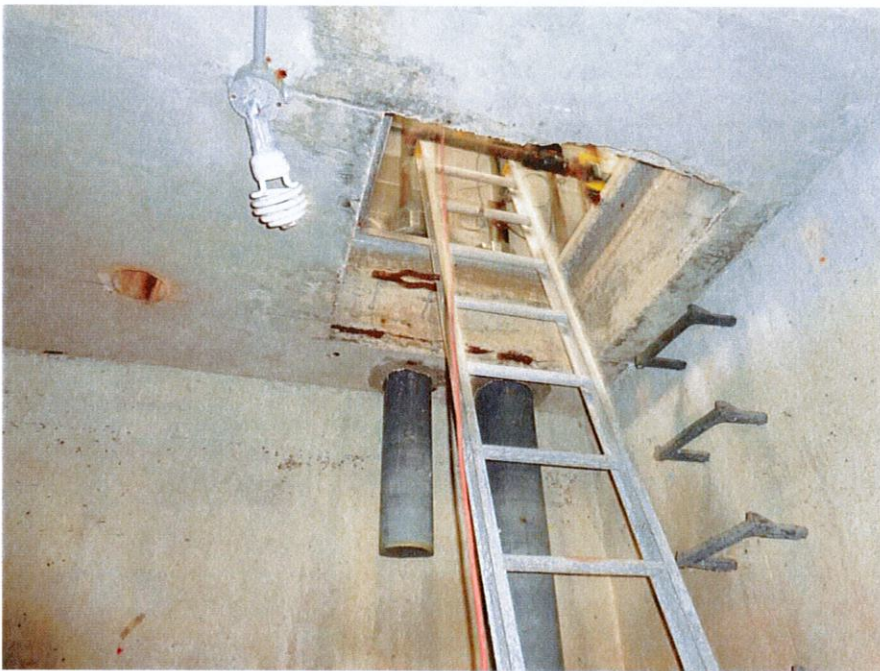
9. Deteriorated rebar at tank openings typical north and south tank

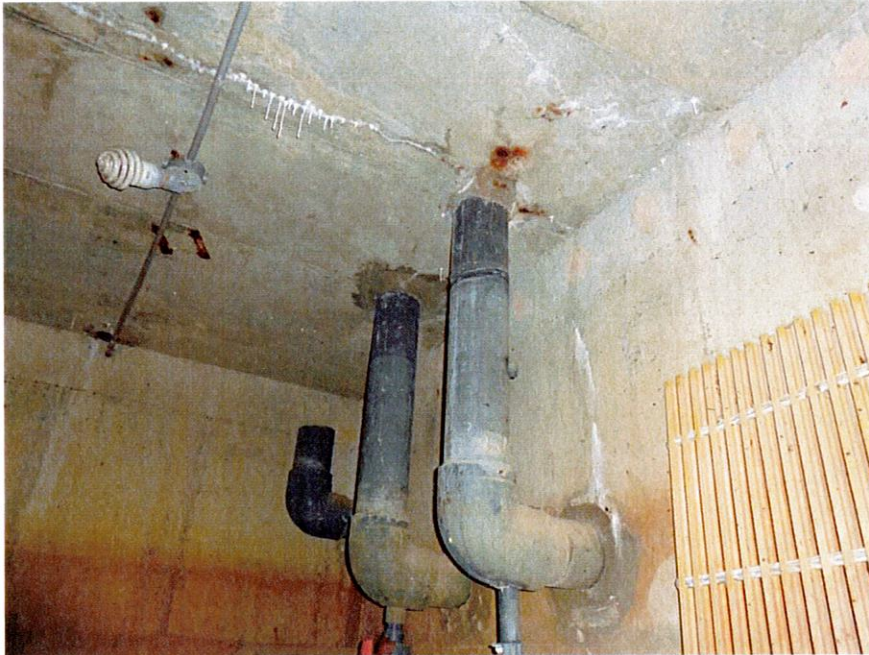
10. Rigid Pipe Connection through west wall

- An Aquatic or mechanical engineer should investigate using a flexible connection for the pipes that pass through the walls. The flexible connection would allow some future settlement. (Picture 10).

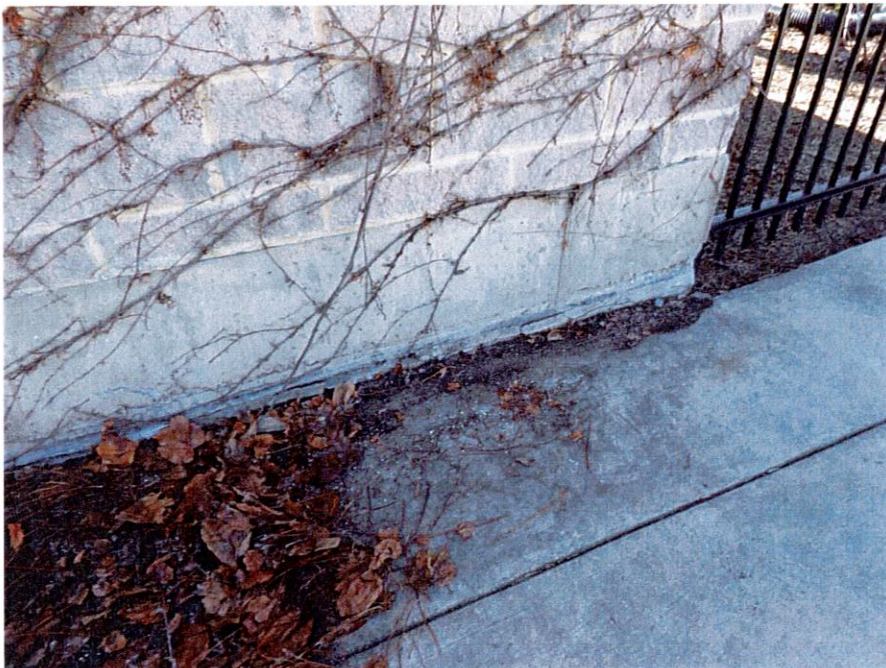
11. Pool slab depressed north west corner of building

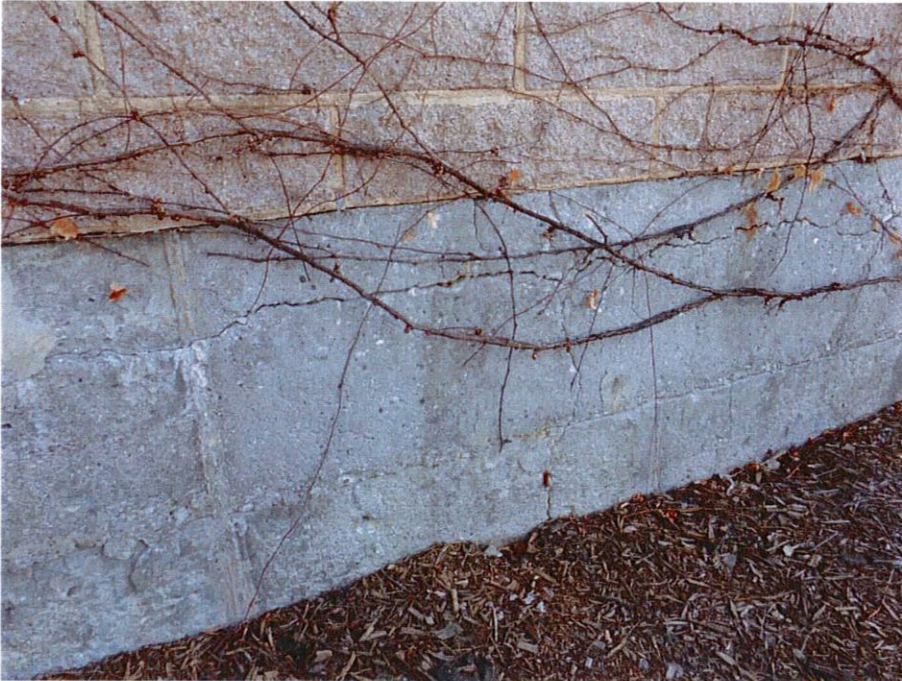
Although the gaps in the control joints have changed only slightly from the measurements taken in 2010, the new horizontal crack in the west wall indicates the tank is still settling even with the micropiles. The north end of the crack was measured to be ~1/2" therefore the tank is assumed to have settled an additional 1/2" since 2010. The settlement has not significantly impacted the structural framing but it has impacted the rigid pipe connections that pass through the wall resulting in the recent damage to the pipes passing through the west wall.

12. Horizontal crack top of tank wall West Exterior Elevation

Further investigation is recommended in order to better determine the cause of the ongoing settlement. We have recommended a geotechnical testing service be engaged to obtain soil borings both outside and inside the building to determine additional stabilization of the building.
