A Guide to the Wood River Watershed

MADISON, JERSEY, & MACOUPIN COUNTIES ILLINOIS

THE WOOD RIVER WATERSHED & THE PLAN

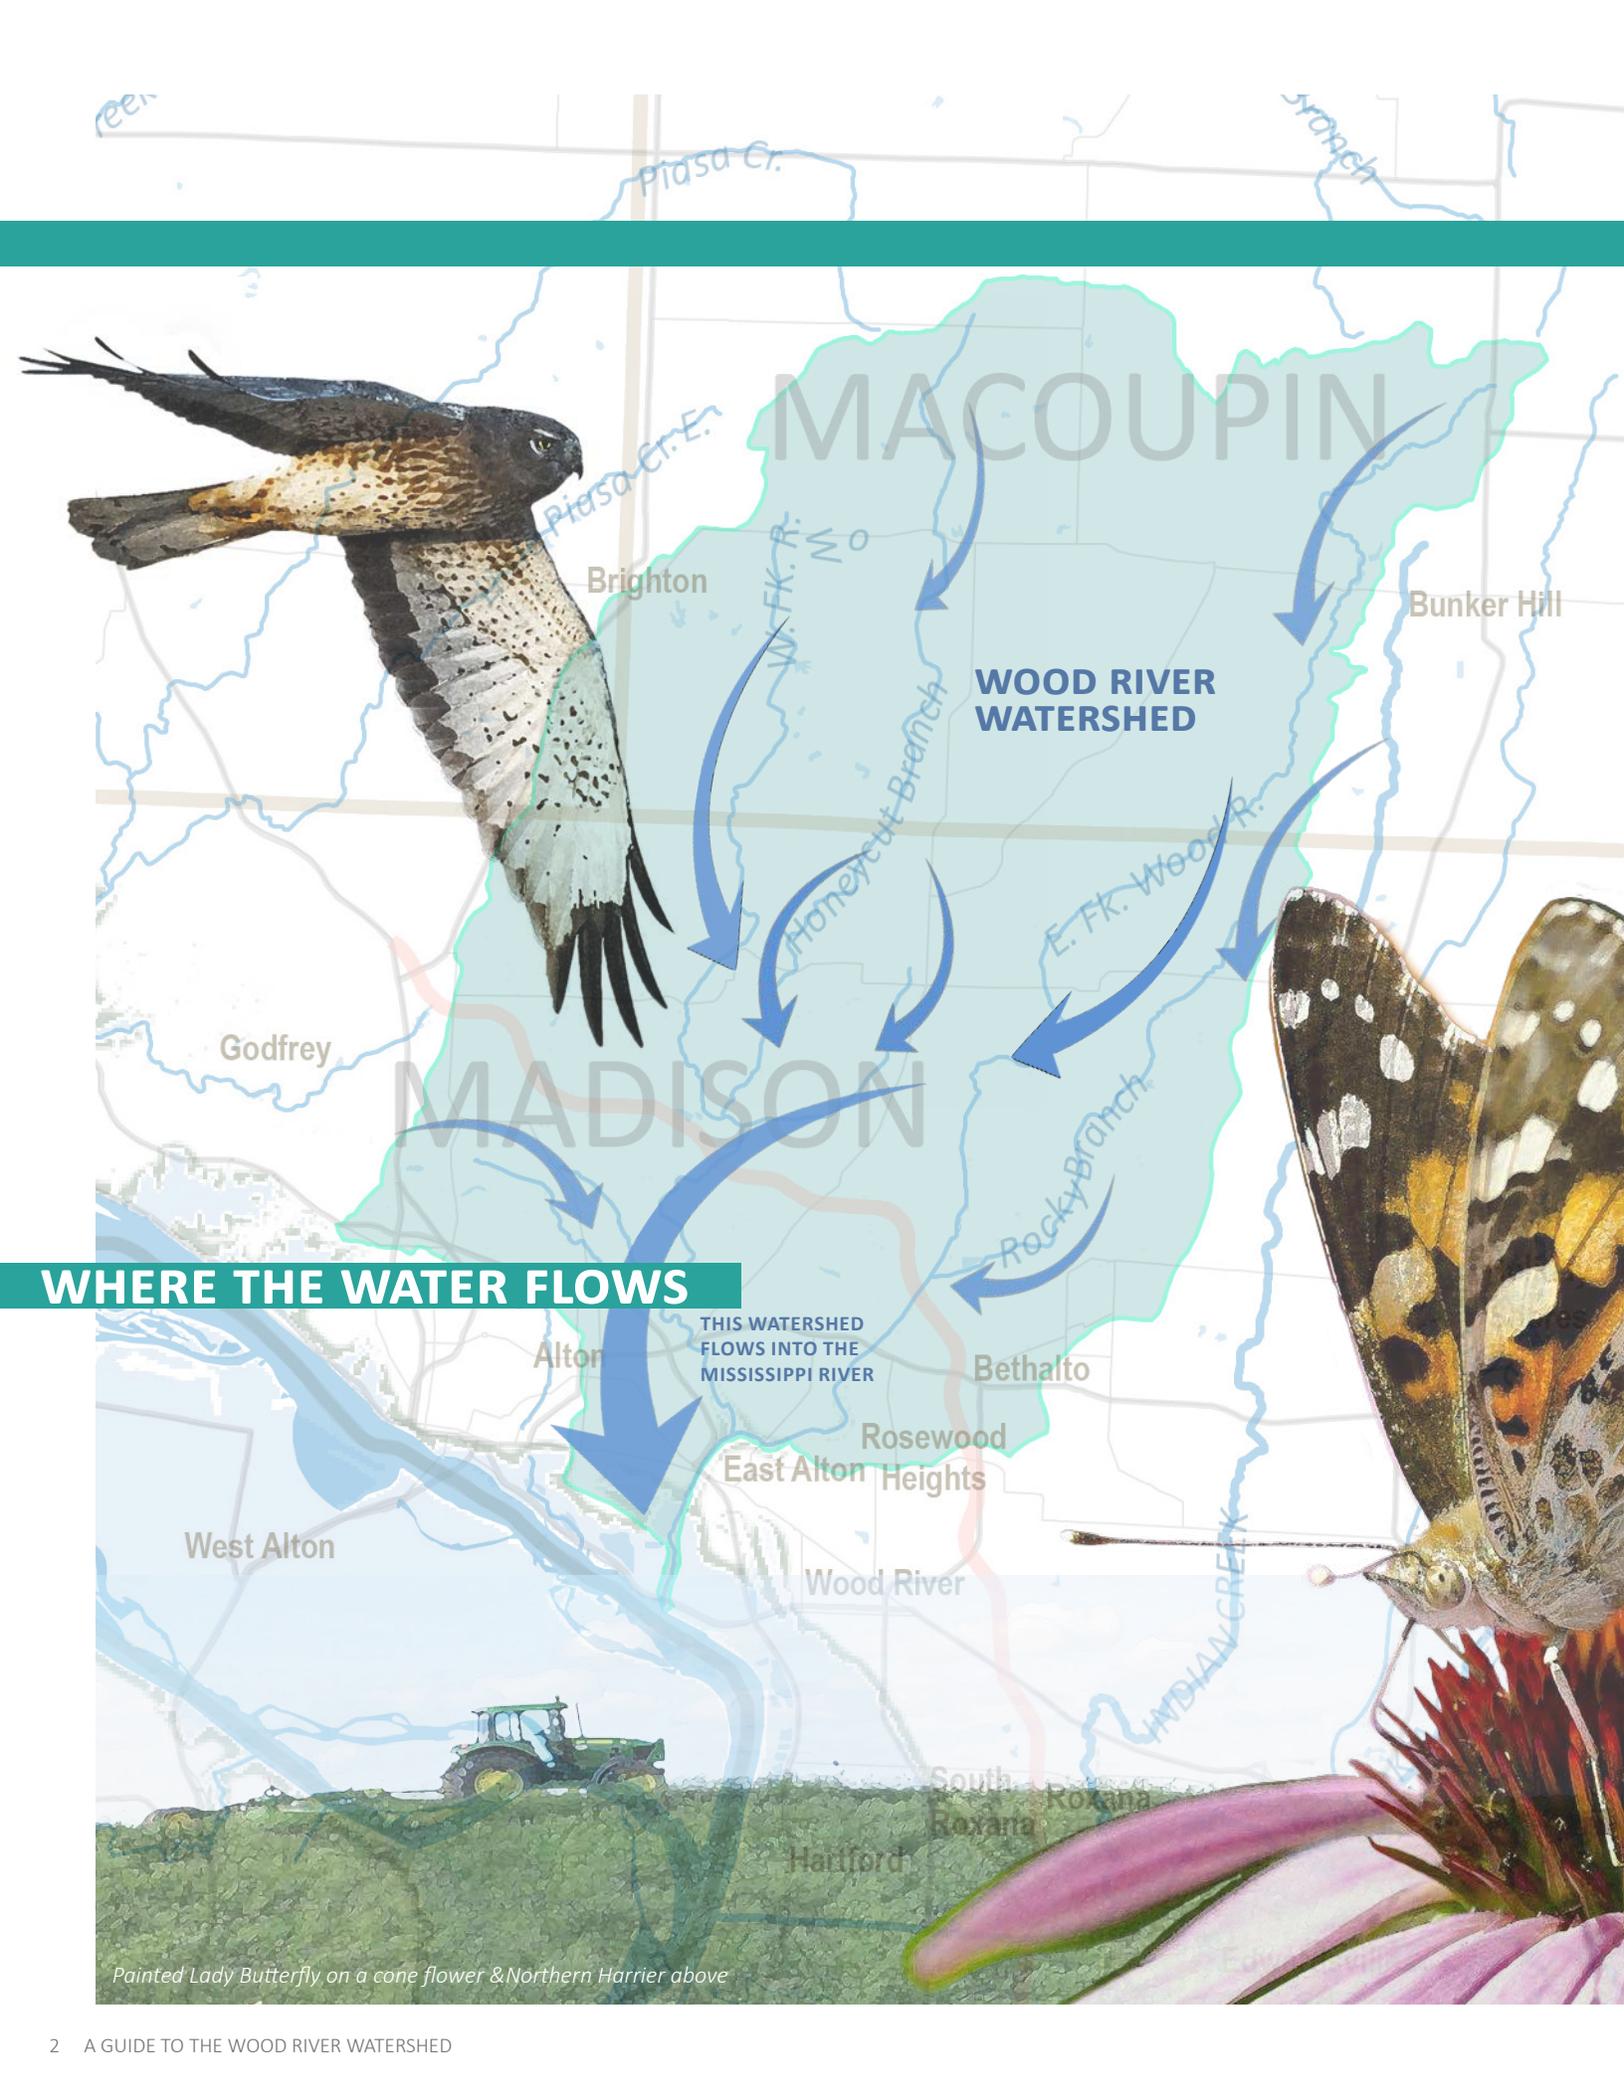
WOOD RIVER WATERSHED

WHERE THE WATER FLOWS

THIS WATERSHED FLOWS INTO THE MISSISSIPPI RIVER

Water in the Wood River watershed generally flows north to south and east to west. Water flow starts in Macoupin County and moves south and west through Alton to the Mississippi River.

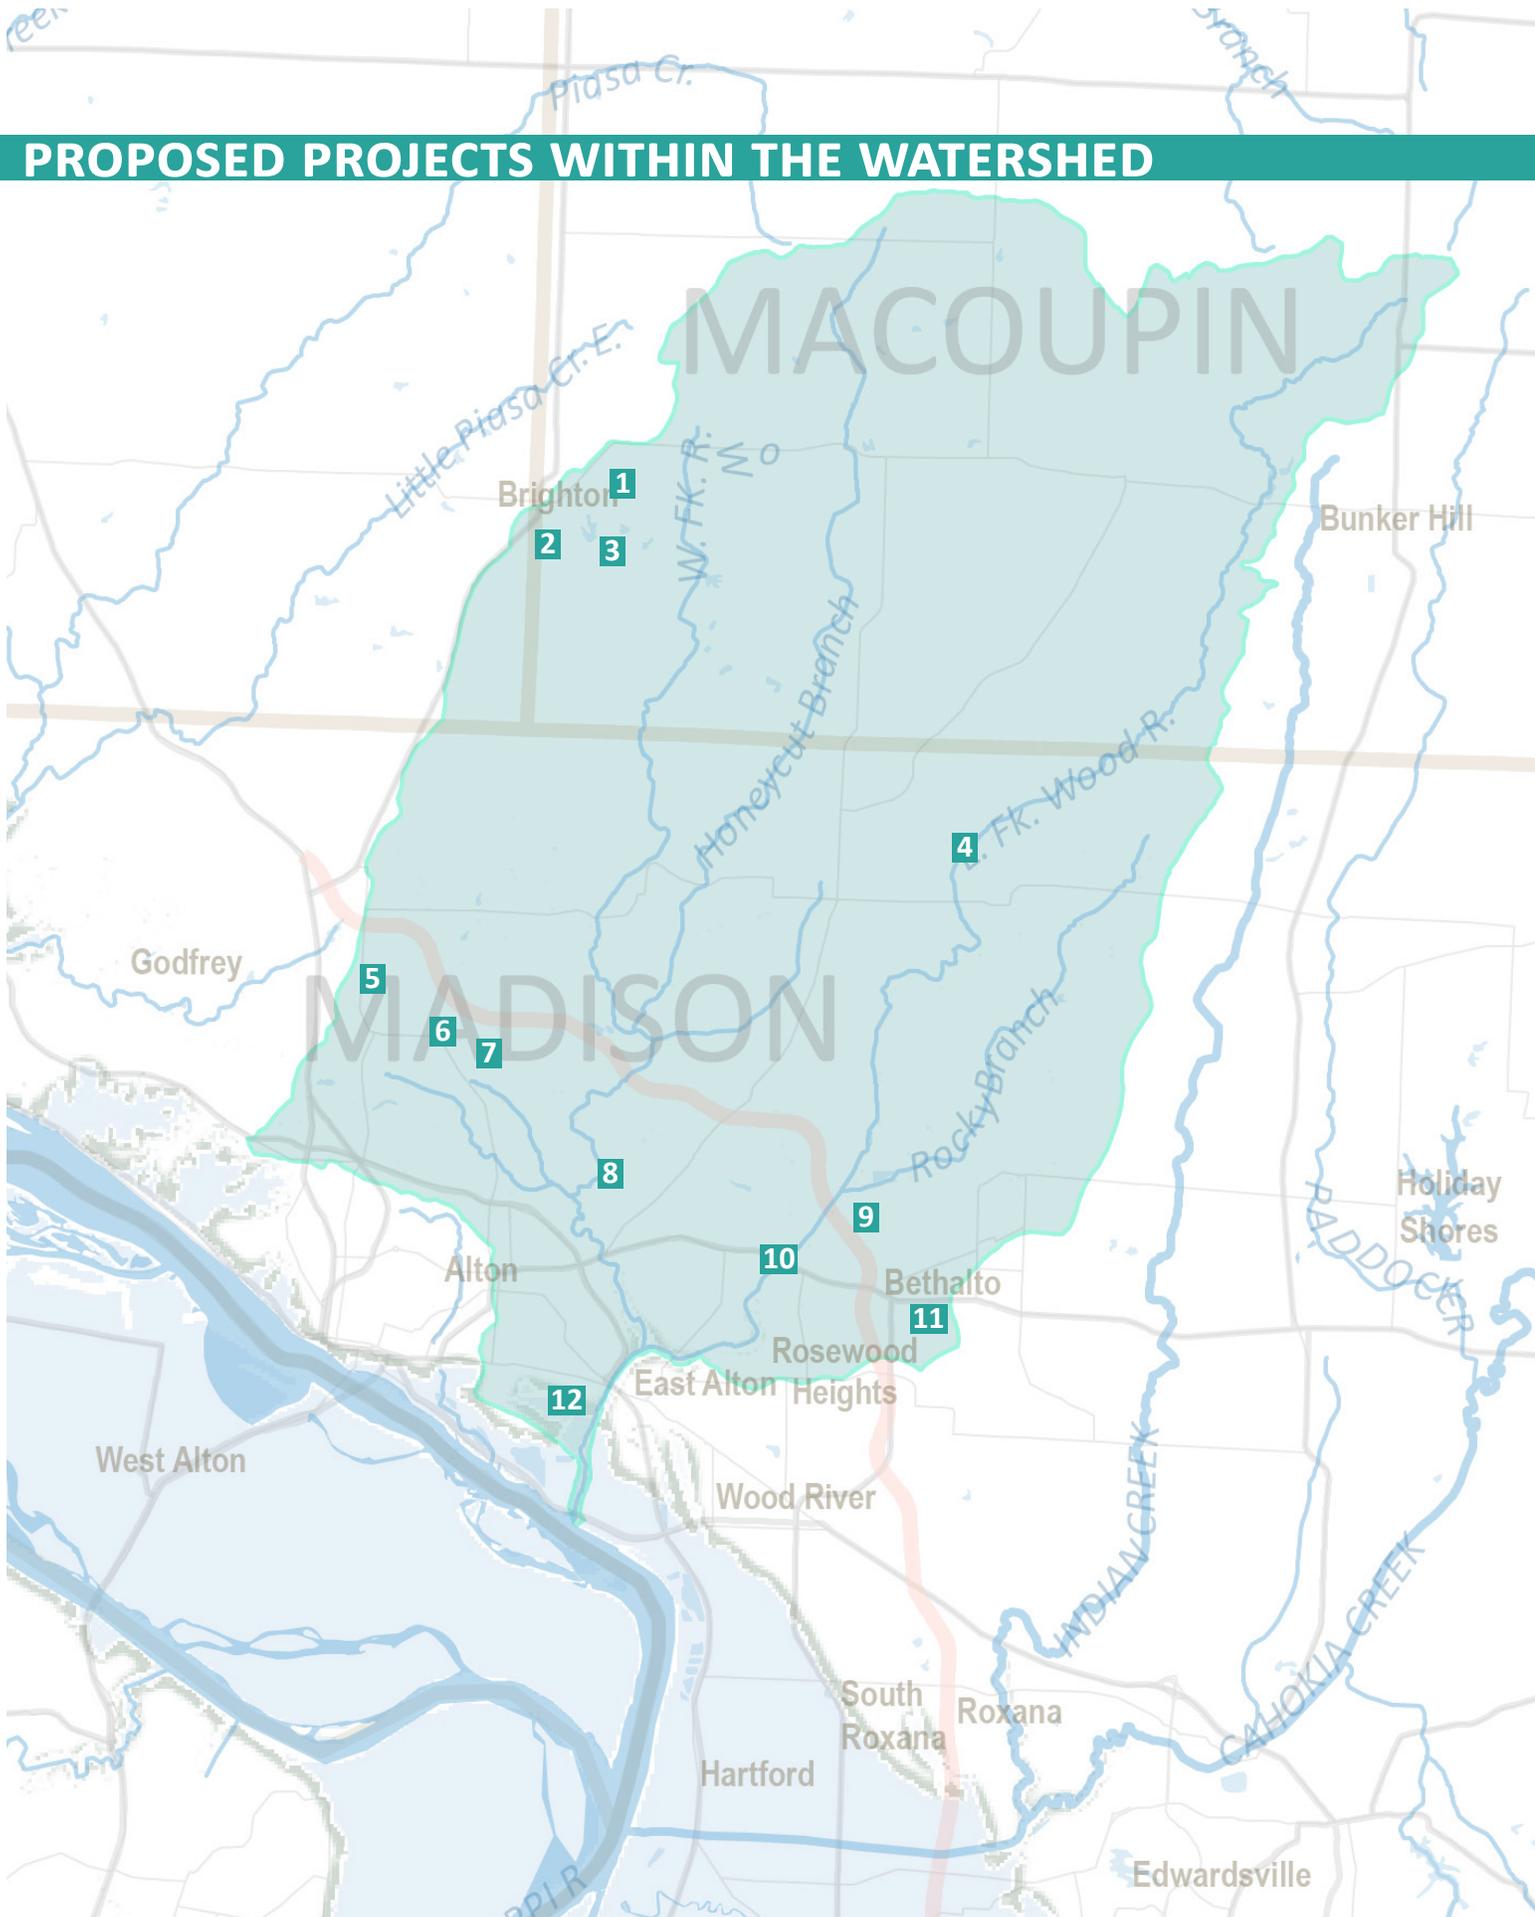
LIST OF SPECIFIC PROJECT LOCATIONS

Twelve specific project locations were identified in the watershed. These projects address life safety issues and multiple goals of the plan by implementing a variety of Best Management Practices.

SPECIFIC PROJECT LOCATIONS

- [1] Countryview Lake Drive Flooding (Brighton)**
- [2] Village of Brighton Flooding**
- [3] Briarwood Lake Dam (Brighton)**
- [4] Honeycut Branch | East Fork Wood River Erosion (Foster Township)**
- [5] Pearl | Isabel | Gladys Street Flooding and Sanitary Sewer Overflow (Godfrey)**
- [6] Humbert and Wick-Mor Road Flooding (Godfrey)**
- [7] Savannah Trace Subdivision (Godfrey)**
- [8] Harris Land and Woods Station Road Flooding (Alton)**
- [9] Bethalto Sports Complex Flooding**
- [10] Erosion and Flooding at Route 111 (Cottage Hills)**
- [11] St. Louis Regional Airport | Stuart Road Flooding (Bethalto)**
- [12] Chessen Lane Flooding (Alton)**
