NORTHFIELD TOWNSHIP
WASTEWATER
ASSET MANAGEMENT PLAN
DRAFT

200-12748-18002

September 2020

Northfield Township, MI
8350 Main Street
Whitmore Lake, MI 48189

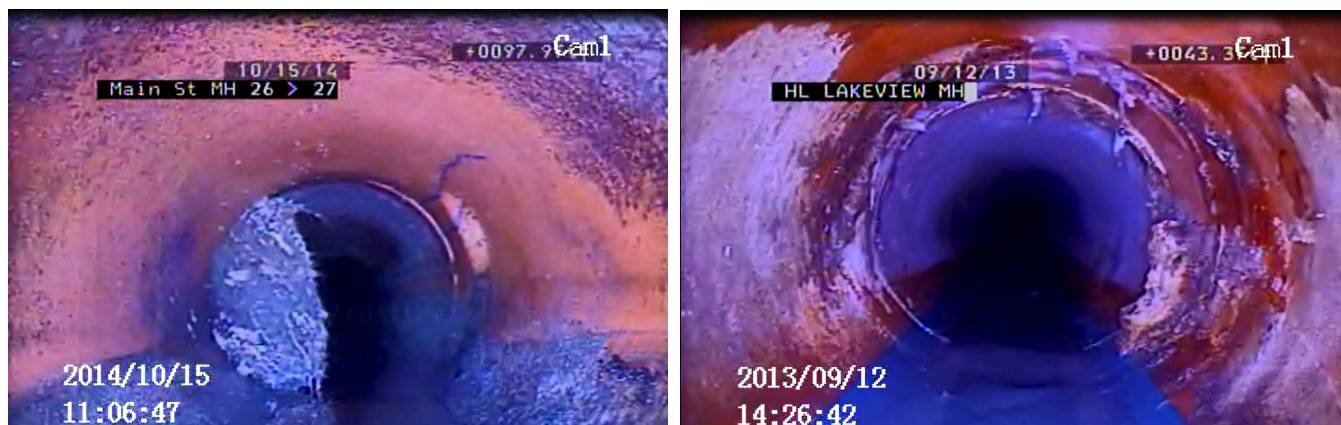
Figure 3-1. Grade 3 Defect vs. Grade 4 Structural Defect

An example of determining the ECR would be a case where roots are located at a joint. It will receive a Grade 4 defect and look like the photo on the left in Figure 3-1.

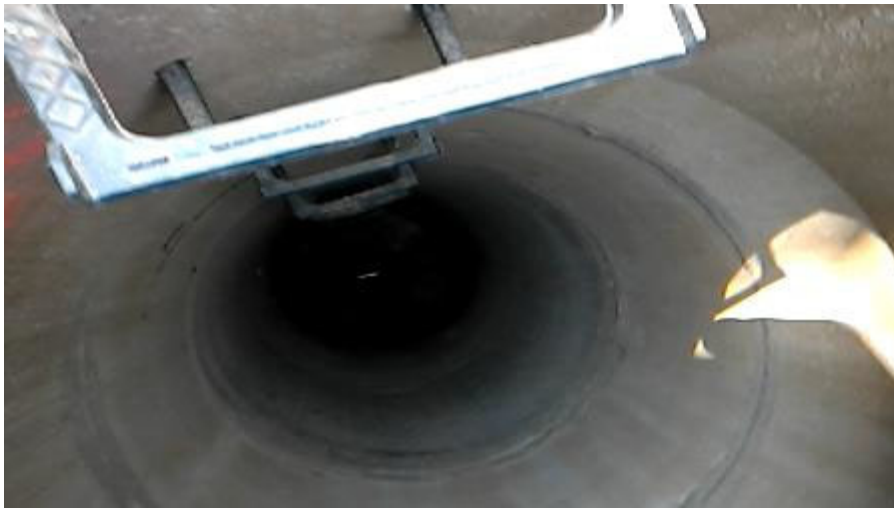
Figure 3-5. Precast Concrete Manhole

In general, the results of the manhole inspections showed that the manholes were in good condition with many having already been repaired or rehabilitated. Figure 3-5 is an example of a precast concrete manhole in good condition.

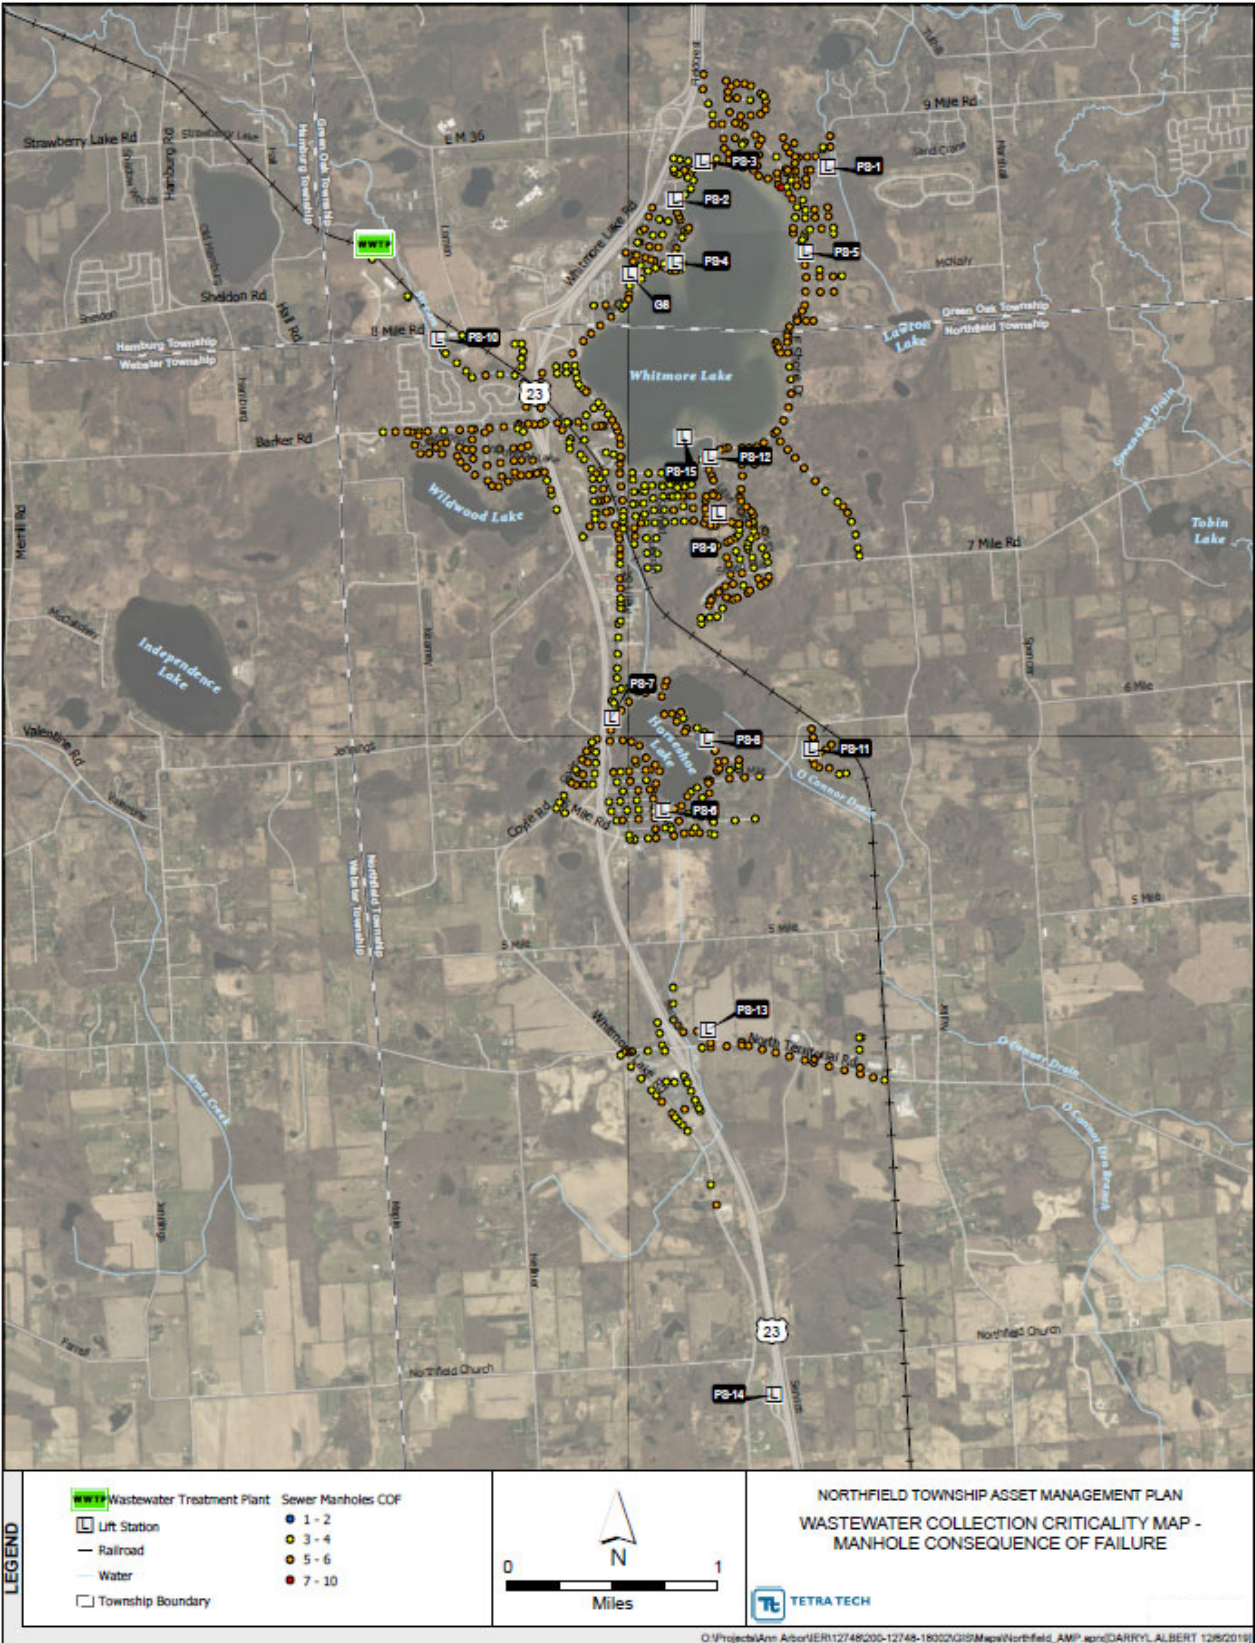
Figure 5-6. Manhole COF Map

The results for the manholes were similar to those for gravity mains. Table 5-8 and Figures 5-5 through 5-7 summarize the POF, COF and BRE scoring for manholes. Full-sized maps displaying the POF, COF, and BRE results for manholes have been included in Appendix G.

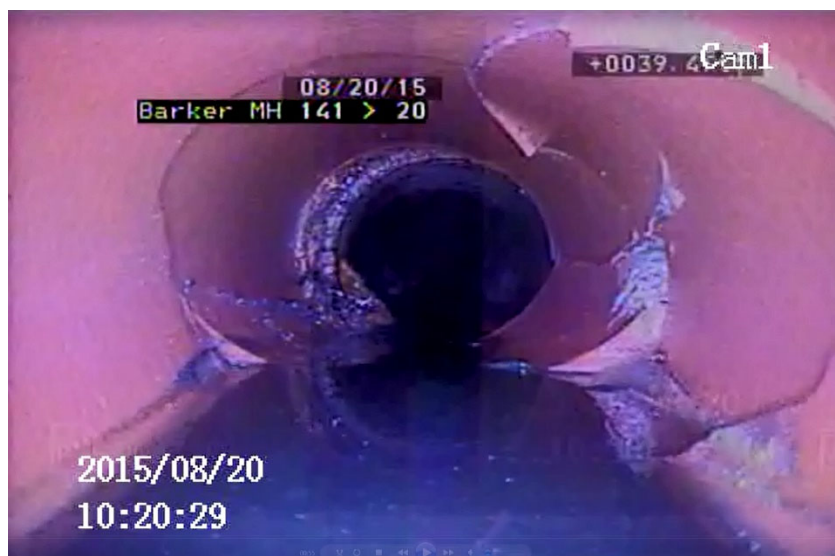
Figure 8-6. Broken Sewer under Barker Road

An example of a broken and deformed pipe requiring a spot repair is shown in Figure 8-6. This image is from a sewer under Barker Rd. In this case, the condition of the sewer was so severe, that it was repaired in the summer of 2020. As noted previously, the condition and POF of the gravity mains were prepared in 2019. The repair of sewer SP-389 will be incorporated in a future updated of the AMP.

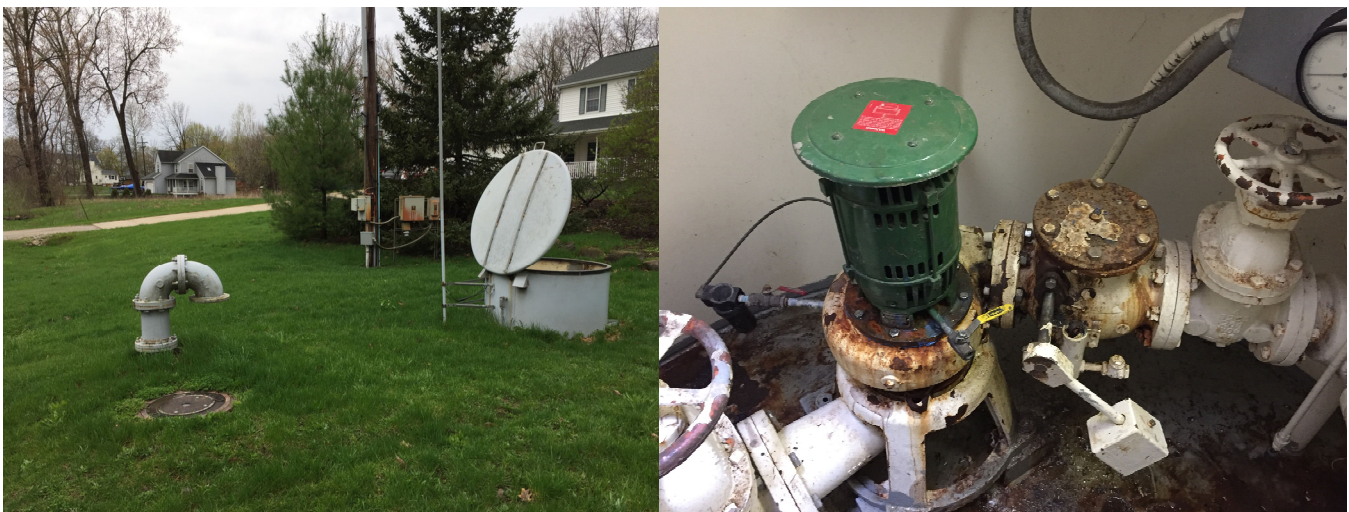
Figure 8-7. Main Street Pump Station Site View and Pump, Discharge Piping and Valve Corrosion

The Main Street Pump Station was installed in 1969 on Main Street along the west side of Whitmore Lake. The station currently services the northwest side of Whitmore Lake (the area between Kenton Drive and the Department of Natural Resources boat launch) in addition to receiving discharge flows from the North Shore 1 Pump Station. The pump station consists of a concrete wet well with pumps and valves all located inside the separate steel dry pit structure. Various parts of the station are showing signs of age and corrosion, including the floor of the dry pit, the electrical enclosures and panels, the pumps, discharge piping and valves and the wet well as shown in Figure 8-7.

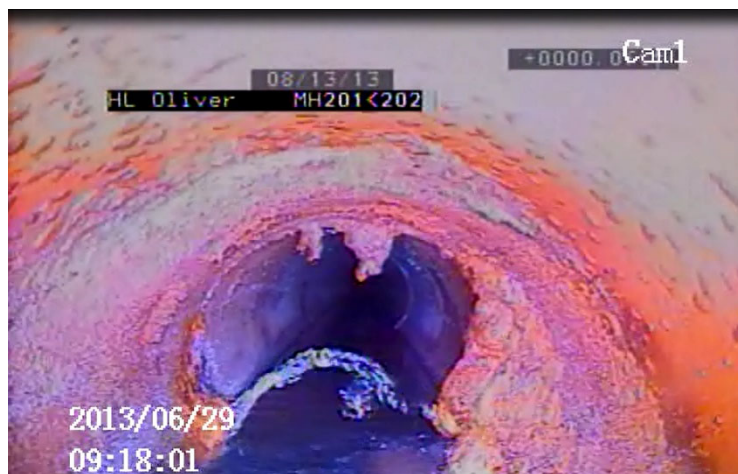
Grade 4 defects that were identified include O&M defects such as root intrusions, gushing and dripping infiltration and high water potentially caused by blockages. Structural defects identified include cracked and fractured pipe. Full-length CIPP lining is often a preferred remedy for the rehabilitation of sewers that have become afflicted with root intrusion, infiltration, cracking and fracturing throughout or nearly throughout the entirety of the run. Partial-length lining may also be used as an alternative when a pipe run has been determined to not be deformed but exhibits related O&M defects over a small portion of the run. Examples of pipe experiencing these issues are shown in Figures 8-8 through 8-10.

Figure 8-8. Gushing Infiltration and Encrustation Under Oliver Boulevard

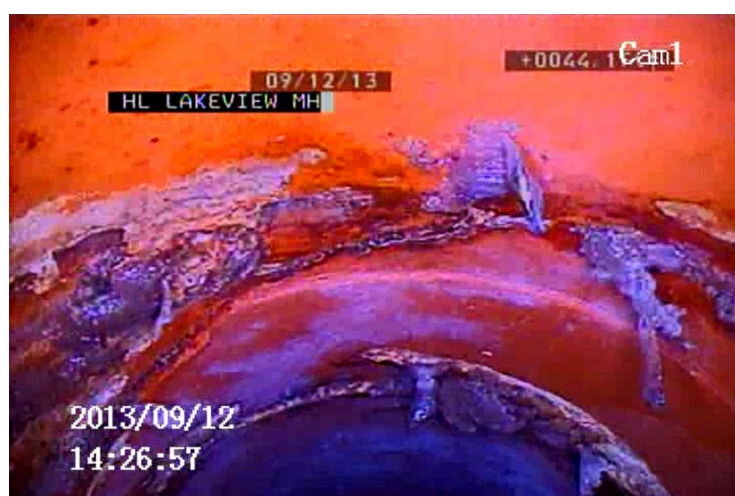
Figure 8-10. Multiple Fractures under Lakeview Drive

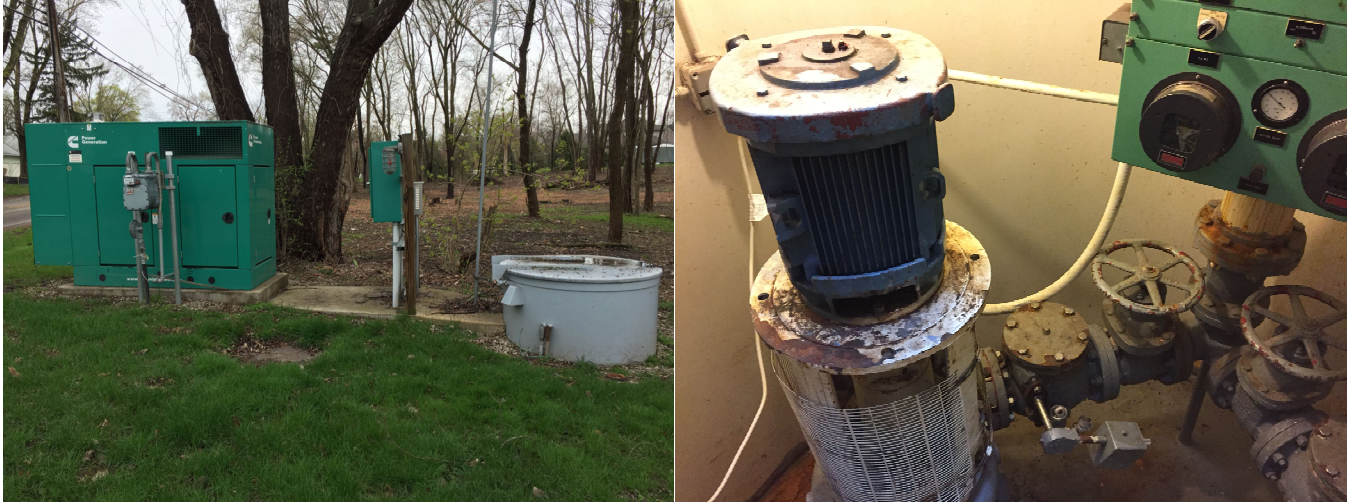
The East Shore 2 Pump Station was installed in 1969 at the end of Preservation Drive. The station currently services the developments around the northeast side of Whitmore Lake in addition to the flows discharged from the 9 Mile Road Pump Station. The pump station consists of a steel dry pit housing the pumps, valves and discharge piping along with a concrete wet well that houses suction piping. Various parts of the station are showing signs of age and corrosion, including the pumps, discharge piping, valves, dry pit structure, the electrical enclosures and panels, as shown in Figure 8-12. There appears to be space available adjacent to the station in the grass on the south side of the driveway to allow for a new pump station that more closely meets current Township standards. Considering the available space, the new pump station can be built before taking the old one out of service, which will allow the Township to continue to provide uninterrupted service. This project is estimated to be necessary by 2030. The opinion of cost to design and construct a project to replace this pump station is approximately \$635,000.

Figure 8-12. East Shore 2 Pump Station Site View and Corrosion in Dry Pit

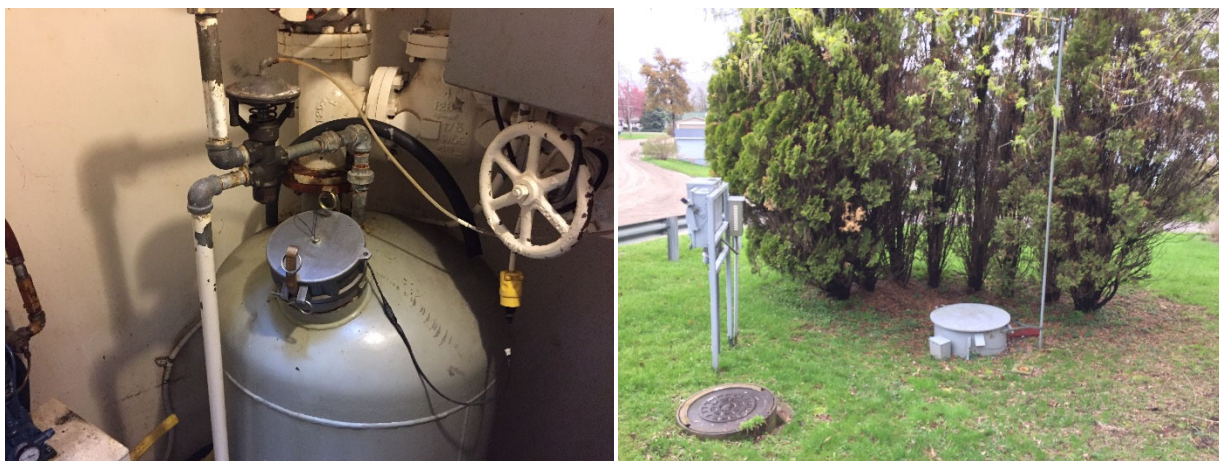
Figure 8-13. North Shore 1 Pump Station Site View and Ejector Pumps

The North Shore 1 Pump Station was installed in 1969 at the corner of North Shore Drive and Shore Drive. The station currently services homes along North Shore Drive in addition to receiving flows from the North Shore 2 and Canal (Elmcrest) Pump Stations. The pump station consists of a concrete wet well housing suction piping along with a steel dry pit that contains pumps, discharge piping, valves and electrical equipment. Various parts of the station are showing signs of age and corrosion, including the discharge piping and electrical enclosures, as shown in Figure 8-13. Additionally, the existing pumps are ejector pumps, which are not commonly utilized in modern pump stations. To provide a more effective system, Tetra Tech recommends utilizing conventional submersible pumps. There appears to be space available adjacent to the station in the grass to allow for a new pump station that more closely meets current Township standards. Considering the available space, the new pump station can be built before taking the old one out of service, which will allow the Township to continue to provide uninterrupted service. This project is estimated to be necessary by 2030. The opinion of cost to design and construct a project to replace this pump station is approximately \$509,000.

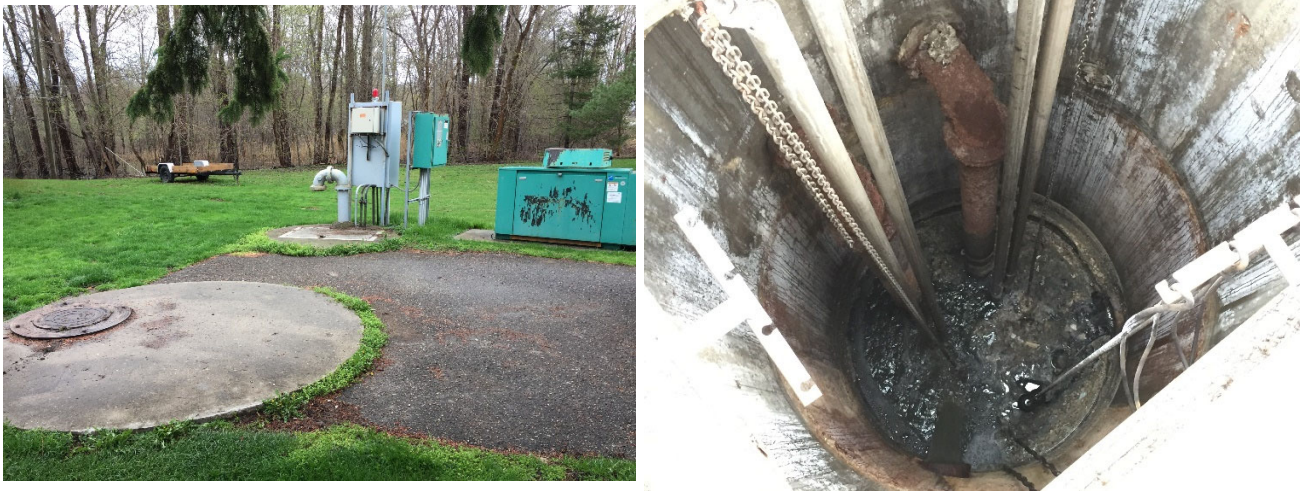
The Horseshoe Lake 1 Pump Station was installed in 1978 on Main Street on the west side of Horseshoe Lake. The station currently services developments on the west side of US-23, around the west half of Horseshoe Lake in addition to receiving discharge from the Horseshoe Lake 2, Horseshoe Lake 3 and Shadowoods Pump Stations. The pump station consists of a concrete wet well with submersible pumps and discharge piping along with a concrete valve vault. Various parts of the station are showing signs of age, infiltration and corrosion, including the wet well structure, discharge piping, generator, the electrical enclosures and panels and valves, as shown in Figure 8-14. There appears to be space available adjacent to the station on the south side to allow for a new pump station that more closely meets current Township standards. Considering the available space, the new pump station can be built before taking the old one out of service, which will allow the Township to continue to provide uninterrupted service. This project is estimated to be necessary by 2030. The opinion of cost to design and construct a project to replace this pump station is approximately \$650,000.

Figure 8-14. Horseshoe Lake 1 Pump Station Site View and Corrosion/Infiltration in Wet Well

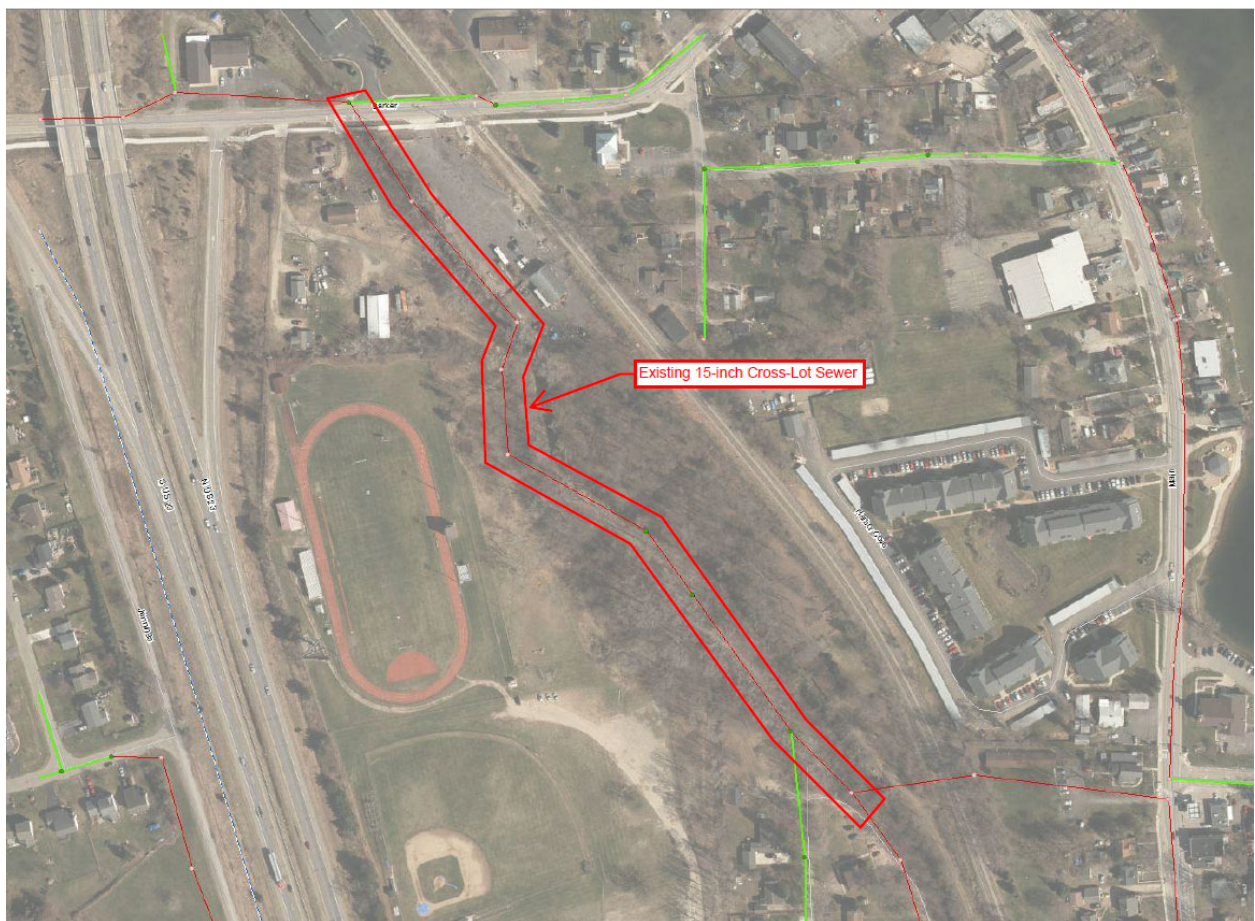
**Figure 8-15.** Existing 15-inch Cross-Lot Sewer between Brookside Drive and Barker Road

The existing 15-inch cross-lot sewer (shown boxed in red in Figure 8-15 below) that runs between the north end of Brookside Drive and Barker Road has been determined to be nearing the end of its useful life. Additionally, it has also been determined by hydraulic modeling to be under capacity for conveying peak flows during a 25-year, 24-hour design storm (Study Segment C improvement in Modeling Report). Tetra Tech recommends the replacement of the approximately 1,700-foot section of 15-inch trunk sewer between Brookside Drive and Barker Road with 18-inch sewer. This project is expected to be necessary by 2035, although development requests from the central part of the service area could necessitate this improvement even earlier. The opinion of cost to design and construct a project to replace this sewer is approximately \$690,000.

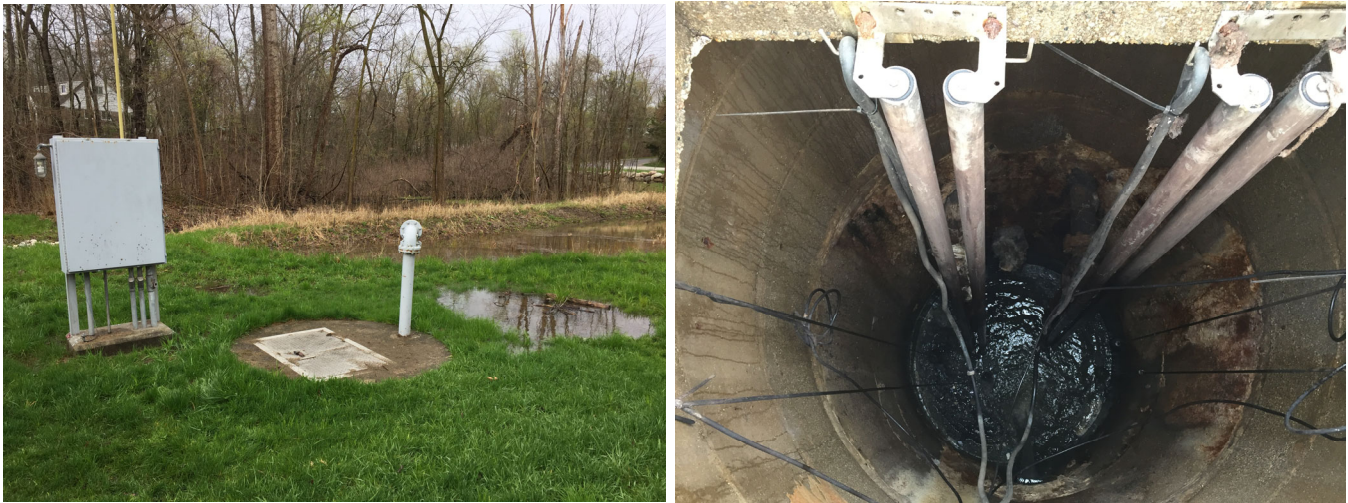
The North Shore 2 Pump Station was installed in 1969 at the corner of North Shore Drive and Department of Natural Resources Park Road. The station currently services approximately 15 homes on North Shore Drive and Elmcrest Road along the northwest corner of Whitmore Lake in addition to receiving flows from the canal (Elmcrest) Pump Station. The pump station consists of a concrete wet well with submersible pumps and discharge piping along with a concrete valve vault that houses valves. Various parts of the station are showing signs of age, infiltration and corrosion, including the wet well structure, discharge piping, generator, the electrical enclosures and panels and valves, as shown in Figure 8-16. There appears to be space available adjacent to the station on the west side to allow for a new pump station. Considering the available space, the new pump station can be built before taking the old one out of service, which will allow the Township to continue to provide uninterrupted service. This project is estimated to be necessary by 2035. The opinion of cost to design and construct a project to replace this pump station is approximately \$629,000.

Figure 8-16. North Shore 2 Pump Station Site View and Corrosion/Infiltration in Wet Well

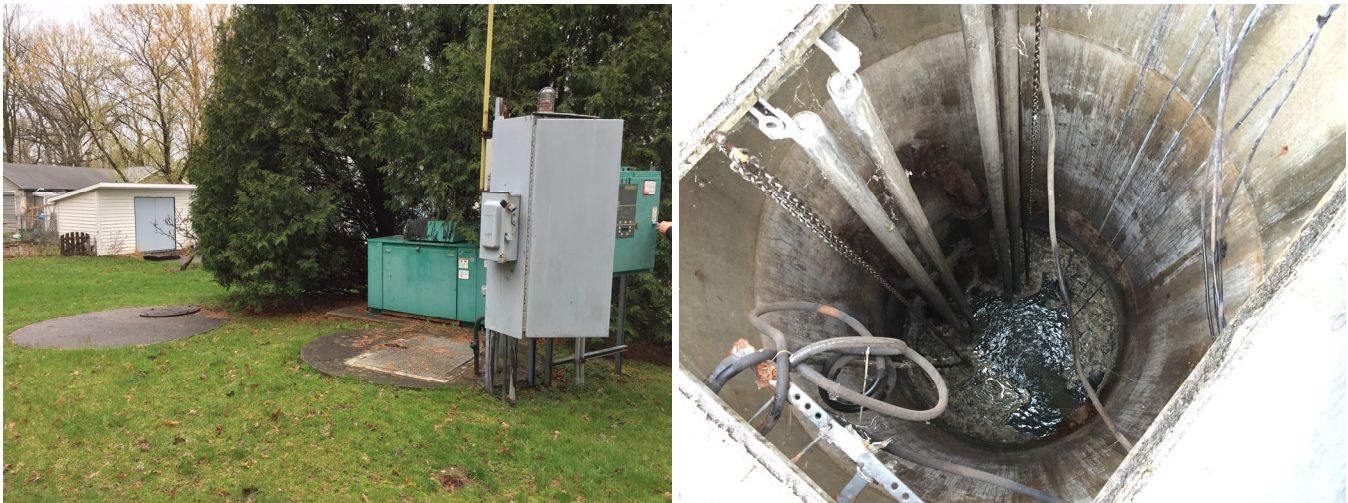
The Horseshoe Lake 2 Pump Station was installed in 1978 on Edmund Street. The station currently services homes along the south side of Horseshoe Lake in addition to receiving discharge flows from both the Horseshoe Lake 3 and Shadowoods Pump Stations. The pump station consists of a concrete wet well housing the submersible pumps and discharge piping along with a concrete valve vault that houses valves. Various parts of the station are showing signs of age, corrosion and infiltration, including the generator, wet well, valve vault, discharge piping, valves and electrical enclosures, as shown in Figure 8-17. There appears to be space available adjacent to the station in the grass to allow for a new pump station. Considering the available space, the new pump station can be built before taking the old one out of service, which will allow the Township to continue to provide uninterrupted service. This project is estimated to be necessary by 2040. The opinion of cost to design and construct a project to replace this pump station is approximately \$545,000.

Figure 8-17. Horseshoe Lake 2 Site View and Wet Well Infiltration and Discharge Piping Corrosion

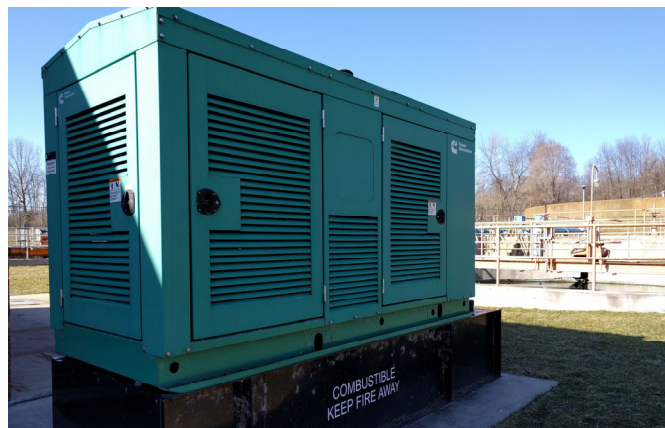
Figure 8-24. Generator

The existing 250kW emergency diesel generator, shown in Figure 8-24, was installed in 2008. The recommended useful life for this equipment is 25 to 30 years.

The opinion of probable project cost to replace the generator is \$372,000. The project is scheduled to take place in 2037.

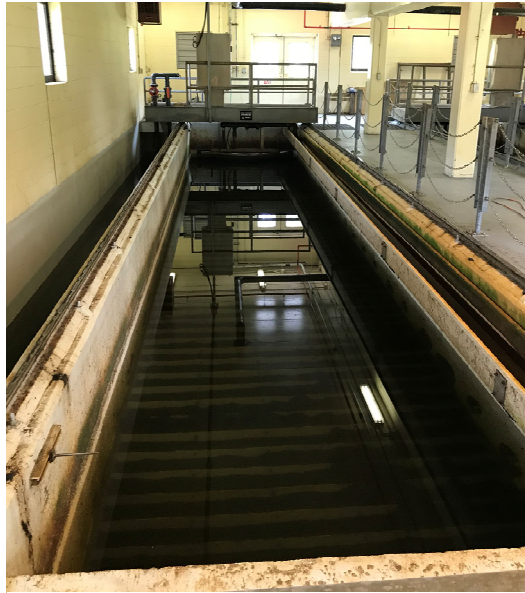
Figure 8-25. Existing Traveling Bridge Filter

The traveling bridge filters were installed in 1998 and require periodic maintenance. They were last serviced in 2015 when the sand and wear strips were replaced. One of the traveling bridge filters is shown in Figure 8-25. At the end of the filters expected useful life, it is suggested that the traveling bridge filters be replaced with cloth media filters. Two units will be required to provide firm capacity, as the whole filter would be backwashed at one time. The existing channels in Filter Building No. 2 could be modified to accommodate the cloth media filters.

The opinion of probable project cost to replace the tertiary filters is \$1,637,000. The project is scheduled to take place in 2040.

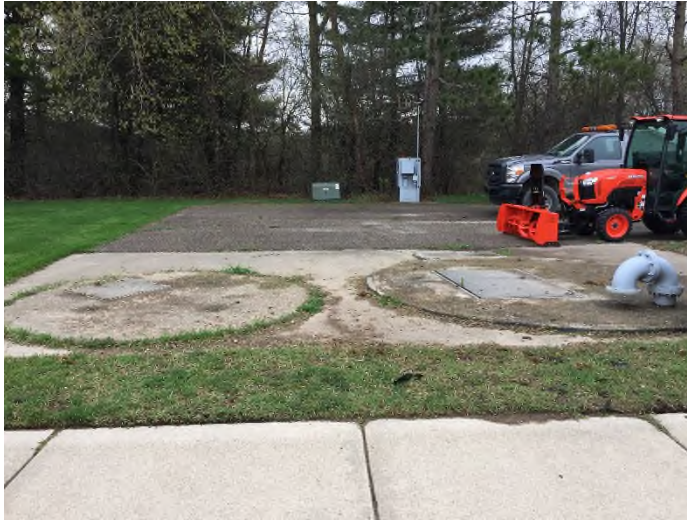
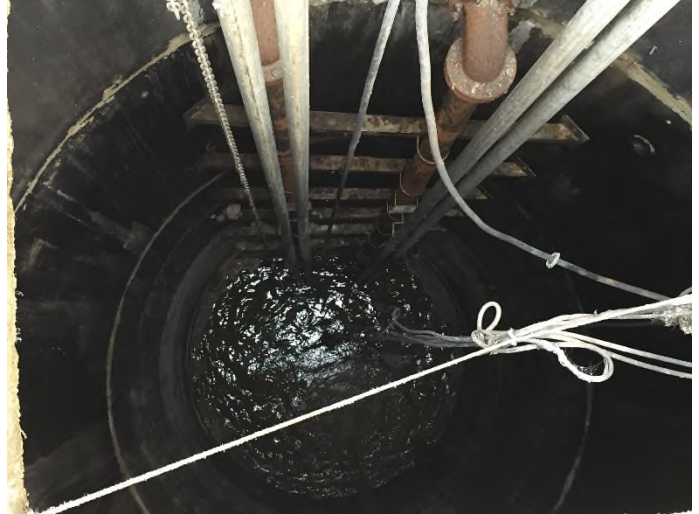
PS-1 Eagle Gardens

Location: Lake Pine Dr-Eagle Gardens Subdivision

Description: Pump Station PS-1 is a duplex submersible pump station with a 10-foot round precast concrete wet well which houses pumps and discharge piping. The station also incorporates a precast concrete valve vault which houses discharge piping and valves. The station is designed to service homes in the Eagle Gardens development on the south side of Whitmore Lake. The station was originally constructed in 1995 and currently discharges to an existing 10-inch sewer via a 10 inch force main. The pumps and valves are in fair condition. The controls and control cabinet are also in fair to good condition.

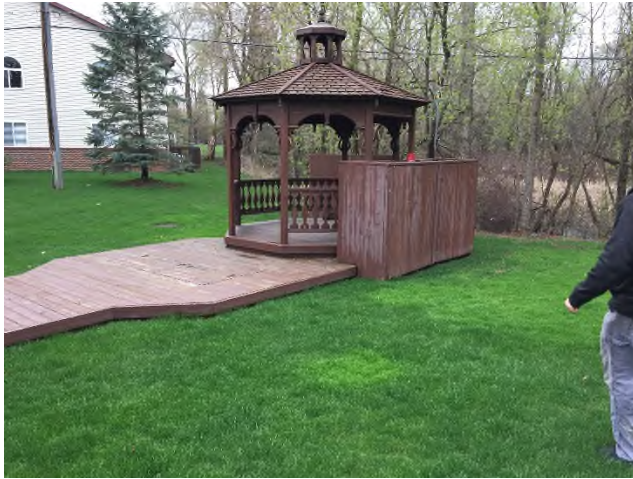
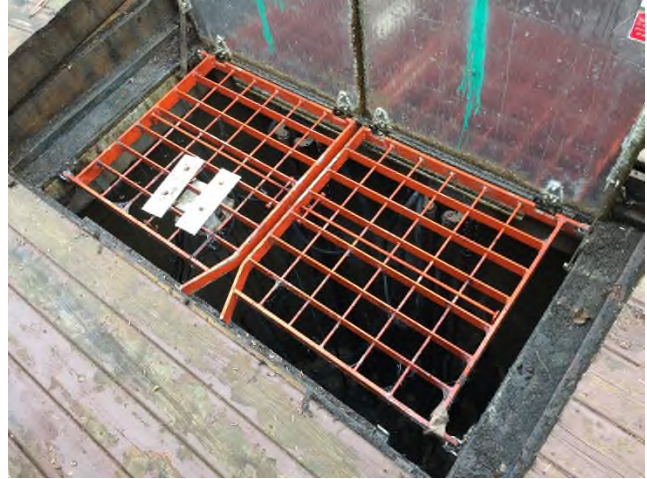
PS-2 East Shore 1

Location: Lake Pine Dr.

Description: Pump Station PS-2 is a duplex submersible pump station with a 10-foot round precast concrete wet well (buried under a wooden gazebo) which houses pumps and discharge piping. The station services flows from the Eagle Gardens subdivision that aren't picked up by the Eagle Gardens station (approximately 70 homes) in addition to flows discharged from the Lake Point Dr., Eagle Gardens, and East Shore 2 pump stations. The station was originally constructed in 1960 and replaced in 2007. The station currently discharges through an existing 6-inch force main to an existing 12-inch sewer. The pumps and valves are in good working condition. The controls and control cabinet are also in fair condition. The station's odor control canister unit is in fair condition.

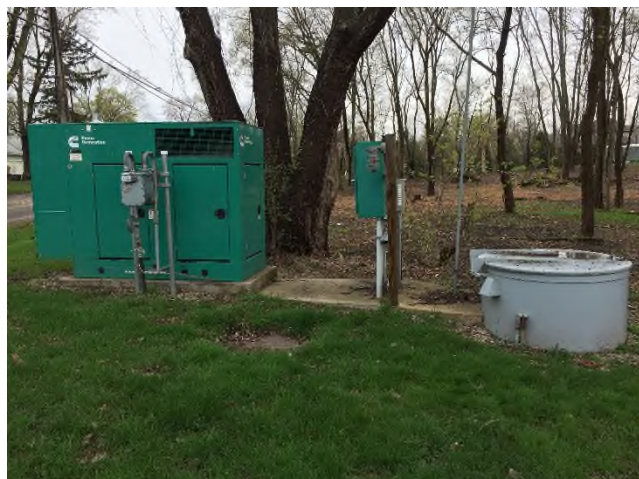
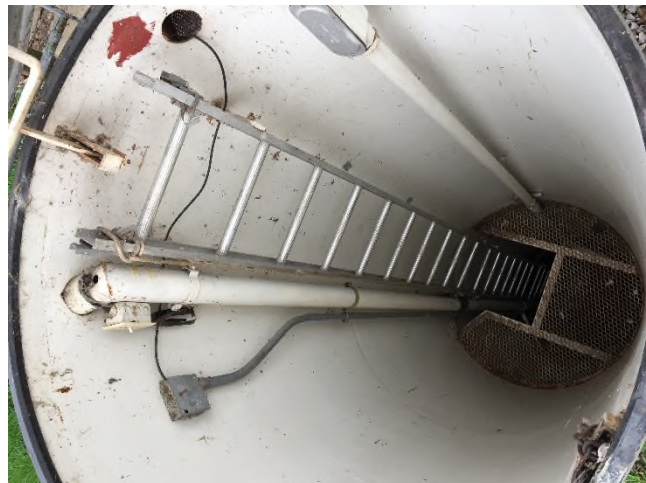
PS-3 East Shore 2

Location: End of Preservation Drive

Description: Pump Station PS-3 is a duplex submersible pump station with an 8-foot round precast concrete wet well which houses the pump suction bells. The station also includes a 4-foot x approximately 8-foot steel can dry pit valve vault that houses the pumps, discharge piping and valves. The station services the developments around the northeast side of Whitmore Lake in addition to the flows discharged from the 9 Mile Rd. pump station. The station was originally constructed in 1969 and currently discharges through an existing 6-inch ductile iron force main to an existing 12-inch VCP sewer. The pumps and valves are in poor to fair condition. The controls and control cabinet are also in poor to fair condition. The wet well and valve vault are in fair condition.

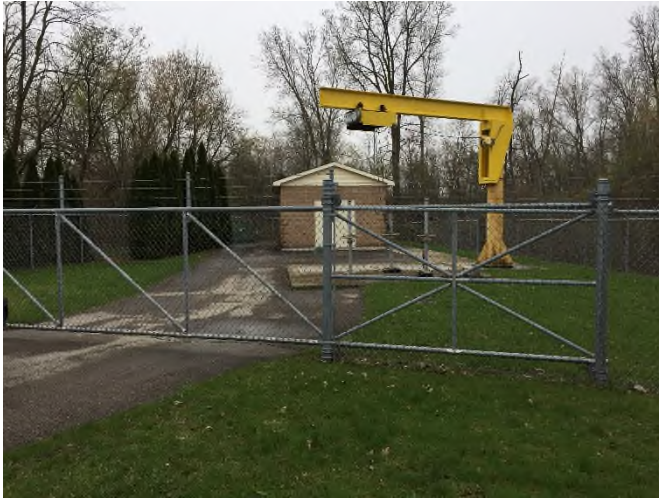
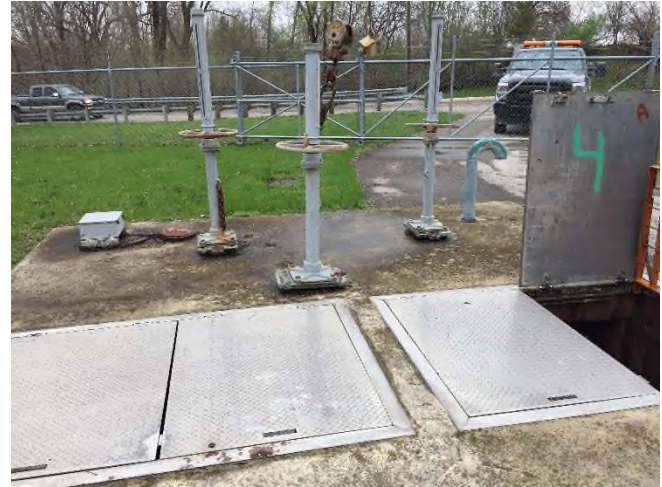
PS-4 Eight Mile Rd.

Location: Eight Mile Road between Emerald Cir. And Lemen Rd.

Description: Pump Station PS-4 is a quadplex submersible pump station with a 14-foot by 16-foot rectangular concrete wet well which houses pumps, inlet gates and discharge piping. The station receives flow from the entire Township before pumping it directly to the wastewater treatment plant headworks. The station was originally constructed in 2001 and currently discharges through an existing 12-inch force main to the wastewater treatment plant. The pumps and valves are in good working condition. The controls and control cabinet are also in good condition. The inlet gates are in fair condition. The crane is in good condition. The site fence and drive are in good condition. Pumps 2 and 3 were replaced in 2012 and 2014, respectively. VFD 4 was replaced in 2019.

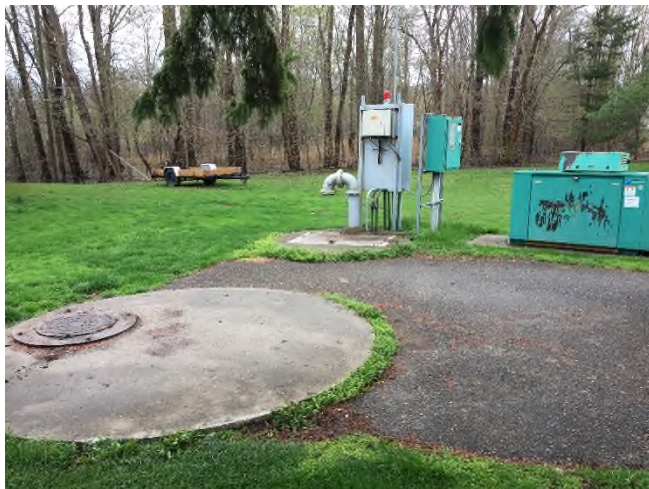
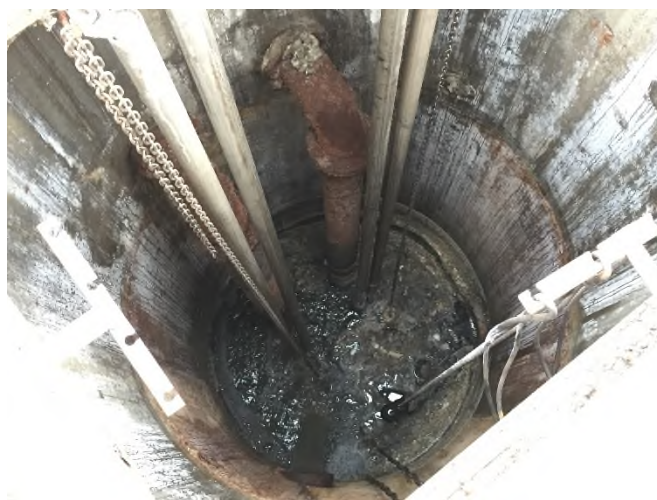
PS-5 Horseshoe Lake 1

Location: 8082 Main St.

Description: Pump Station PS-5 is a duplex submersible pump station with an 8-foot round precast concrete wet well which houses pumps and discharge piping. The station also includes a precast concrete valve vault that houses discharge piping and valves. The station services developments on the west side of US 23, developments around the west half of Horseshoe Lake in addition to receiving flow from the Horseshoe Lake 2, Horseshoe Lake 3 and Shadowwoods pump stations. The station was originally constructed in 1978 and currently discharges through an existing 6-inch force main to an existing 12-inch concrete sewer. The pumps are in fair working condition. The controls and control cabinet are also in fair condition. The discharge piping and valves appear to be corroded and in poor condition. The generator and generator controls appear to be in poor to fair condition. The pumps were replaced in 2010.

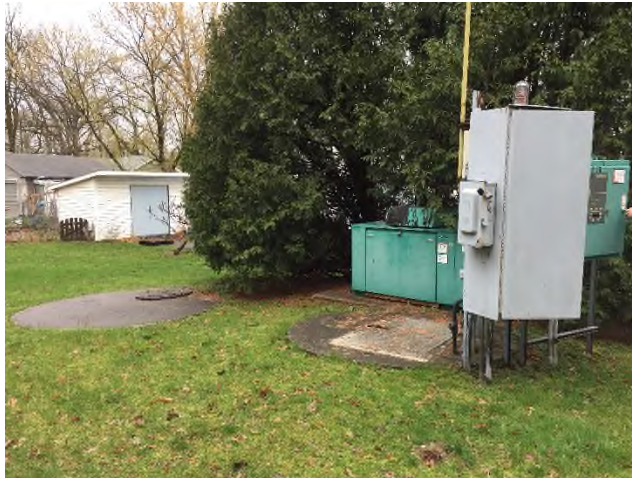
PS-6 Horseshoe Lake 2

Location: Edmund St.

Description: Pump Station PS-6 is a duplex submersible pump station with an 8-foot round precast concrete wet well that houses pumps and discharge piping. The station also incorporates a precast concrete valve vault, which houses discharge piping and valves. The station services homes along the south side of Horseshoe Lake in addition to receiving discharge flows from both the Horseshoe Lake 3 and Shadowwoods pump stations. The station was originally constructed in 1978 and currently discharges to an existing 10-inch sewer via a force main. The pumps and valves are in fair working condition. The controls and control cabinet are also in fair condition.

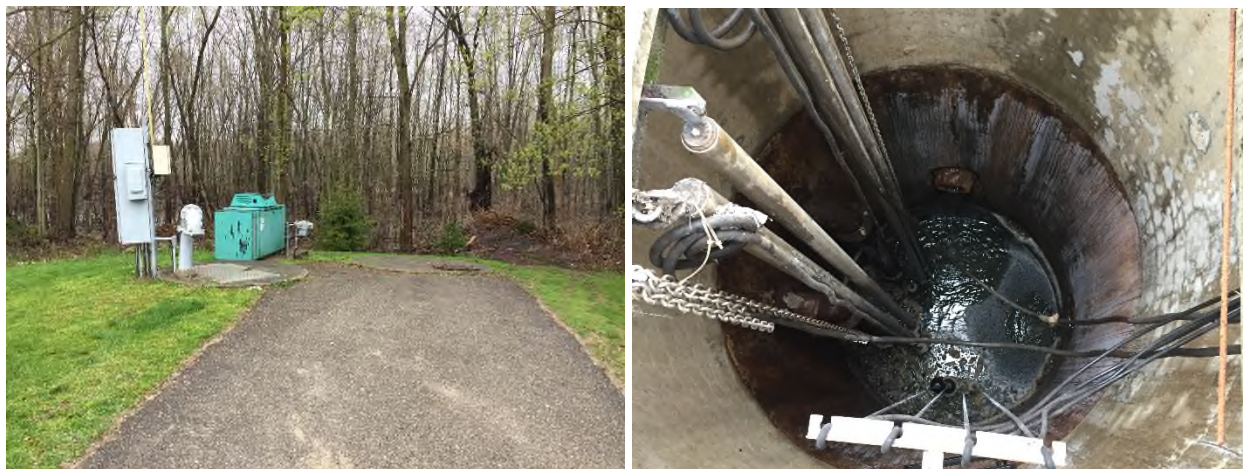
PS-7 Horseshoe Lake 3

Location: Lakeshore Rd.

Description: Pump Station PS-7 is a duplex submersible pump station with an 8-foot round precast concrete wet well which houses pumps and discharge piping. The station also incorporates a precast concrete valve vault, which houses discharge piping and valves. The station services homes on Lakeshore Rd. north of Highland Rd. The station was originally constructed in 1978 and currently discharges through a 4-inch force main to an existing 8-inch sewer. The pumps and valves are in fair working condition. The controls and control cabinet are also in fair condition. The pumps were replaced in 2010.

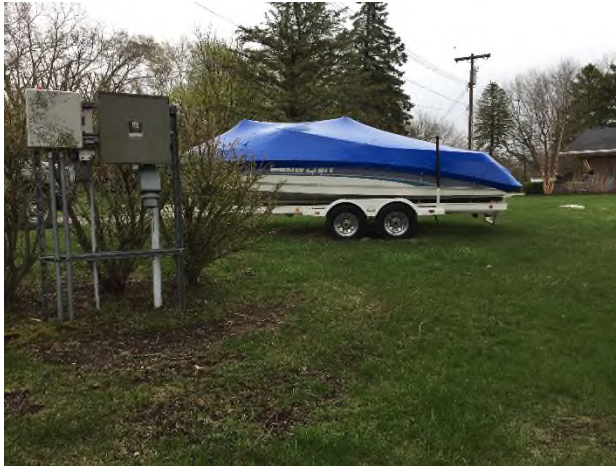
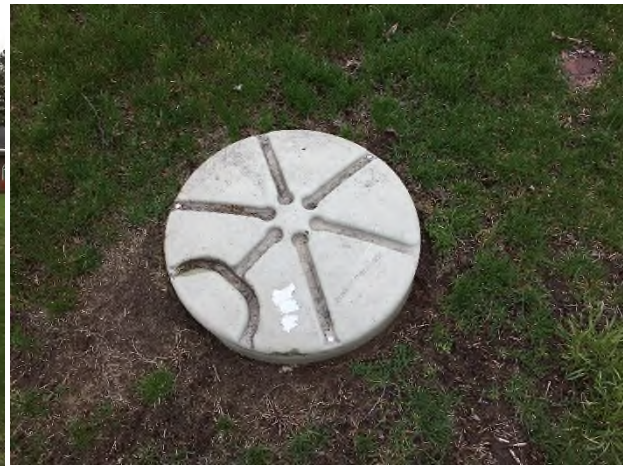
PS-8 Lake Point Dr.

Location: End of Lake Point Dr.

Description: Pump Station PS-8 is a duplex grinder pump station. The station services 4 homes on the Lake Point Dr. peninsula on the south side of Whitmore Lake. The station was originally constructed in 2004 and currently discharges through a 2-inch force main to an existing 12-inch sewer. The pumps and valves are in good working condition. The controls and control cabinet are also in good condition.

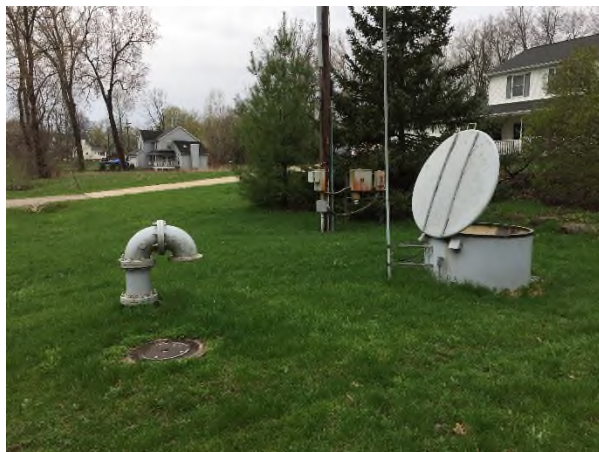
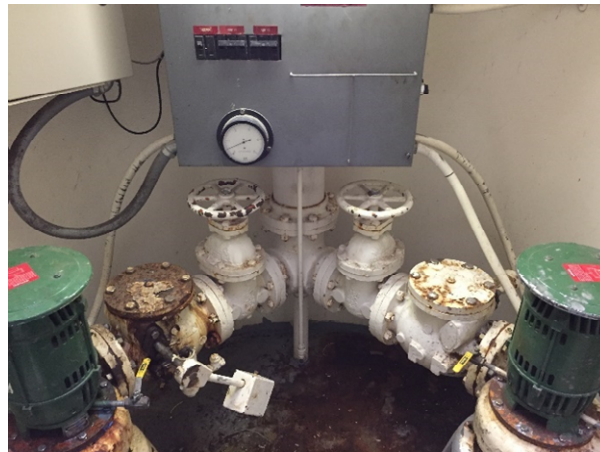
PS-9 Main St.

Description: Pump Station PS-9 is a duplex dry pit pump station with an 8-foot round precast concrete wet well which houses the pump suction bells. The station also incorporates an approximate 4-foot by 8-foot steel can valve vault, which houses pumps, discharge piping, valves and controls. The station services the northwest side of Whitmore Lake (area between Kenton Dr. and the DNR boat launch) in addition to receiving discharge flows from the North Shore 1, North Shore 2 and Canal (Elmcrest) pump stations. The station was originally constructed in 1969 and currently discharges through a 6-inch force main to an existing 10-inch sewer. The pumps and valves are in fair to good working condition. The controls and control cabinet are also in fair condition. The pump pots were replaced in 2009. The existing discharge force main is set to be replaced in Spring 2019.

Deficiencies: Existing discharge force main has leaked on multiple occasions; Infiltration

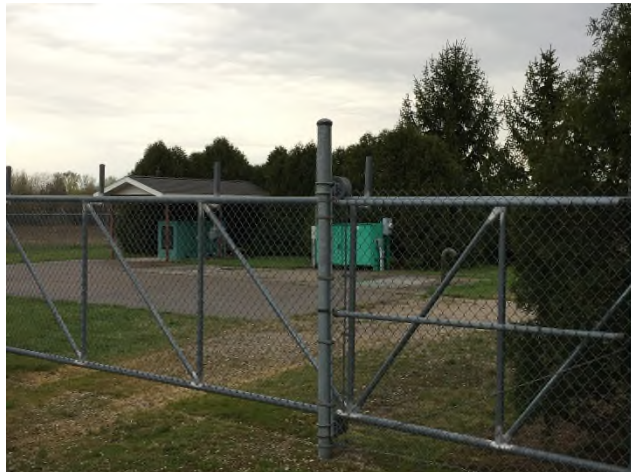
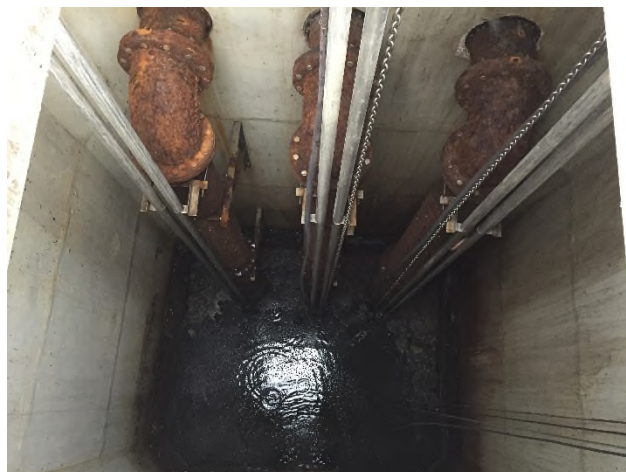
PS-10 N. Territorial Rd

Description: Pump Station PS-10 is a triplex submersible pump station with a 10-foot by 12-foot rectangular precast concrete wet well which houses pumps and discharge piping. The station also incorporates a rectangular precast concrete valve vault. The station services flows from the MDOT Rest Area pump station on US 23 in addition to flows from developments along US 23 at the North Territorial Rd. exit and along North Territorial Rd. east of US 23. The station was originally constructed in 2002 and currently discharges through a 12-inch force main to the Eight Mile Rd. pump station. The pumps and valves are in fair condition. The discharge piping appears corroded and in poor condition. The controls and control cabinet are in good condition. The site fence is in good condition.

Deficiencies: Corrosion on discharge piping and valves; Infiltration in valve vault (valves submerged)

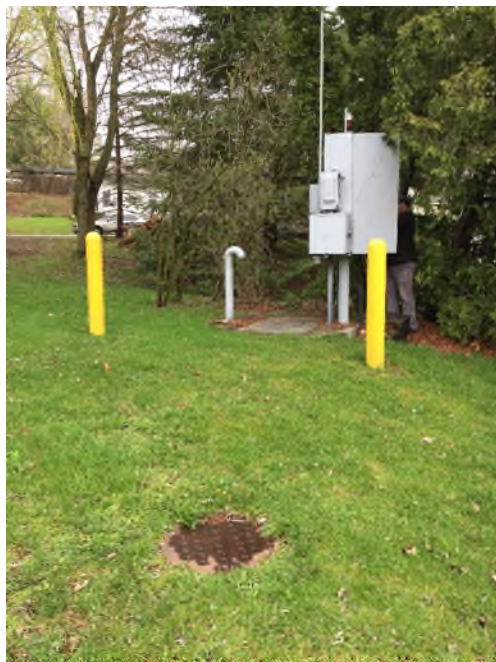
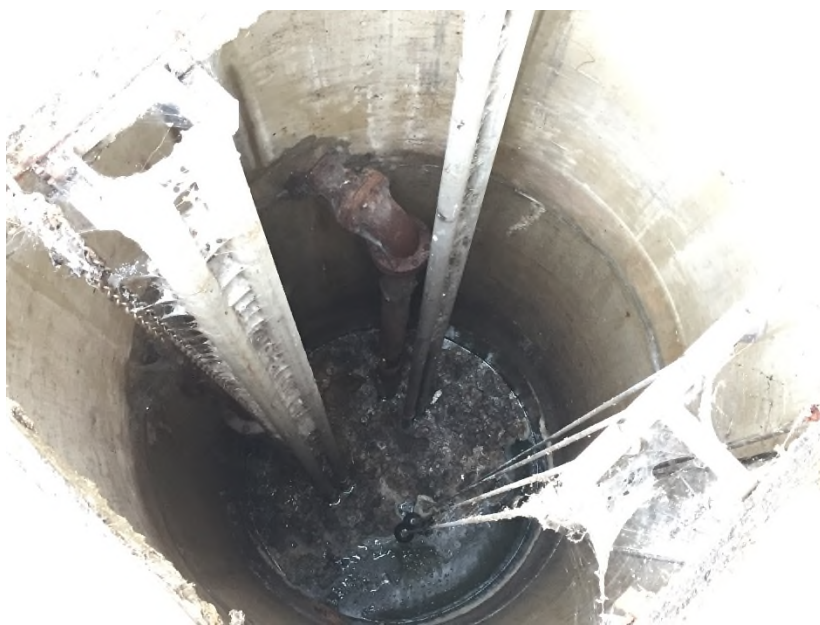
PS-11 Nine Mile Rd.

Description: Pump Station PS-11 is a duplex submersible pump station with an 8-foot round precast concrete wet well which houses pumps and discharge piping. The station also incorporates a precast concrete valve vault, which houses discharge piping and valves. The station services approximately 23 homes along Nine Mile Rd. and Lakeview Dr. on the northeast side of Whitmore Lake. The station was originally constructed in 1978 and currently discharges through a 4-inch force main to an existing 8-inch sewer. The pumps and valves are in fair condition. The controls and control cabinet are in fair to good condition. Pump 1 was rebuilt in 2009.

Deficiencies: Infiltration in valve vault; corrosion on discharge piping and valves; minor corrosion on interior of control panel enclosure
