NORTHFIELD TOWNSHIP
WASTEWATER
ASSET MANAGEMENT PLAN
DRAFT

200-12748-18002

September 2020

Northfield Township, MI
8350 Main Street
Whitmore Lake, MI 48189

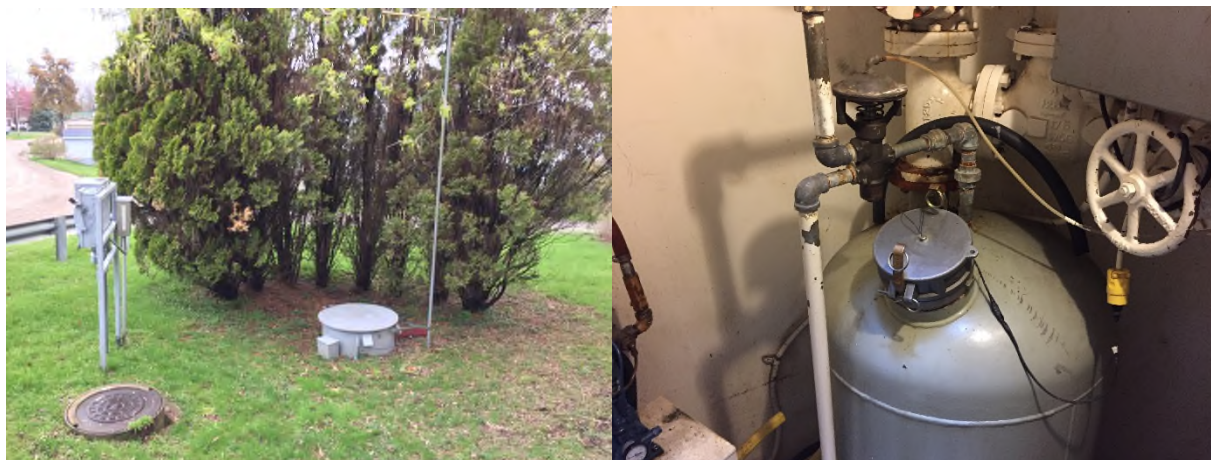
PS-12 North Shore 1

Description: Pump Station PS-12 is a duplex ejector pump station with an approximate 4-foot by 8-foot steel can dry pit which houses pumps, valves, discharge piping and controls. The station services homes along North Shore Dr. in addition to receiving flows from North Shore 2 and Canal (Elmcrest) pump stations. The station was originally constructed in 1969 and currently discharges through a four-inch force main to an 8-inch sewer. The pumps and valves are in fair to good condition. The controls and control cabinet are also in fair to good condition. New air/water tanks were installed in 2009.

Deficiencies: Minor corrosion on discharge piping and control panel enclosure

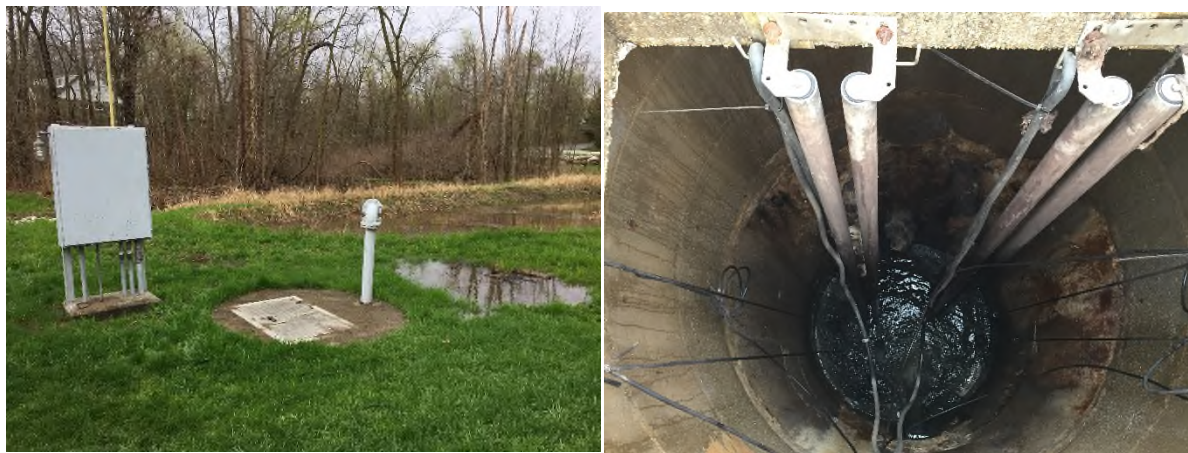
PS-13 North Shore 2

Description: Pump Station PS-1 is a duplex submersible pump station with a 8-foot round precast concrete wet well which houses pumps and discharge piping. The station also incorporates a precast concrete valve vault. The station services approximately 15 homes on North Shore Dr. and Elmcrest Rd. along the northwest corner of Whitmore Lake in addition to receiving flows from the Canal (Elmcrest) pump station. The station was originally constructed in 1969, but was replaced in 1985. The station currently discharges through a 4-inch force main to an existing existing 10-inch sewer. The pumps are in fair condition. The discharge piping appears to be in poor to fair condition. The wet well appears to be in poor to fair condition with some infiltration and corrosion present on the walls of the lower half of the well. The controls and control cabinet are in fair condition. The valve vault was submerged in stormwater drainage due to the recent construction on the boat launch parking area.

Deficiencies: Infiltration through and corrosion on wet well walls; corrosion on discharge piping; minor corrosion on interior of control panel enclosure; valve vault susceptible to submergence by stormwater drainage.

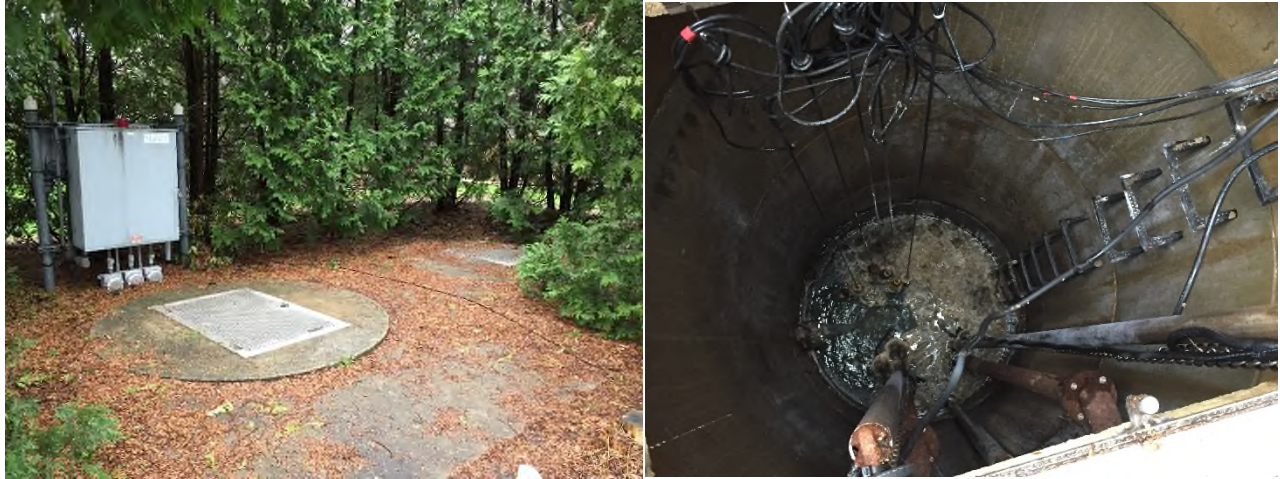
PS-14 Shadowoods

Description: Pump Station PS-14 is a duplex grinder pump station with an 8-foot round precast concrete wet well which houses pumps and discharge piping. The station also incorporates a precast concrete valve vault, which houses discharge piping and valves. The station services 44 homes in the Shadowoods development on Six Mile Rd. east of Horseshoe Lake. The station was originally constructed in 1996 and currently discharges through a 3-inch force main to an existing 8-inch sewer. The pumps and valves were replaced in 2018 and are in good working condition. The controls and control cabinet are also in good condition. The discharge piping and valves are in fair condition.

Deficiencies: Corrosion on discharge piping

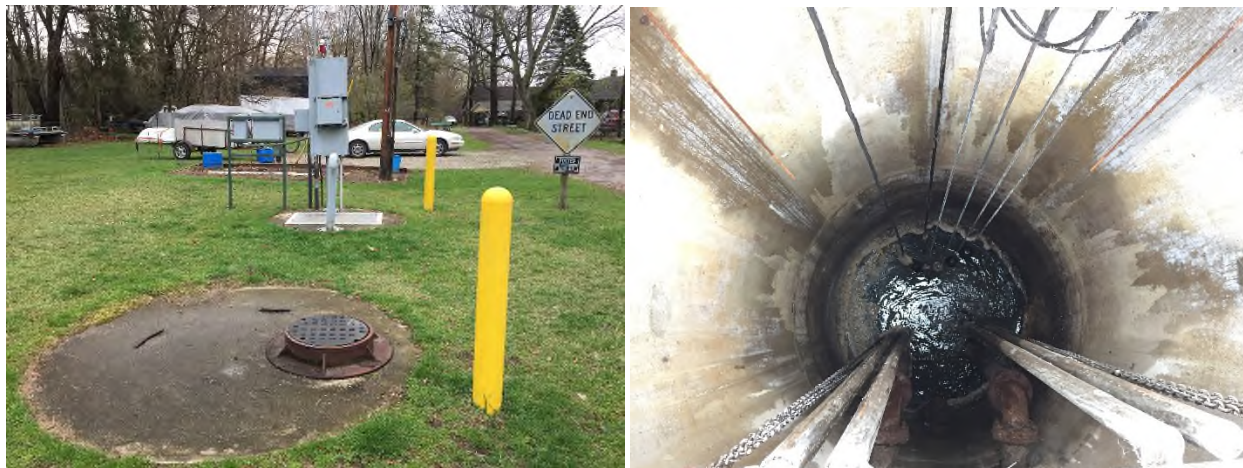
PS-15 Canal (Elmcrest)

Description: Pump Station PS-15 is a duplex submersible pump station with an 8-foot round precast concrete wet well which houses pumps and discharge piping. The station also incorporates a precast concrete valve vault, which houses discharge piping and valves. The station services homes on the north side of Whitmore Lake (south of Nine Mile Rd.) in addition to the Stilsonburg Station development and some homes along Fieldcrest Dr. The station was originally constructed in 1978 and currently discharges through a 4-inch force main to an existing 10-inch sewer. The pumps are in fair condition. The impellers and wear rings were replaced in 2018. The discharge piping and valves are in poor to fair condition. The controls and control cabinet are in fair condition.

Deficiencies: Infiltration in wet well and valve vault; corrosion on discharge piping and valves; corrosion on interior of control panel enclosure; minor cracking in top slab of wet well

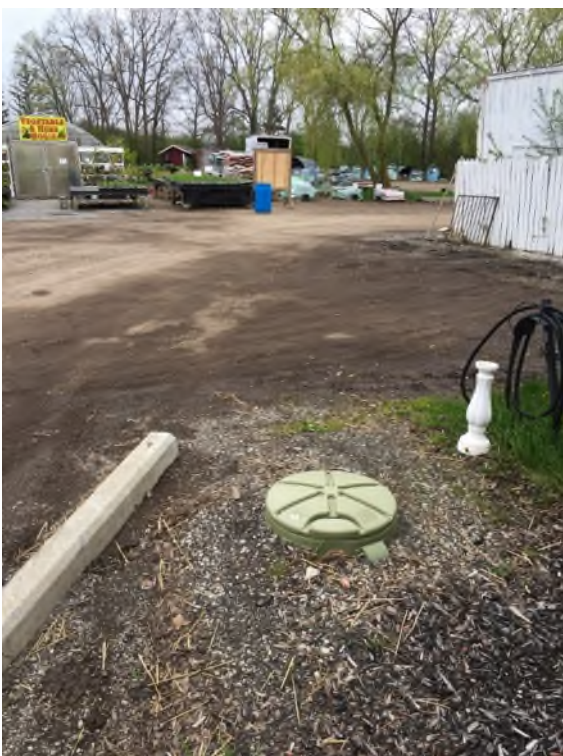
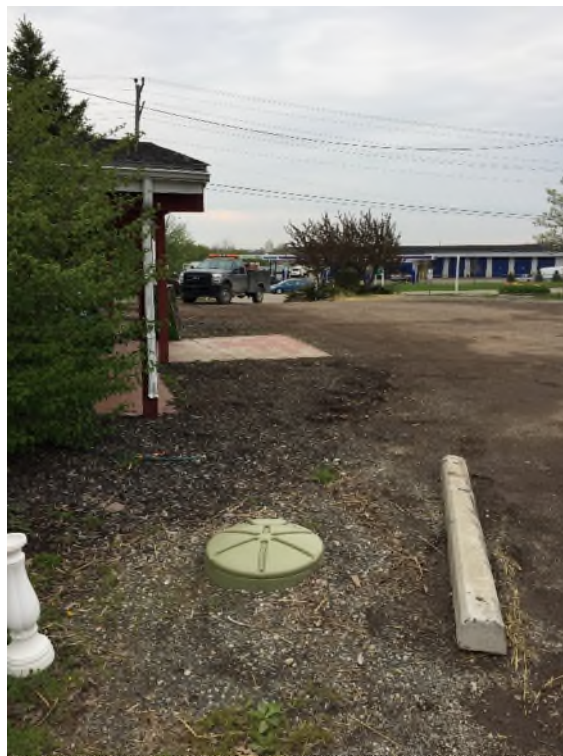
Grinder Station GS-1

Description: Pump Station GS-1 is a simplex submersible grinder pump station with a round plastic wet well which houses one pump and discharge piping. The station is designed to service the sanitary sewer discharge from Alexander Farm Market & Greenhouses (6925 Whitmore Lake Rd.). The station was originally constructed in 2016 and currently discharges to an existing 3-inch force main from a 1.5-inch service lead. The station is in good condition.

Deficiencies: None

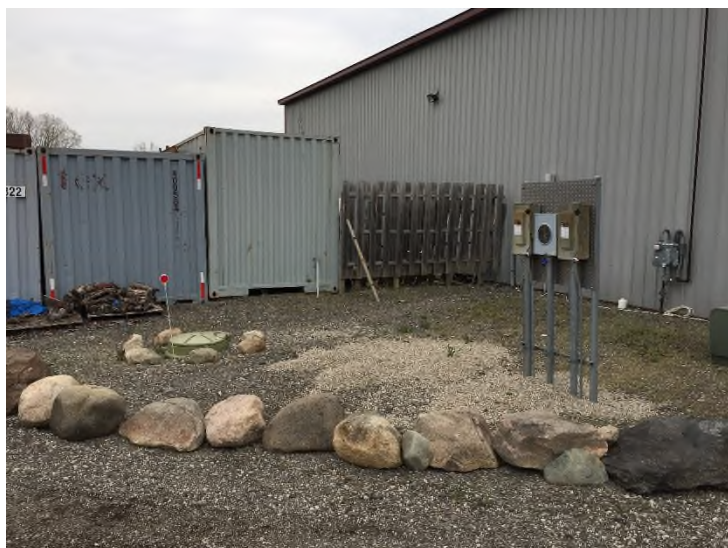
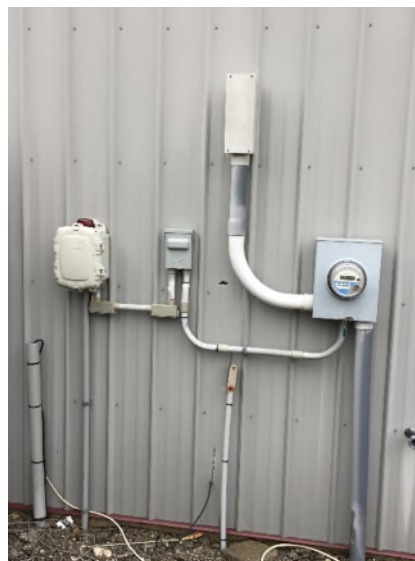
Grinder Station GS-2

Description: Pump Station GS-2 is a simplex submersible grinder pump station with a round plastic wet well which houses one pump and discharge piping. The station is designed to service the sanitary sewer discharge from Hamlin Trucking (6542 Whitmore Lake Rd). The station was originally constructed in 2016 and currently discharges to an existing 3-inch force main from a 1.5-inch service lead. The station is in good condition.

Deficiencies: None

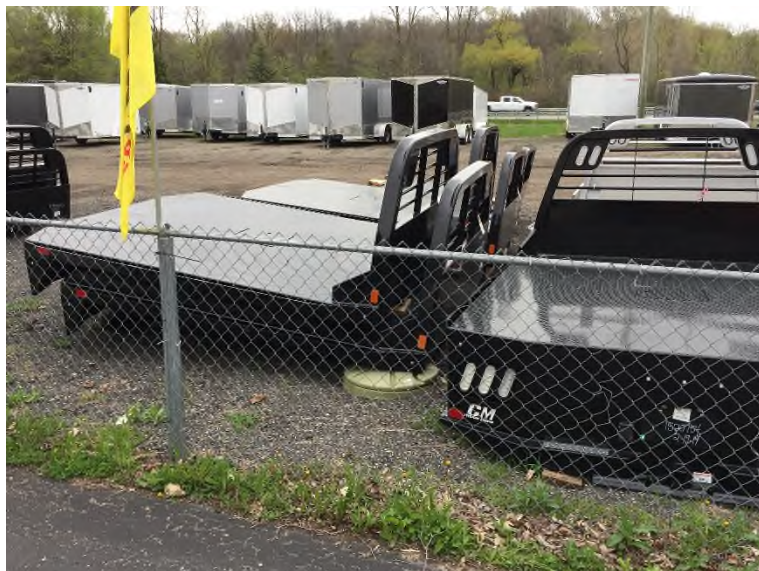
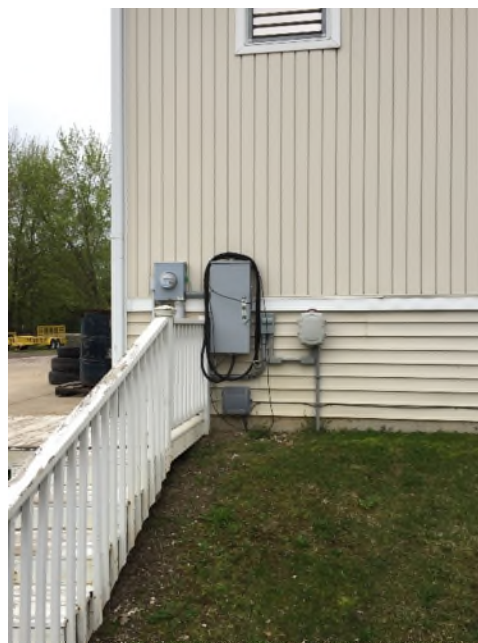
Grinder Station GS-3

Description: Pump Station GS-3 is a simplex submersible grinder pump station with a round plastic wet well which houses one pump and discharge piping. The station is designed to service the sanitary sewer discharge from SLM Trailers (6480 Whitmore Lake Rd). The station was originally constructed in 2016 and currently discharges to an existing 3-inch force main from a 1.5-inch service lead. The station is in good condition.

Deficiencies: None

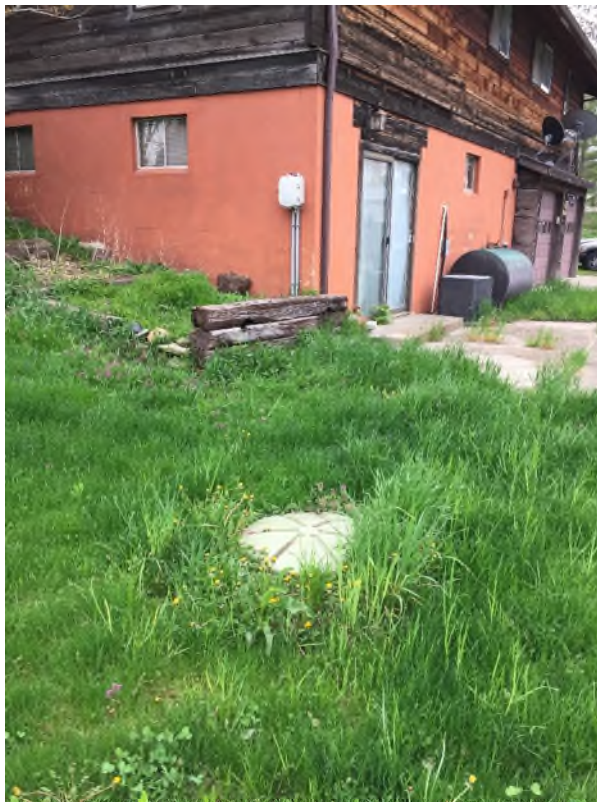
Grinder Station GS-4

Description: Pump Station GS-4 is a simplex submersible grinder pump station with a round plastic wet well which houses one pump and discharge piping. The station is designed to service the sanitary sewer discharge from 6431 Whitmore Lake Rd, a private residence. The station was originally constructed in 2016 and currently discharges to an existing 3-inch force main from a 1.5-inch service lead. The station is in good condition.

Deficiencies: None

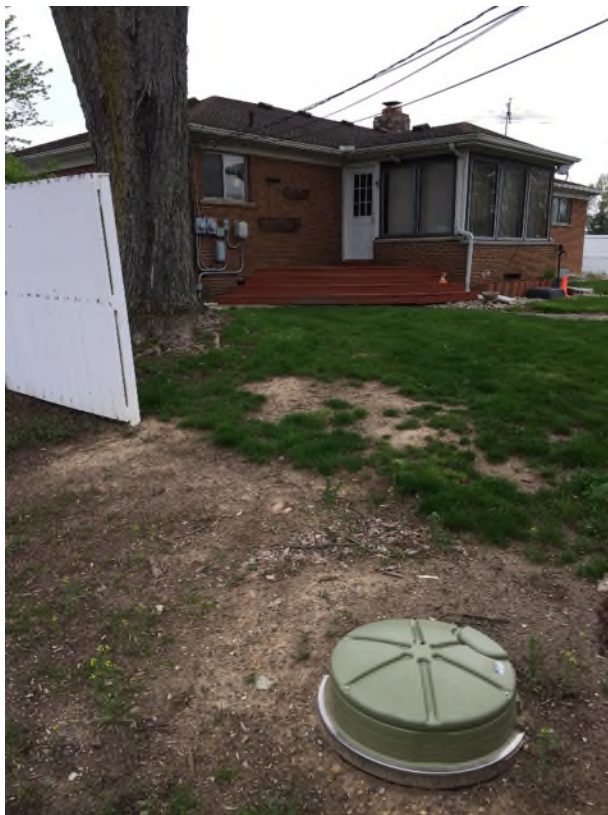
Grinder Station GS-5

Description: Pump Station GS-5 is a simplex submersible grinder pump station with a round plastic wet well which houses one pump and discharge piping. The station is designed to service the sanitary sewer discharge from 6410 Whitmore Lake Rd, a private residence. The station was originally constructed in 2016 and currently discharges to an existing 3-inch force main from a 1.5-inch service lead. The station is in good condition.

Deficiencies: None

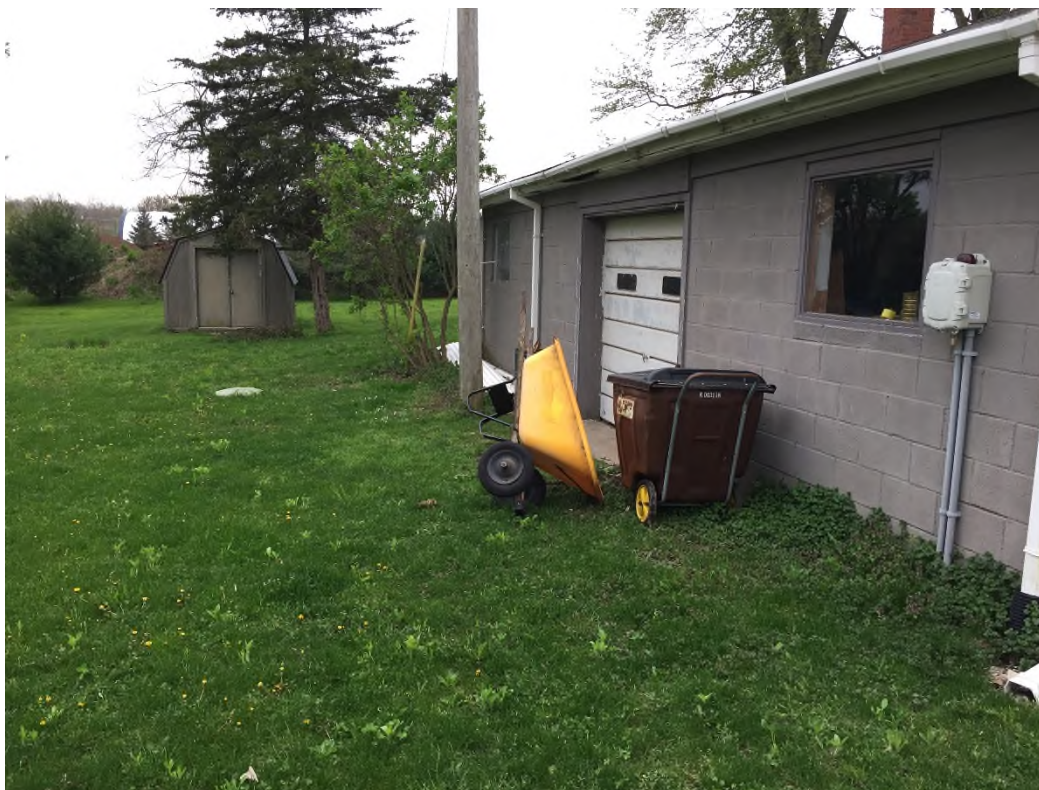
Grinder Station GS-6

Description: Pump Station GS-6 is a simplex submersible grinder pump station with a round plastic wet well which houses one pump and discharge piping. The station is designed to service the sanitary sewer discharge from 6400 Whitmore Lake Rd, a private residence. The station was originally constructed in 2016 and currently discharges to an existing 3-inch force main from a 1.5-inch service lead. The station is in good condition.

Deficiencies: None

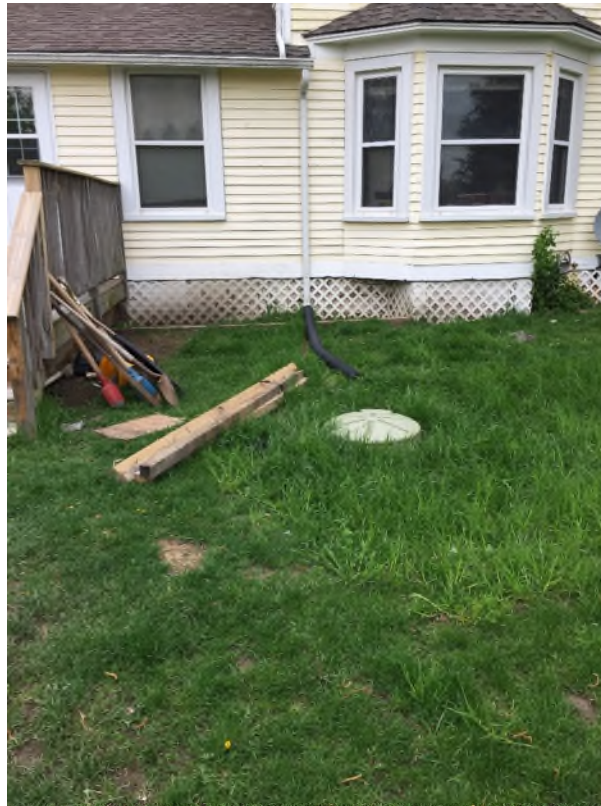
Grinder Station GS-7

Description: Pump Station GS-7 is a simplex submersible grinder pump station with a round plastic wet well which houses one pump and discharge piping. The station is designed to service the sanitary sewer discharge from 6371 Whitmore Lake Rd, a private residence. The station was originally constructed in 2016 and currently discharges to an existing 3-inch force main from a 1.5-inch service lead. The station is in good condition.

Deficiencies: None

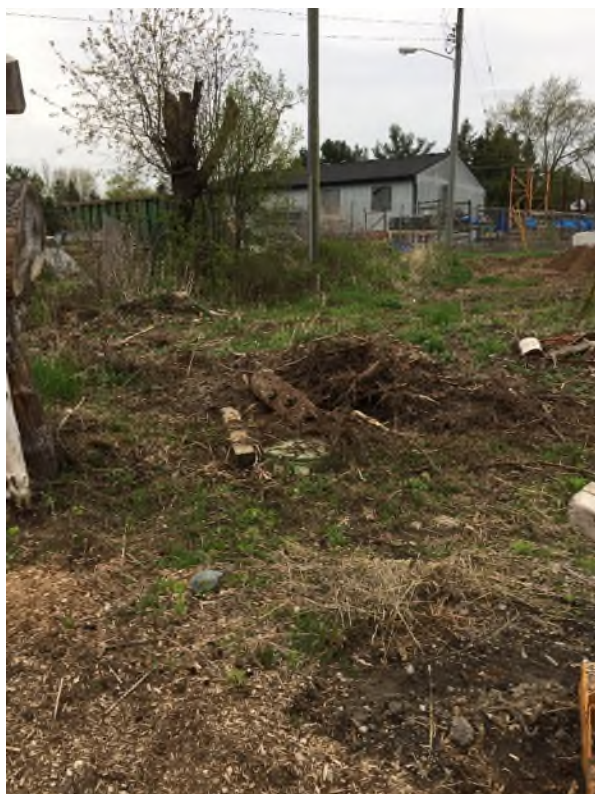
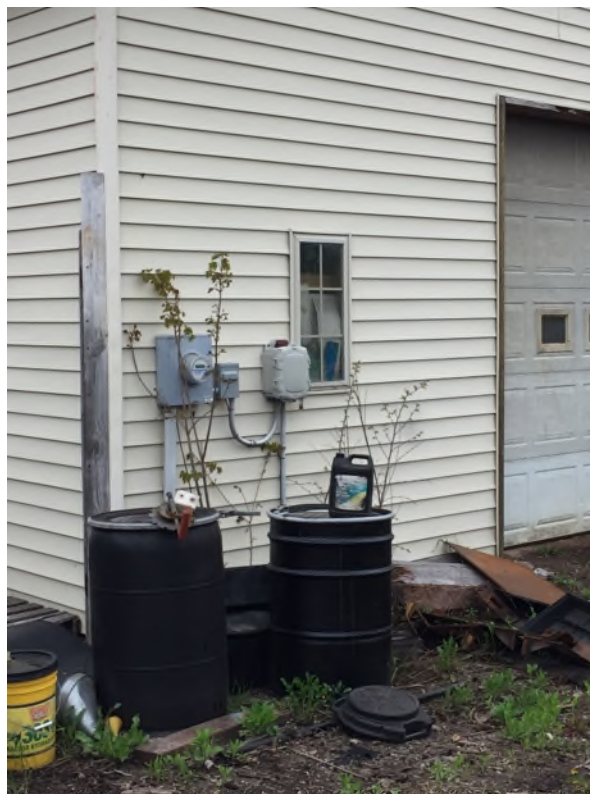
Grinder Station GS-8

Description: Pump Station GS-8 is a simplex submersible grinder pump station with a round plastic wet well which houses one pump and discharge piping. The station is designed to service the sanitary sewer discharge from Broadscape Landscaping-6350 Whitmore Lake Rd. The station was originally constructed in 2016 and currently discharges to an existing 3-inch force main from a 1.5-inch service lead. The station is in good condition.

Deficiencies: None

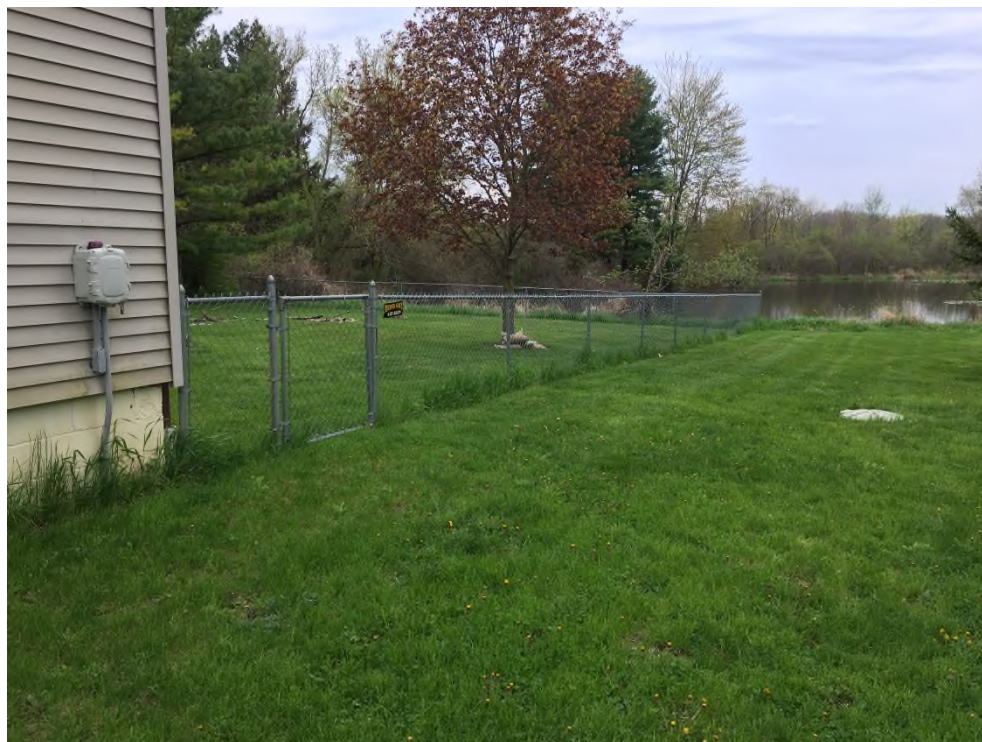
Grinder Station GS-9

Description: Pump Station GS-9 is a simplex submersible grinder pump station with a round plastic wet well which houses one pump and discharge piping. The station is designed to service the sanitary sewer discharge from 6289 Whitmore Lake Rd, a private residence. The station was originally constructed in 2016 and currently discharges to an existing 3-inch force main from a 1.5-inch service lead. The station is in good condition.

Deficiencies: None

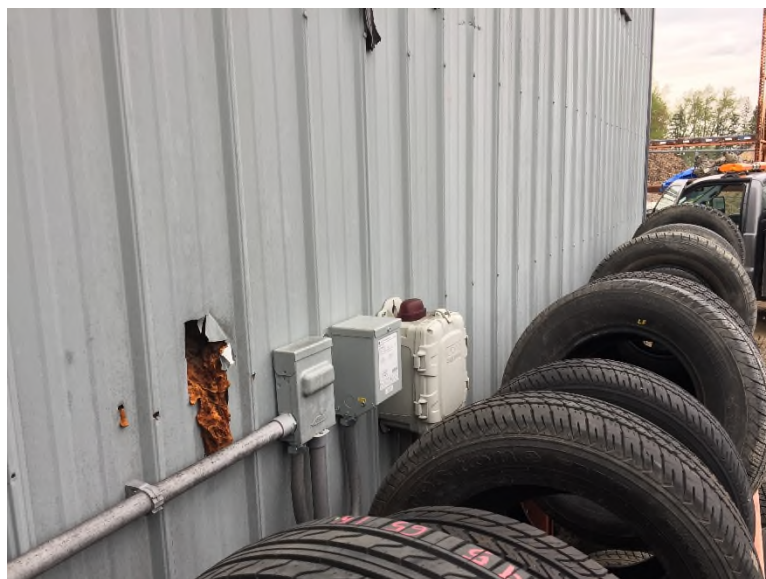
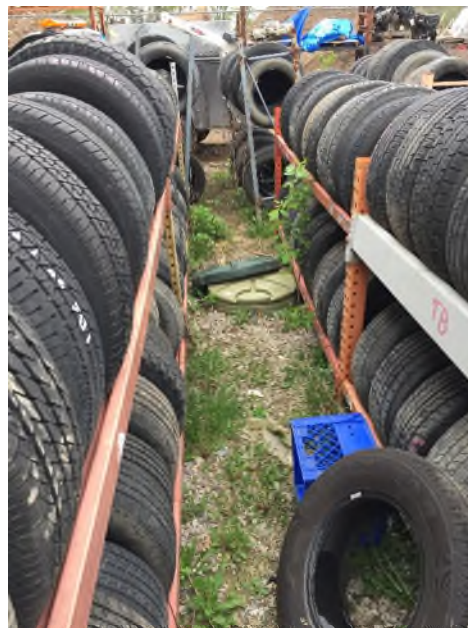
Grinder Station GS-10

Description: Pump Station GS-10 is a simplex submersible grinder pump station with a round plastic wet well which houses one pump and discharge piping. The station is designed to service the sanitary sewer discharge from Regal Recycling (6270 Whitmore Lake Rd). The station was originally constructed in 2016 and currently discharges to an existing 3-inch force main from a 1.5-inch service lead. The station is in good condition.

Deficiencies: None

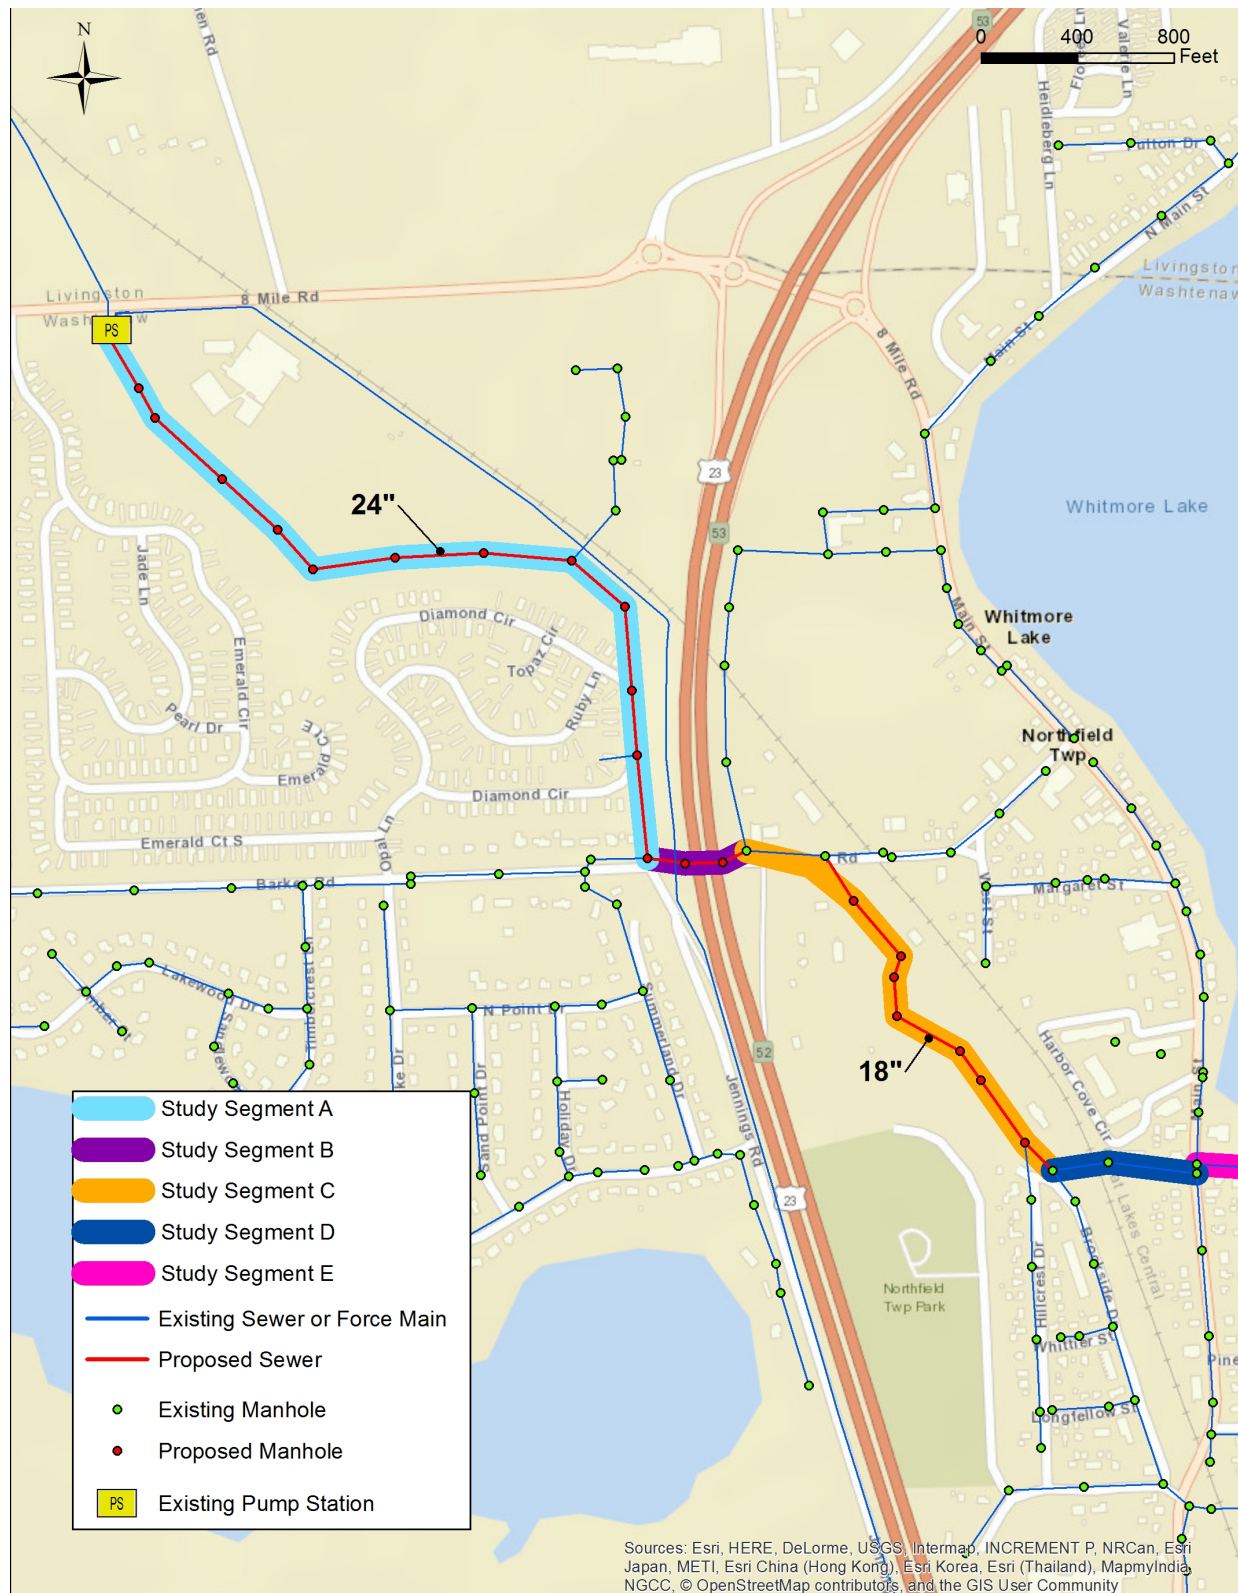
Figure 6-1: Recommended Improvements

The following improvements, also shown in Figure 6-1, are recommended to improve conveyance capacity during the 25-year, 24-hour design storm:

If the recommendations along the downstream trunk sewer are implemented, there would be a reduction in the hydraulic grade line and the risk of basement and surface flooding during the 25-year, 24-hour design storm. The impacts of these recommendations are seen in the hydraulic profiles in Appendix C, where the hydraulic grade line that was surcharged is projected to remain almost entirely within the pipe crown. Figure 6-2 shows a map of sewer capacity relative to projected peak flow rate and projected surcharging for the future growth conditions during the 25-year, 24-hour design storm.
