Center Lake Aquatic Vegetation Management Plan Osceola County, Michigan

**Provided for: The Residents of Center Lake, the Sherman Township Board & the
Kettunen Center**

**Prepared by: Restorative Lake Sciences
Jennifer L. Jermalowicz-Jones, PhD Candidate
Water Resources Director
18406 West Spring Lake Road
Spring Lake, Michigan 49456
www.restorativelakesciences.com**

November, 2015

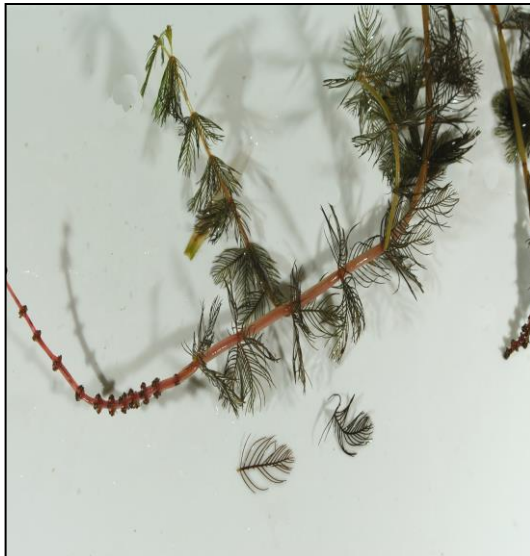
Eurasian Watermilfoil (*Myriophyllum spicatum*; Figure 3) is an exotic aquatic plant first documented in the United States in the 1880's (Reed 1997), although other reports (Couch and Nelson 1985) suggest it was first found in the 1940's. In recent years, this species has hybridized with native milfoil species to form hybrid species. Eurasian Watermilfoil has since spread to thousands of inland lakes in various states through the use of boats and trailers, waterfowl, seed dispersal, and intentional introduction for fish habitat. Eurasian Watermilfoil is a major threat to the ecological balance of an aquatic ecosystem through causation of significant declines in favorable native vegetation within lakes (Madsen et al. 1991), in that it forms dense canopies (Figure 4) and may limit light from reaching native aquatic plant species (Newroth 1985; Aiken et al. 1979). Additionally, Eurasian Watermilfoil can alter the macroinvertebrate populations associated with particular native plants of certain structural architecture (Newroth 1985). Approximately 3.75 acres of Eurasian Watermilfoil was found in Center Lake during the September 29, 2015 aquatic vegetation survey by RLS scientists.

Figure 3. Eurasian Watermilfoil ©RLS

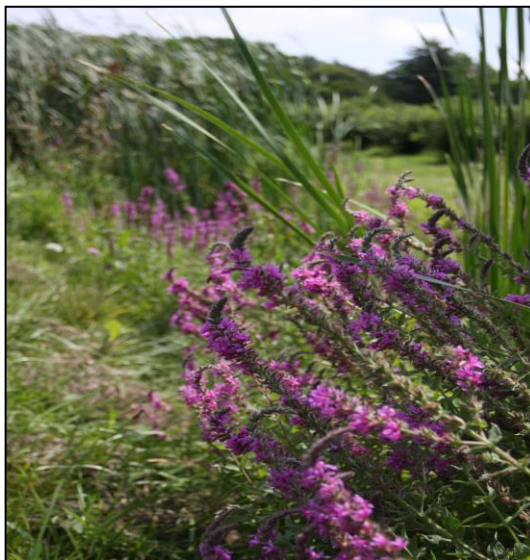
Approximately 0.25 acres of Purple Loosestrife (*Lythrum salicaria*; Figure 5), an invasive (i.e. exotic) emergent aquatic plant that inhabits wetlands and shoreline areas was found along some areas of the southwest, southeast, and northeast shorelines of Center Lake. *L. salicaria* has showy magenta-colored flowers that bloom in mid-July and terminate in late September. The seeds are highly resistant to tough environmental conditions and may reside in the ground for extended periods of time. It exhibits rigorous growth and may out-compete other favorable native emergents such as Cattails (*Typha latifolia*) and thus reduce the biological diversity of localized ecosystems. The plant is spreading rapidly across the United States and is converting diverse wetland habitats to monocultures with substantially lower biological diversity. Lake residents should be educated about its invasiveness and threat to the health of the Center Lake ecosystem. It should be removed promptly (i.e. by hand pulling or using a shovel to remove the roots and then discarding the plant into the garbage) if it is discovered to avoid further infestation. If the plant is not promptly removed by hand, it could dominate in wetland areas and require larger-scale systemic herbicide treatments.

Figure 5. Purple Loosestrife ©RLS

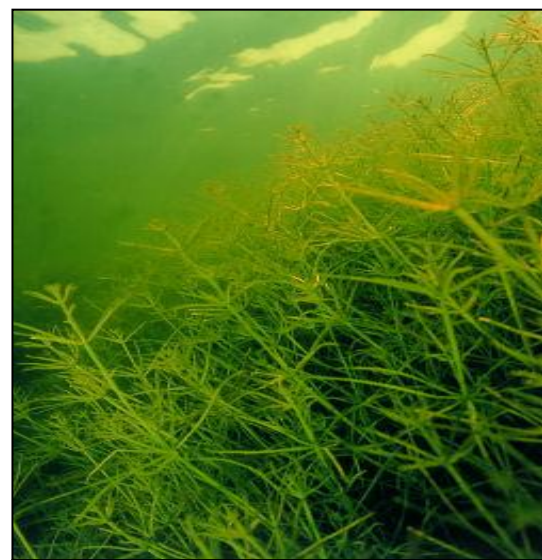
Starry stonewort (*Nitellopsis obtusa*; Figure 6) is an invasive macro alga that has invaded many inland lakes of Michigan and was originally discovered in the St. Lawrence River. Approximately 0.70 acres of this invasive alga was found in Center Lake. The "leaves" appear as long, smooth, angular branches of differing lengths. In clear lakes, the alga has been observed in dense beds at

depths beyond several meters and can grow to heights in excess of a few meters. It prefers clear alkaline waters and has been shown to cause significant declines in water quality and fishery spawning habitat.

Figure 6. Starry Stonewort

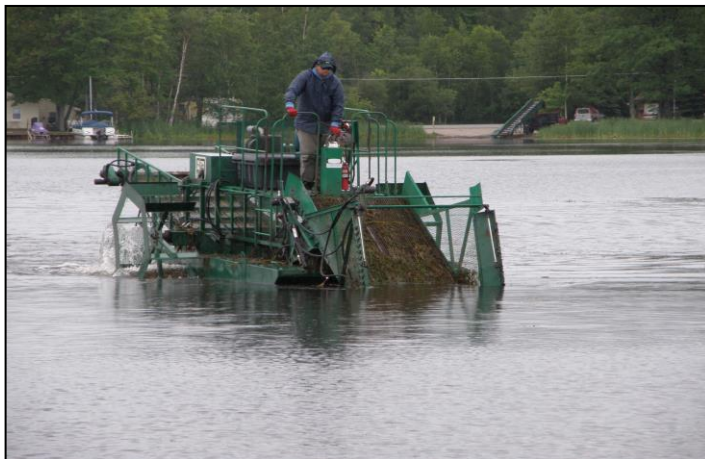
Mechanical harvesting involves the physical removal of nuisance aquatic vegetation with the use of a mechanical harvesting machine (Figure 30). The mechanical harvester collects numerous loads of aquatic plants as they are cut near the lake bottom. The plants are off-loaded onto a conveyor and then into a dump truck. Harvested plants are then taken to an offsite landfill or farm where they can be used as fertilizer. Mechanical harvesting is preferred over chemical herbicides when primarily native aquatic plants exist, or when excessive amounts of plant biomass need to be removed. Mechanical harvesting is usually not recommended for the removal of Eurasian Watermilfoil since the plant may fragment when cut and re-grow on the lake bottom. Due to the threat of milfoil fragmentation, the use of mechanical harvesting for the removal of the milfoil in Center Lake is not recommended. Mechanical harvesting does not require a permit from the Michigan Department of Environmental Quality (MDEQ); however, some counties require a launch site use permit from the Michigan Department of Natural Resources (MDNR) if a public access site is present.

Figure 30. A mechanical harvester

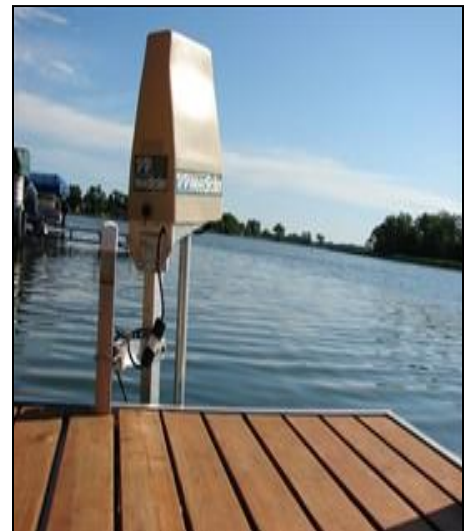
Weed Rollers are electrical devices which utilize a rolling arm that rolls along the lake bottom in small areas (usually not more than 50 feet) and pulverizes the lake bottom to reduce germination of any aquatic vegetation in that area.

Figure 32. A Weed Roller.

Both methods are useful in recreational lakes such as Center Lake and work best in beach areas and near docks to reduce nuisance aquatic vegetation growth.

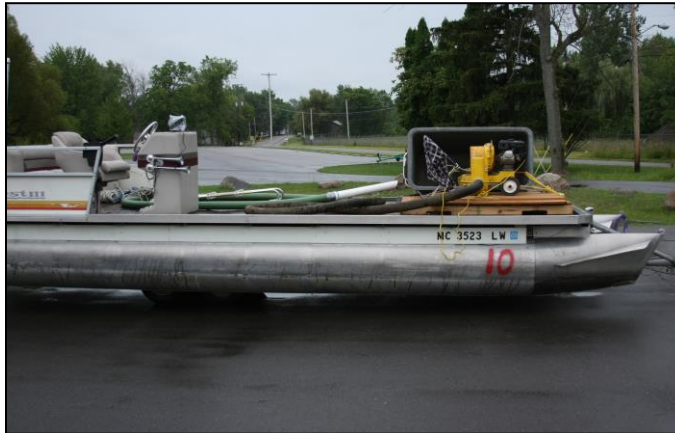
Suction harvesting via a Diver Assisted Suction Harvesting (DASH) boat (Figure 33) involves hand removal of individual plants by a SCUBA diver in selected areas of lake bottom with the use of a hand-operated suction hose. Samples are dewatered on land or removed via fabric bags to an

offsite location. This method is generally recommended for small (less than 1 acre) spot removal of vegetation since it is costly on a large scale. It may be used in the future to remove small remaining areas of milfoil after large-scale initial treatments have been successful or is useful on nearshore growth.

Figure 33. A DASH boat for hand-removal of milfoil or other nuisance vegetation. ©Restorative Lake Sciences

This method is a sustainable option for removal of plant beds in beach areas and areas where herbicide treatments may be restricted. The process requires a permit from the MDEQ.
