Yacht Club Condition Assessment and Discussion

Winter Retreat
January 26, 2023

Yacht Club Complex

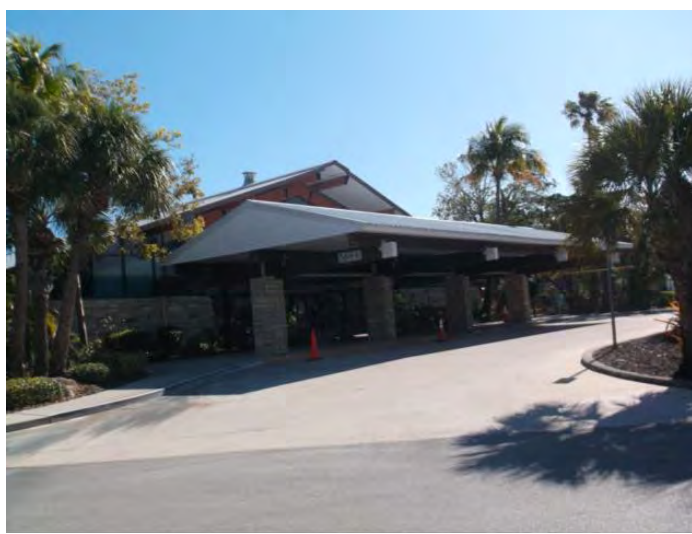
Ballroom Building

Building Appraisal:	\$680,000
FEMA 50% Value:	\$340,000
Cost to Repair:	\$520,000*

- Adjoining Mechanical/Electric/Equipment building repairs estimated at \$300,000 (2/3 to Ballroom and 1/3 to Rotino)
- Building supplies power through complex
 - buildings, pool, lighting, pumps, etc.
- Appraisals from Maxwell, Hendry, Simmons
- Repair costs from Tetra Tech Damage Assessments

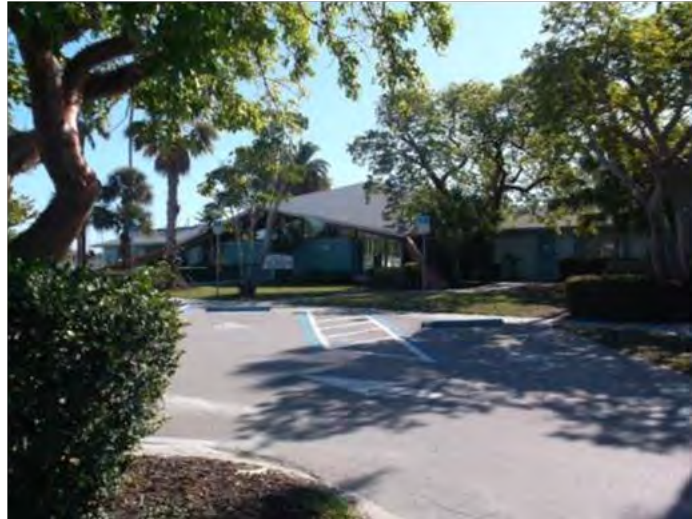
Rotino Center

Building Appraisal:	\$467,000
FEMA 50% Value:	\$233,500
Cost to Repair:	\$350,000*
