**BURNS FIELD
WARMING SHELTER / FIELD HOUSE
HINSDALE, ILLINOIS**

September, 2009

Completed by:
Anne T. Sullivan, AIA

BURNS FIELD WARMING SHELTER

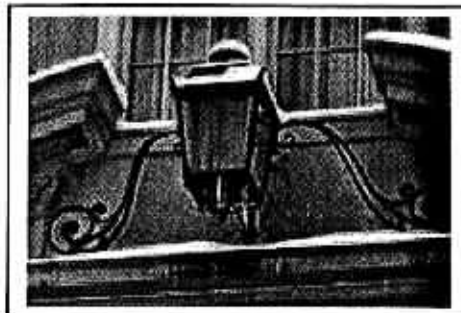
Image 7: Appropriate type of fixture for a Georgian Revival entryway

- Modern security-type light fixtures are mounted above the main entry doors. Painted iron brackets, presumably where original fixtures once hung, remain over each door. There is a need for security lighting around the building with photo-sensitive (on and off at dusk) operation. We recommend that the modern fixture be removed and a period-appropriate light fixture be selected for installation above the main entries. (An example of the appropriate style is shown in Image 7). Care should be taken to select a fixture that is either designed to be vandal-proof or can be

retrofitted with safety glass. Additional security lighting can be integrated in locations other than immediately over the door. Site lighting with photo-sensitive capabilities can be mounted at grade, pointing toward the building to provide illumination that is both adequate for security and that enhances the architectural features of the building.

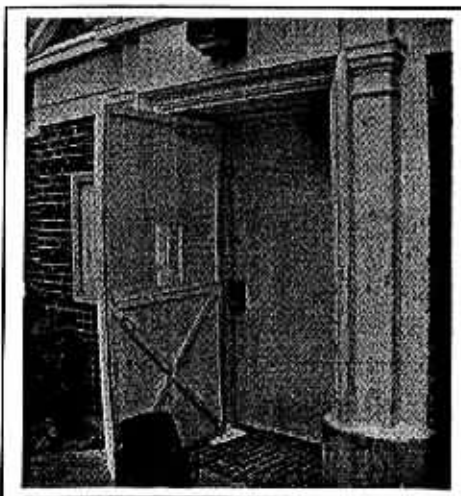
Image 8: Existing entry door

- Both main entry doors are supplemented by exterior-applied wood storm-doors. We see the need for this type of swinging door for use during the skating season, to save the heavy door from deterioration due to "slamming" but find the doors to deter from the appearance of the building. We also identified the need for greater ventilation within the building during the summer months, and recommend that new seasonal swinging doors be fabricated which have solid panels (with an integrated clear vision panel) for the winter months, but which could be retrofit with screening for the summer months. The design should reflect, but not deter from the design of the paneled door beyond.

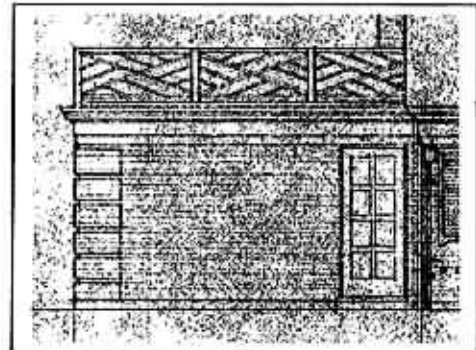
Image 13: From original drawings.

- The architectural drawings show that painted wood "fencing" was originally mounted at the roof level, around the perimeter of the north and south wings. (see **Image 13**) It is not known when these were removed; presumably longer than 20 years ago (i.e. before Mr. Piontkowski's time).

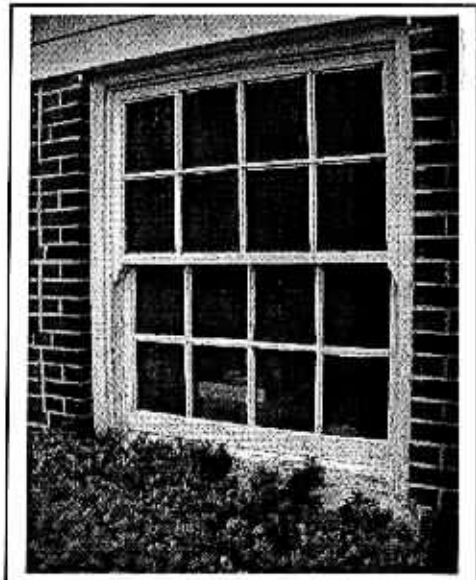
- The windows in the central pavilion are in worse condition than the other windows, probably due to greater use and possibly to vandalism. These windows area in poor condition but not irretrievable. Window sills are deteriorated by UV light; and in need of replacement or epoxy consolidation and repair. The wood sash can also be restored with an epoxy repair system. Some of the muntins will need to be re-milled and replaced. (Image 15) Holes remain in the window surrounds from where metal screens were once fastened, and should be filled. (Image 16)

Image 14: Existing double-hung window

- We recommend that the original wood double hung windows be retained, restored and re-used. We think they should remain operable, and that traditional wire screens be fabricated to allow for them to be opened during the summer months to provide greater cross-ventilation (in

place of integrating air conditioning). In order to reduce maintenance of the putty joints holding glazing within the sash, small triangular wood stops can be fabricated and nailed to the muntins to hold the glass in place.

- The existing float glass can be replaced with either tempered glass to prevent shards if broken, or with laminated glass to prevent breakage in general.

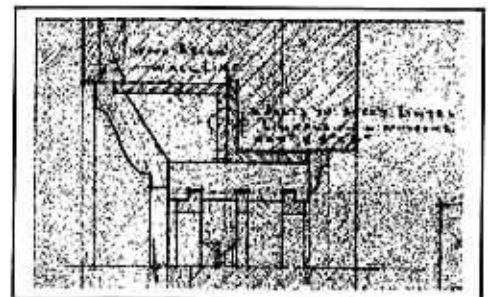
Image 18: From original drawings

- The window lintels appear in very good condition. No steel corrosion or cracked brick at the upper corners of the window openings was observed. Based on the architectural drawings, the steel lintels are protected from view by the wood trim (Image 18) Because they are covered we were unable to tell whether the lintels are bowing, but there is no indication of that on either exterior or interior; and no rust runoff visible. When the window sash are removed for restoration, an attempt should be made to expose the steel lintels above the window openings. These metal lintels should be brushed or ground to white metal, and immediately primed and painted with rust prohibitive paint..

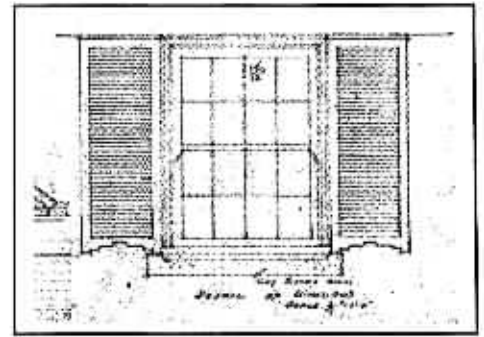
Image 19: From original drawings

- The architectural drawings indicate that wood shutters were once mounted on either side of the double-hung windows. (Image 19) These no longer exist. In a restoration program, new shutters designed to match those shown in the drawings should be fabricated and installed.

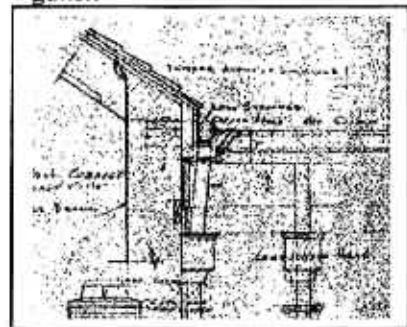
Image 22: From original drawings

- Original drawings show a built-in gutter system, with downspouts and decorative leader boxes with decorative brick anchors (Image 22) Existing downspouts are copper, or in some cases what appears to be lead coated copper (or galvanized steel). Some terminate at a splash blocks (Image 23a) and some terminate abruptly at the base of the building (Image 23b) which is not advisable. While there is no basement at this building, collecting water at the base of a building is not recommended and could lead to heaving during winter months. Splash blocks should be set to drain away from building, and the gutters and downspouts should be cleared at least three times a year.
- The decorative copper leader boxes and downspout anchors are missing; and should be replicated in a restoration program.

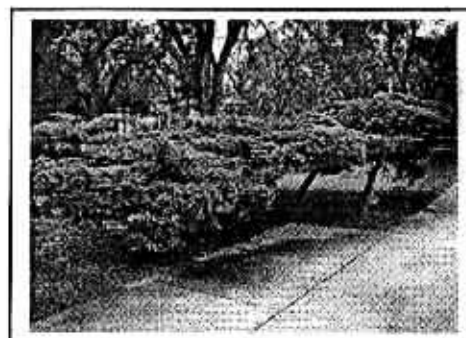
- Overgrown evergreen bushes flank the fore-court in front of the field house (Image 28). A long walkway leads to a flagpole. (Image 29)
- Mr. Pionkowski told us that at one time a shallow wading pool was located in front of the field house, between it and the flagpole. A shallow bump in the land shows approximately where the perimeter of the pool was once positioned.

Image 28: Plantings at entry fore-court

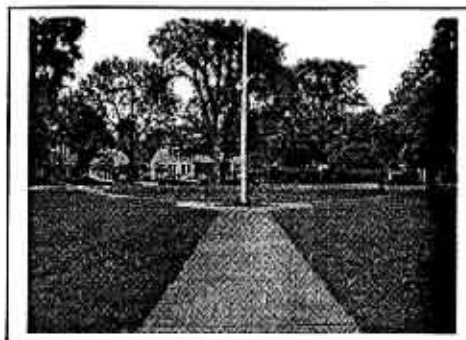
Image 29: Looking east toward flagpole

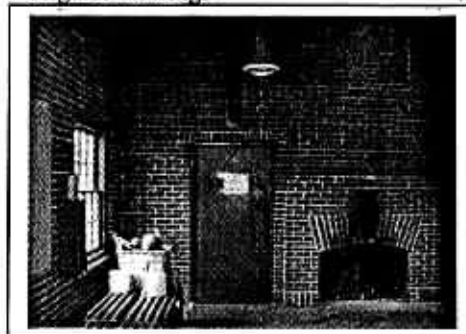
Image 32: North interior view

- The interior is much as it was originally. On the north wall a door to the left of the fireplace leads to a small storage closet while a door to the right of the fireplace leads to Mens toilet room. On the opposite wall, a single door to the left of the fireplace leads to the Ladies toilet room. This elevation was depicted in the architectural drawings. (Image 31) As we can see, little has changed. (Image 32)

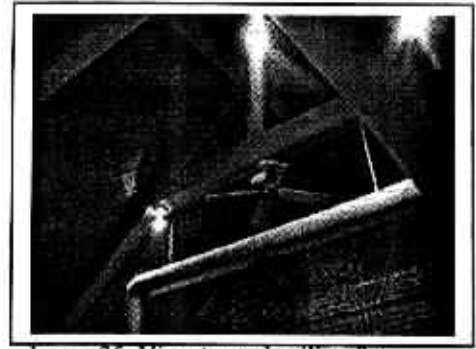
- The ceiling is comprised of the underside of the peaked roof, with exposed tongue-in-groove diagonal sheathing over painted wood trusses. (Image 35) No water intrusion was observed.

Image 35: View toward ceiling fan

- We recommend that the fans be replaced with similarly industrial-type fans, possibly with integral lighting. Although they were not original, it would be appropriate to install hanging pendant lights, similar to those shown in (Image 37), to illuminate the interior of the space appropriately.

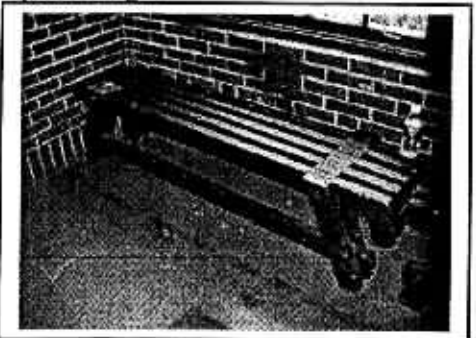
- Several wood benches are positioned along the walls in the field house. (Image 38) These are not original to the building. The architectural drawings show that custom benches were designed for the space. (Image 39) Whether these were ever fabricated is unknown. Benches of this type could be created for use here, or the existing benches could remain, and two large tables, with their designs based upon the Zook bench designs, could be fabricated. These could be used by the daycare children during the summer, and by the concessions during the winter months. They would also provide working space for Park District programs to be held in the field house.

Image 38: Existing benches
