# Stormwater Master Plan – August 2014

*Prepared for:*  
**Merrillville Stormwater Utility**  
Mr. Matthew Lake, M.S. – Executive Director  
7404 Broadway  
Merrillville, IN 46410

*Prepared by:*  
**Christopher B. Burke Engineering, Ltd.**  
9575 W. Higgins Road, Suite 600  
Rosemont, IL 60018

## Town of Merrillville

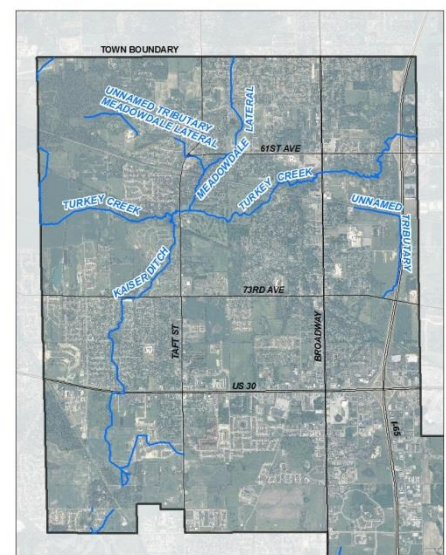
**Figure 2. Regulated Drains on the West Side of the Town of Merrillville**

Lake County Plan Commission are responsible to administer, implement and enforce the provisions of the Town's or County Ordinance. There are five (5) Regulated Drains (**Figure 2**) on the west side of Town within the Town's municipal boundary that were studied in this SWMP including:

The Lake County Surveyor's Office (LCSO) maintains and manages Lake County's 600-mile legal drain (stormwater drainage) system. The land within 75 feet of the centerline to each bank of any ditch or drain tile within the Lake County Regulated Drainage System is regulated and maintained by the LCSO. For projects directly impacting or discharging to a Lake County Regulated Drain, both the Town's engineer and the

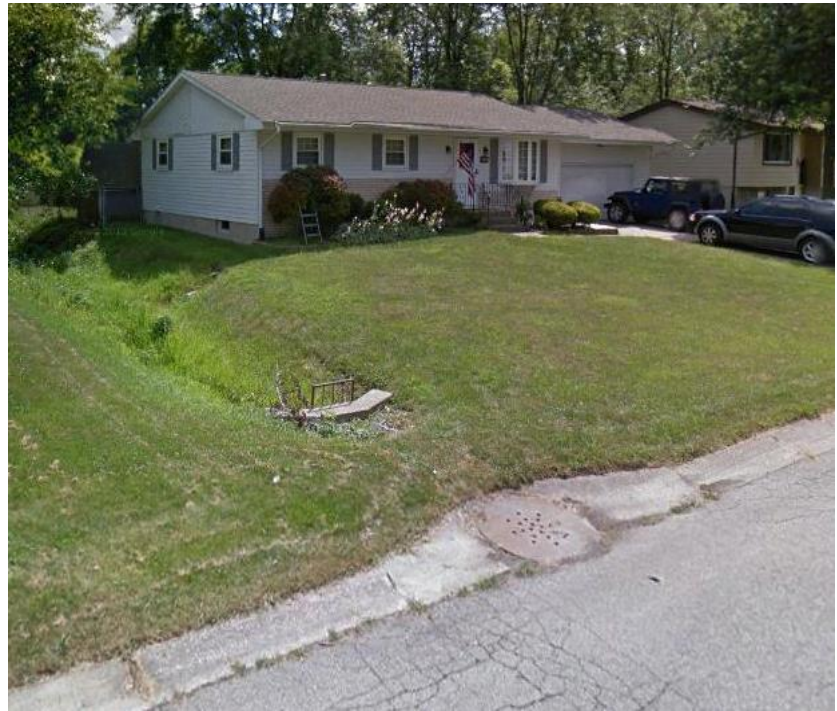
**Figure 8. Restrictive Culvert at 79<sup>th</sup> Place**

for backing water upstream leading to street flooding and subsequent structure flooding. In some cases, the problem areas created by a restrictive culvert crossing are compounded by silt and/or debris combined with either a failing or collapsed pipe. In addition to public roadway overtoppings, main areas of significant flooding were identified and are shown in Table 9.

A comparison of the elevations used in the CBBEL delineated 100-year Inundation Area to the public roadway overtopping elevations from Lake County aerial topography showed nine (9) major roadway overtoppings and 13 minor roadway overtoppings (Figure 7). The minor versus major public roadway overtopping classification refers to the capacity of the public roadway or if the public roadway is arterial and crucial to emergency vehicle traffic during storm events. The public roadway overtoppings are due to restrictive culvert crossings and are responsible

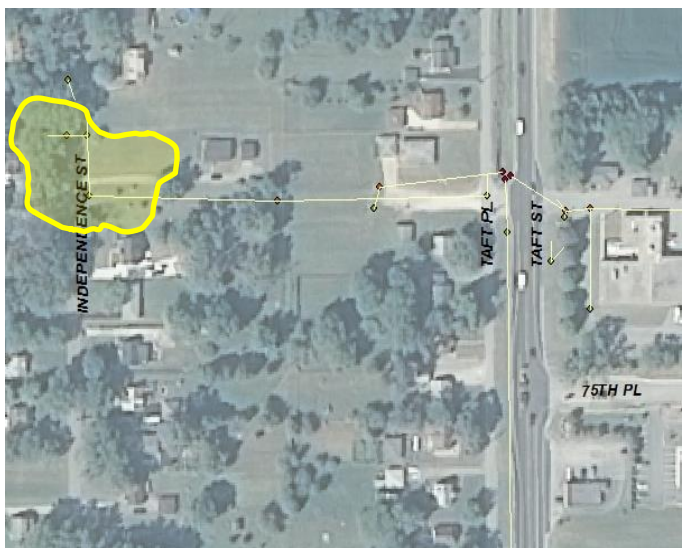
**Figure 13. Independence Street Problem Area**

A known problem area with localized flooding is located on Independence Street and is due to a depressional area with a 12" outlet intended to discharge east, to the open channel along Taft Street (**Figure 13**). The outlet at the open channel is in poor condition and is below the channel invert, preventing the low area on Independence from draining by gravity. A small pump station in this area is the proposed solution for this area and is estimated to cost \$400,000. The existing storm sewer outlet should be televised to verify condition and may lead to the replacement of the sewer and additional cost.

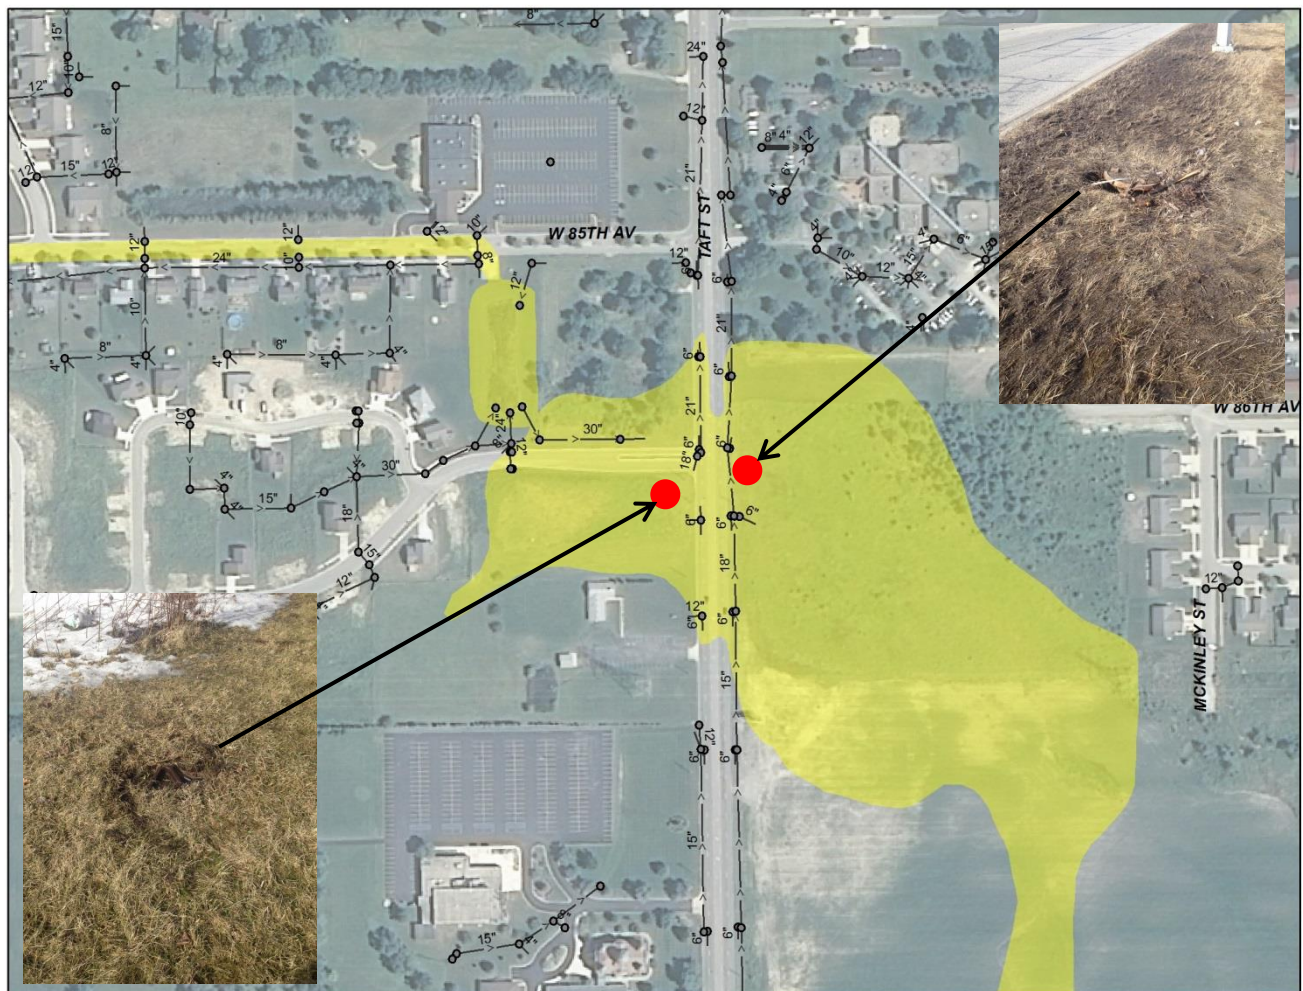
Figure 14. Taft Street South of 95<sup>th</sup> Avenue

An additional analysis and field visit was performed for the potential overtopping location on Taft Street near 95<sup>th</sup> Avenue. CBBEL staff verified that storm sewers convey flow north to US 30 and that the 30-inch storm sewer continuing west does not convey stormwater west, away from Taft Street. According to the field survey, it was assumed that this storm sewer conveyed drainage west from Taft Street through the subdivision drainage system and detention facility. CBBEL found that the manhole on the north side of 95<sup>th</sup> Avenue along the 30-inch storm sewer line was filled with debris (**Figure 14**). The manhole on the east side of Taft Street was conveying substantial flow north and was in poor shape (**Figure 14**). In addition, two other manholes were discovered that were not included with the survey data. It is unknown where the manhole on the west side of Taft Street drains. The existing condition CBBEL delineated inundation area has been based on the findings of the CBBEL field investigation. We recommend that the manholes in this area be further investigated or uncovered to verify flow direction and condition.

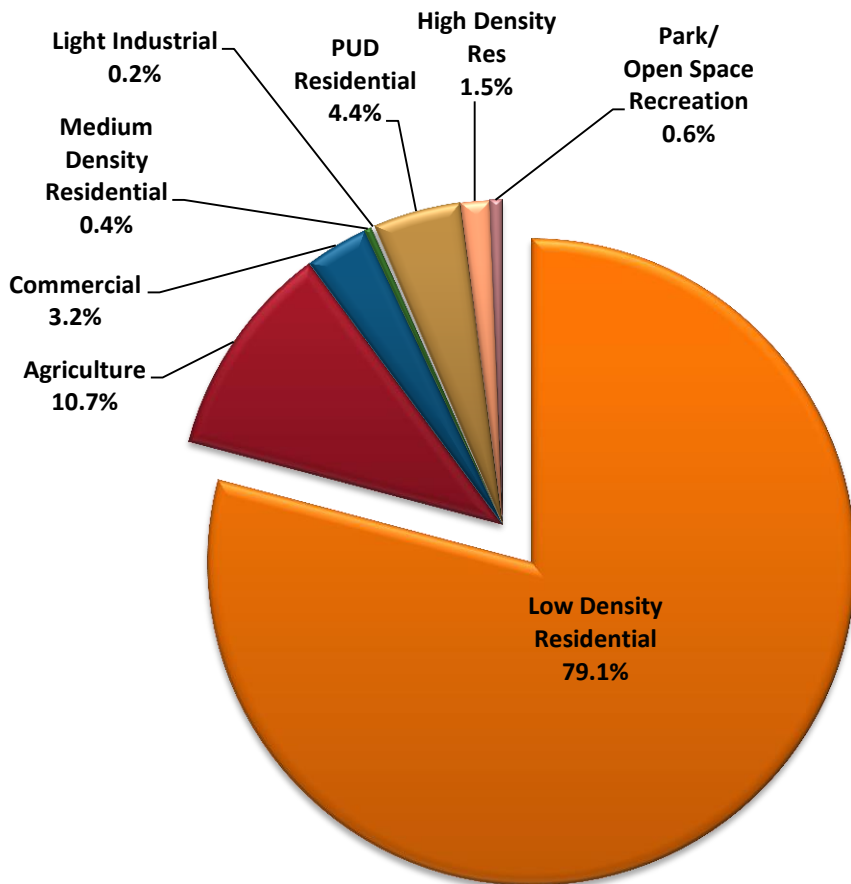
**Figure 16. Meadowdale Lateral Subwatershed Land Use**

The total tributary area to Meadowdale Lateral is 4,636 acres of which 2,683 acres are located outside the Town's limits. The subwatershed land use within the Town limits is mostly low density residential and agricultural (Figure 16). Following the delineation of the tributary areas to large diameter storm sewers and drainage ways, CBBEL created an HEC-HMS hydrologic and unsteady HEC-RAS hydraulic analysis of the

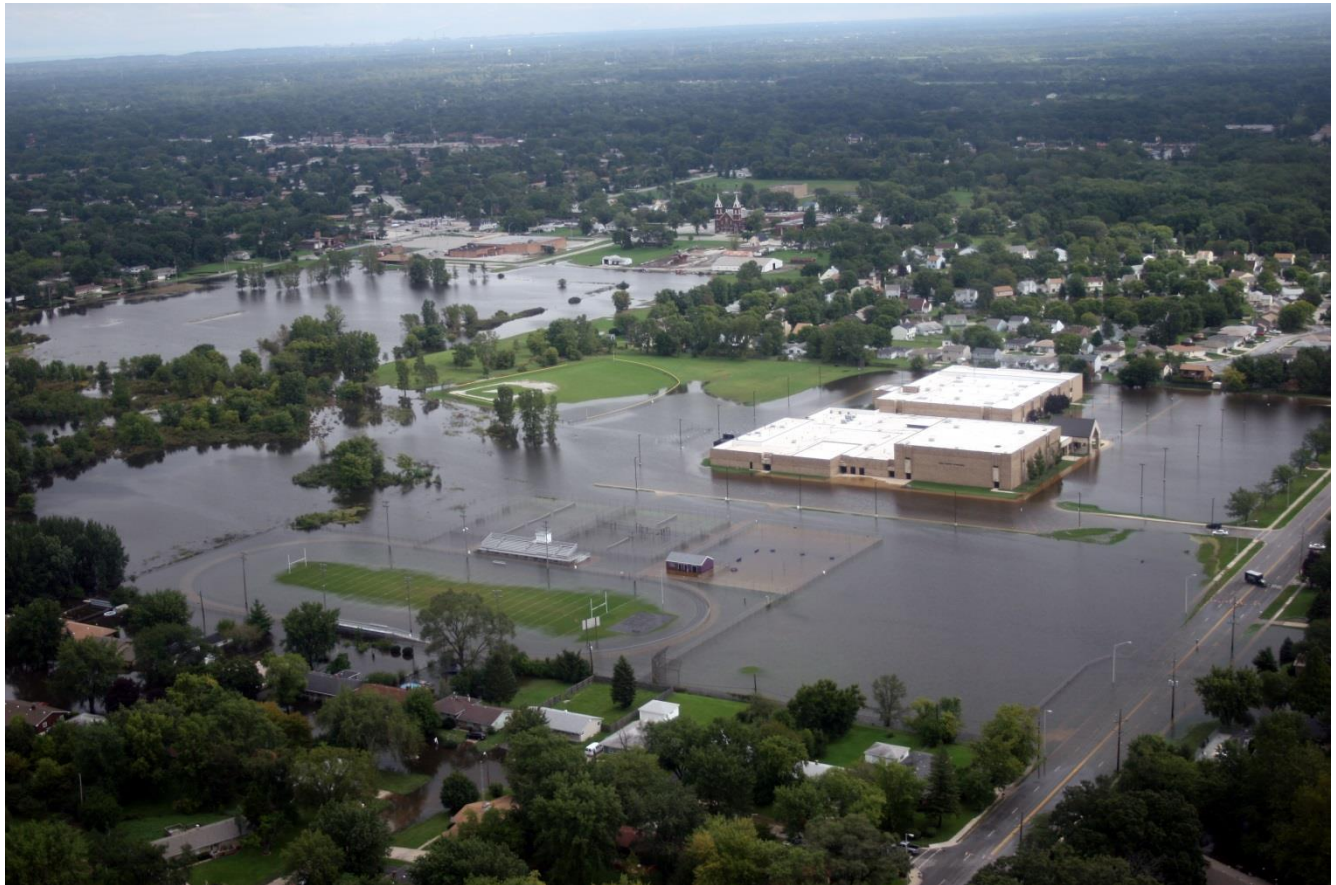
- It should be noted that these improvements do not remove all structures from the proposed condition inundation area. **According to the proposed condition 100-year CBEL delineated inundation area, 365 structures will remain in the inundation area.** The restrictive culvert system both at the Railroad and on the school property at 61<sup>st</sup> Avenue and Grant Place contribute to the flooding problem (**Figure 20**).

**Figure 20. Intersection of Grant Street and 61<sup>st</sup> Avenue – September, 2008**

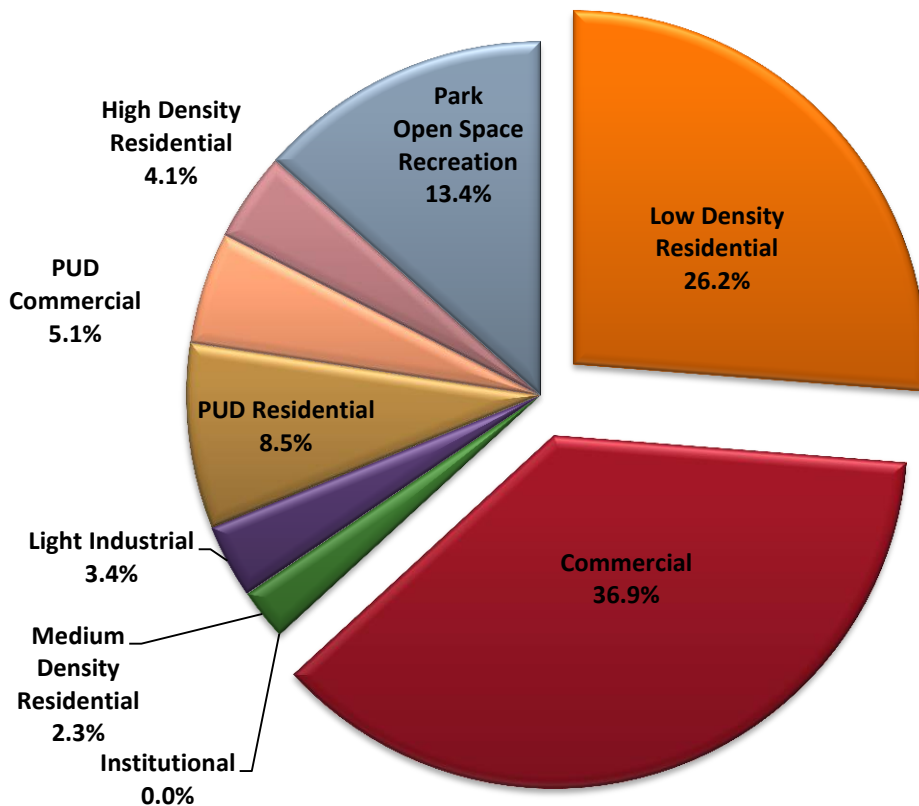
**Figure 25. Chapel Manor Subwatershed Land Use**

The total tributary area in the Chapel Manor Subwatershed is 3,075 acres located completely within the Town's limits. The subwatershed land use is mostly commercial and low density residential with a notable portion of open space (Figure 25). The southwestern portion of the subwatershed consists of large undeveloped areas in the upper portions of the subwatershed. Following the delineation of the tributary areas to large diameter storm sewers and drainage ways, CBBEL created an XP-SWMM analysis of the subwatershed. The analysis combines information from the regulatory HEC-2 hydraulic modeling for Chapel Manor with field survey data and the Lake County 1-foot aerial topography. The regulatory model was obtained from the IDNR-Division of Water and was used for the sections of watercourse and culvert crossings

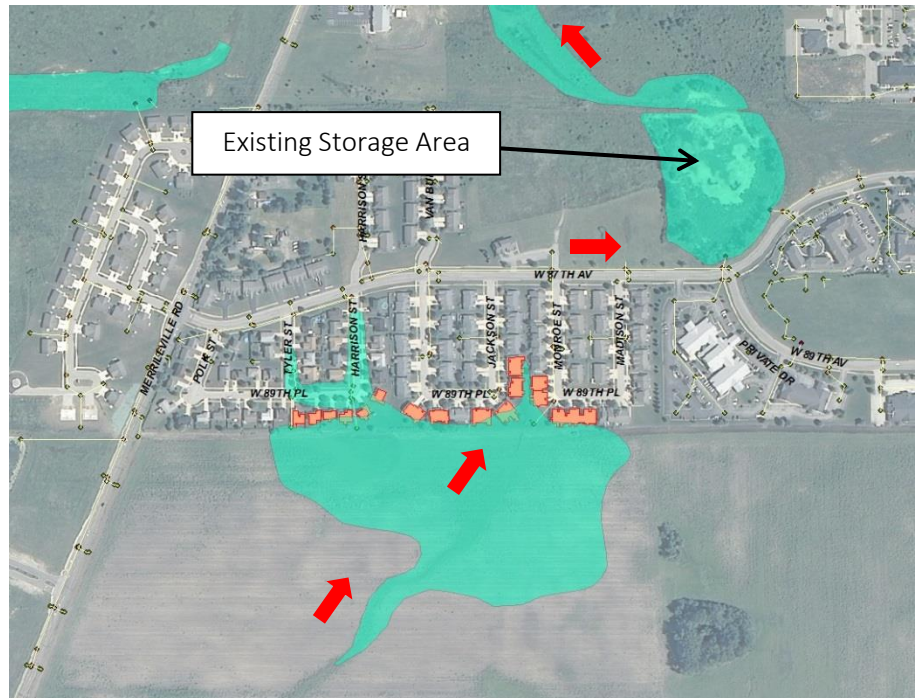
**Figure 30. Chapel Manor - 89<sup>th</sup> Place - CBBEL Delineated 100-year Inundation Area**

A large undeveloped off-site tributary area is bypassed through the backyards of the subdivision along 89<sup>th</sup> Place east of Merrillville Road. The runoff from the area is picked up by a 36-inch RCP and routed through the existing storage area on the north side of 87<sup>th</sup> Avenue (**Figure 30**). This pipe restricts the bypass flow and causes backyard flooding. There are 14 structures shown in the CBBEL delineated 100-year inundation area. The

The proposed condition includes upsizing the bypass pipe from a 36- and 42-inch to a 42- and 54-inch line, combined with approximately 20 ac-ft of additional storage. The enlargement of the existing storage area is required to offset the increased downstream flowrates. The proposed storm sewer improvements combined with 20 ac-ft of storage, removes 13 of the 14 structures from the CBBEL delineated 100-year inundation area. The estimated cost to construct these improvements is \$2.3 million and does not include land acquisition costs. Maintenance of the existing storm sewer system along the backyards and 87<sup>th</sup> Avenue to the existing storage basin is recommended proper conveyance of the bypass flow from the south. A further detailed analysis of the area for pre- and post-construction of the subdivision could be used to show that the existing off-site bypass flow from the south has not been increased as a result of the development. This would eliminate the need for the storage component of the proposed improvements. This would reduce the cost of the proposed improvements from \$2.3 million to \$720,000 for this area if the storage component is eliminated.

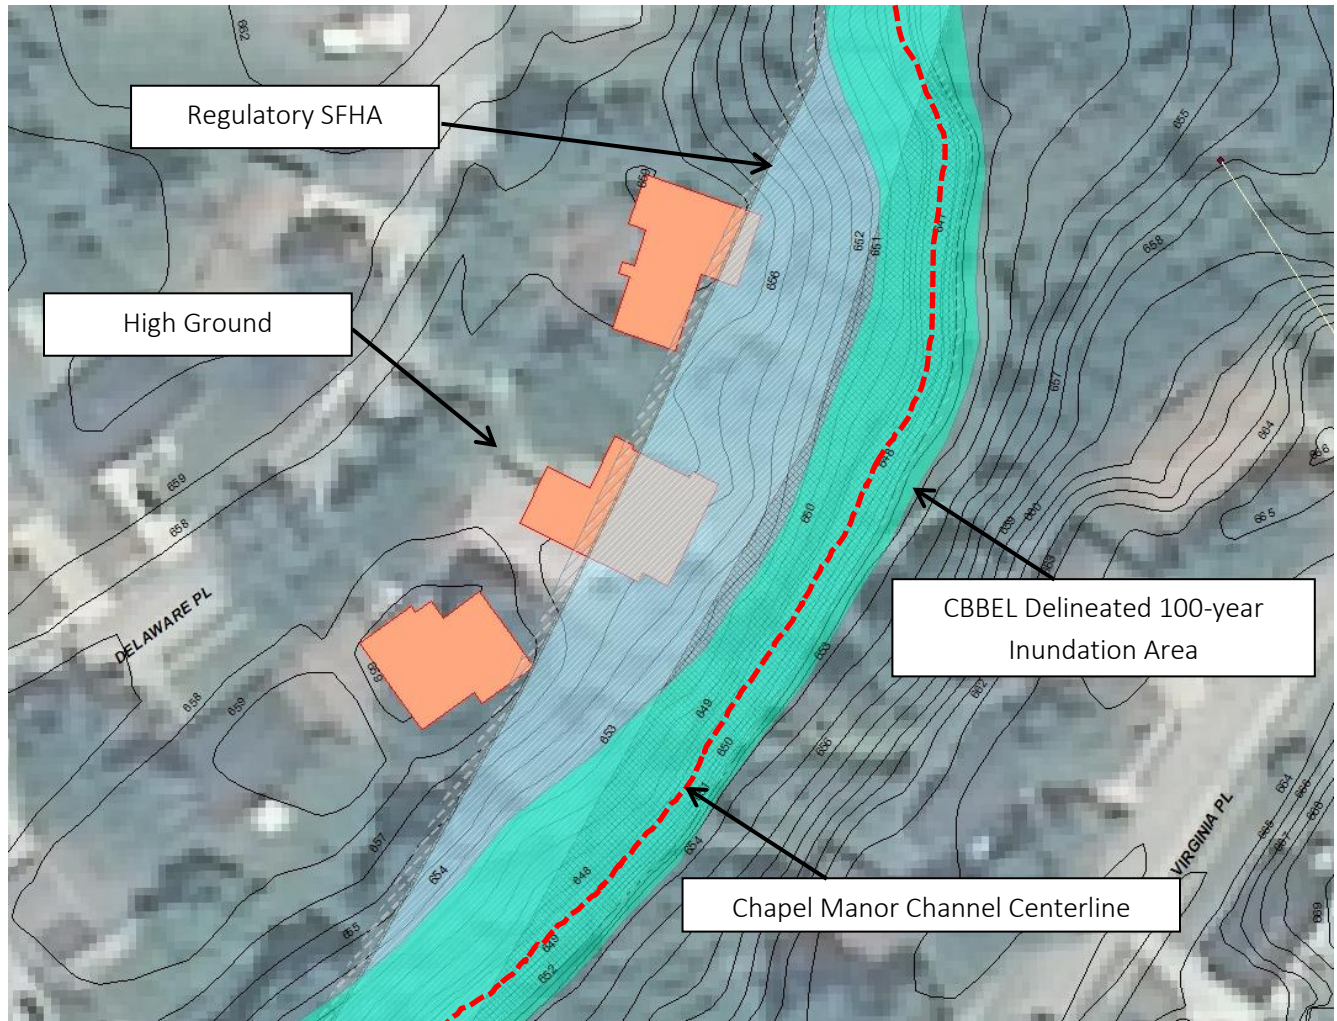
**Figure 31. Chapel Manor Subwatershed Regulatory SFHA versus CBEL 100-year Inundation Area**

An analysis of the 1-foot aerial topography reveals several locations where the channel is shown outside the floodway. There are also locations where high ground is included in the floodplain and places where low ground has been excluded. The regulatory hydraulic model for Chapel Manor is dated October, 1981, and includes minimal cross sections and may have missed topography that impacts the water surface elevations. LCSO is in the process of compiling new 1-foot aerial topography. Using the analysis created for this SWMP, the floodplain should be remapped based on current information.

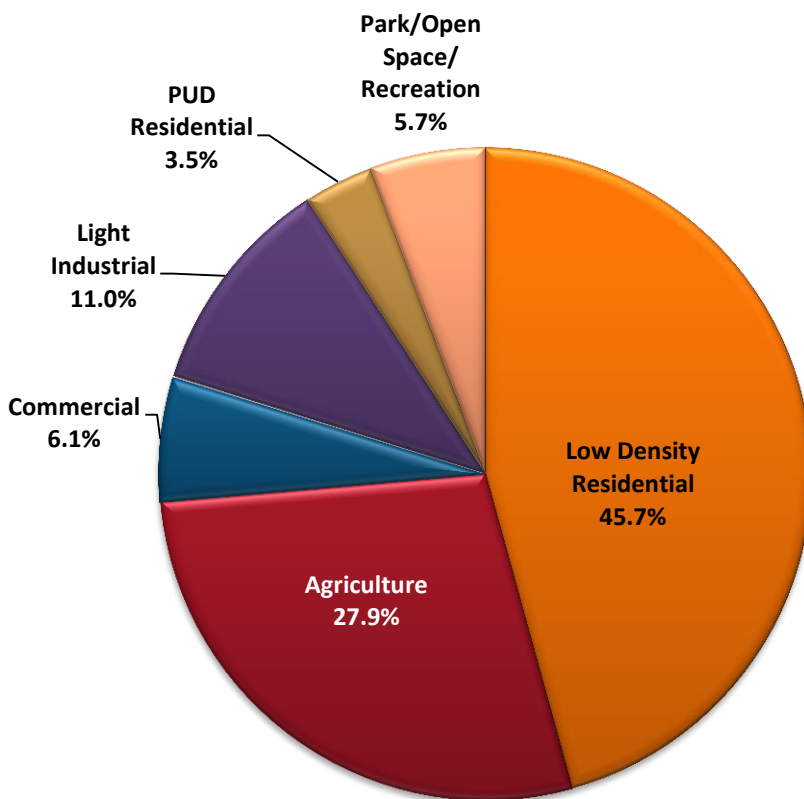
**Figure 33. West Subwatershed Land Use**

The total tributary area in the West Subwatershed is 1877 acres where 749 acres is located within the Town limits. The subwatershed land use is mostly agriculture and low density residential with a notable portion of commercial/light industrial use located predominantly along the US 30 corridor (**Figure 33**). The northern portion of the subwatershed consists of two (2) large depressions or former sand quarries located on either side of the main channel of the tributary.

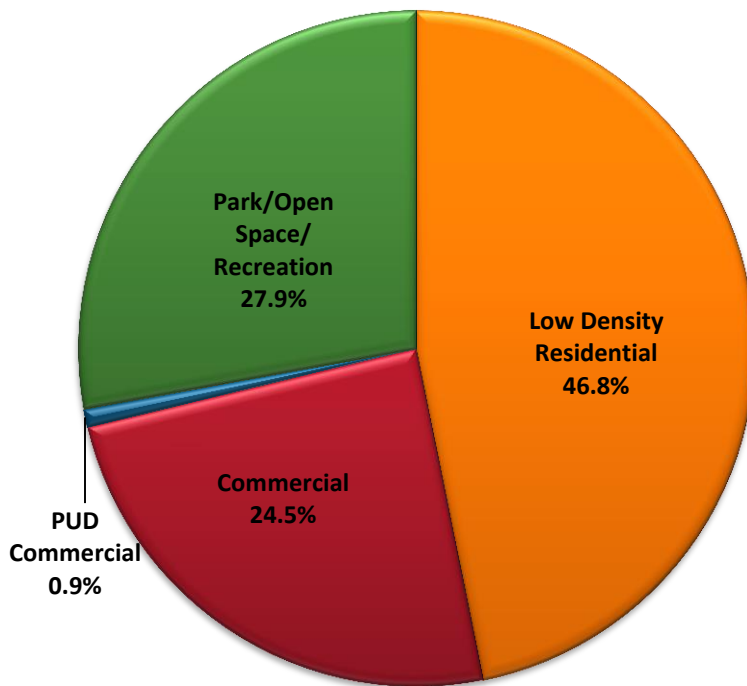
**Figure 38. North Central Turkey Creek Subwatershed Land Use**

The total tributary area in the North Central Turkey Creek Subwatershed is 931 acres of which 56 acres are located outside the Town's limits. The subwatershed land use within the Town limits is low density residential, commercial and open space (**Figure 38**). The northern portion of the subwatershed consists of open space and recreation including Hidden Lake Park and the Ross Township pond (Skinner Pond). Skinner Pond is located between 69<sup>th</sup> and 70<sup>th</sup> Place east of Clifford Peirce Middle School on Ross Township property.

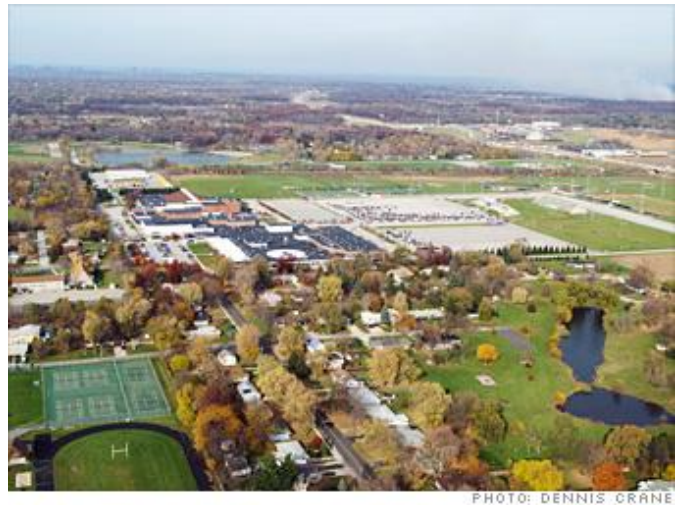
**Figure 40. Skinner Pond (Ross Township) North Central Turkey Creek Subwatershed**

Two problem areas of note in the North Central Turkey Creek Subwatershed are located at the northeast corner of Skinner Pond (Figure 40) and the intersection of Delaware Street and 70<sup>th</sup> Place. Localized street ponding occurs along Delaware Street when the storm sewers in the area reach capacity. According to the existing condition XP-SWMM analysis, Skinner Pond overtops to the northeast upon reaching capacity. The overtopping to the northeast continues north toward the Merrillville High School property and could inundate structures in the immediate areas around the northeast corner of the pond.

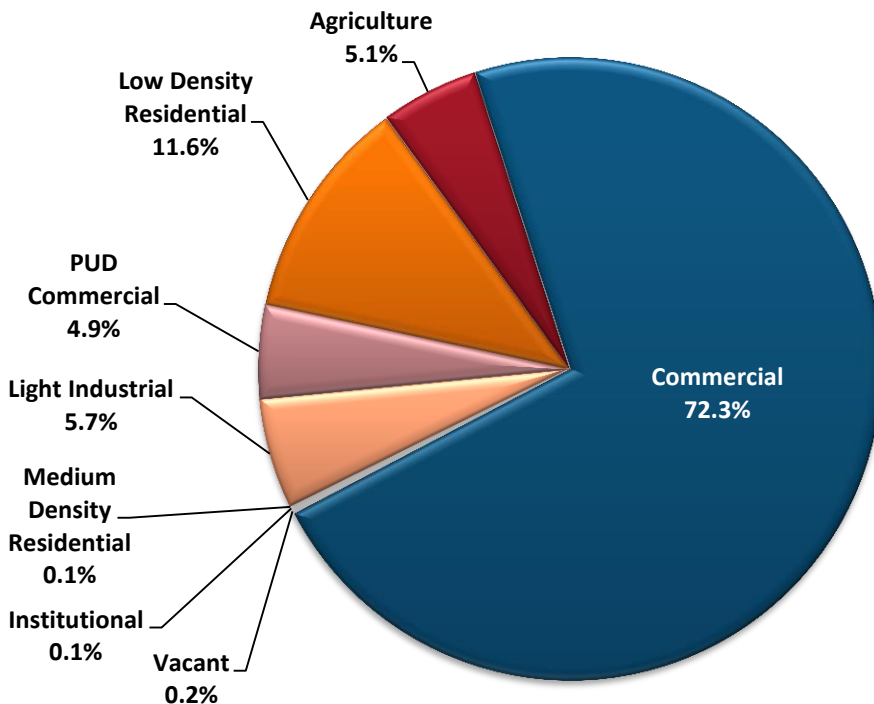
**Figure 45. Broadfield Subwatershed Land Use**

The total tributary area in the Broadfield Subwatershed is 913 acres within the Town limits. The subwatershed land use is mostly commercial and low density residential with a notable portion of commercial/light industrial use located predominantly along the Broadway corridor (**Figure 45**). The majority of the residential portion of the subwatershed is associated with the Broadfield Subdivision north of 93<sup>rd</sup> Avenue.

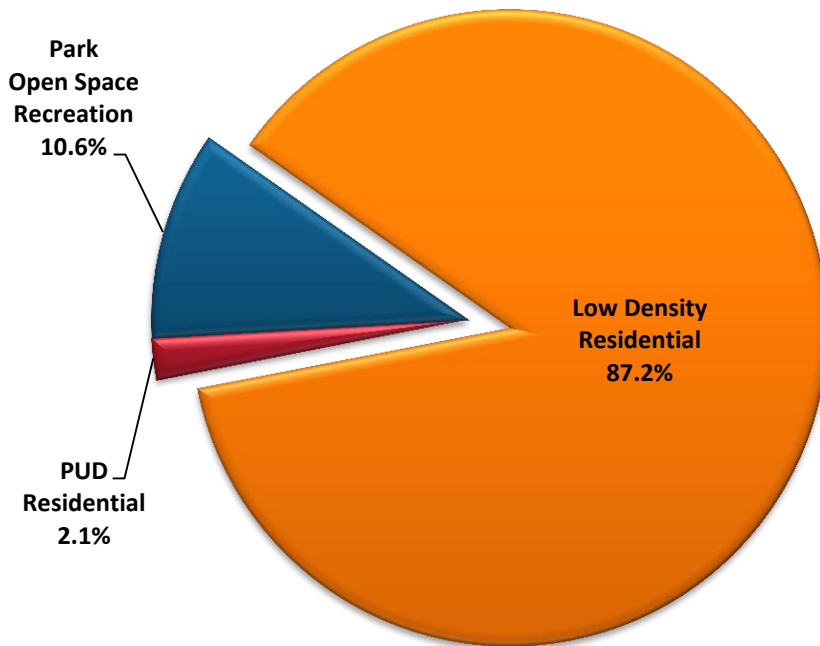
**Figure 52. Turkey Meadows Subwatershed Land Use**

The total tributary area in the Turkey Meadows Subwatershed is 483 acres, which are entirely located within the Town limits. The subwatershed land use is residential with park and open space. The subwatershed is mostly developed with the exception of the area near the abandon railway. (Figure 52).

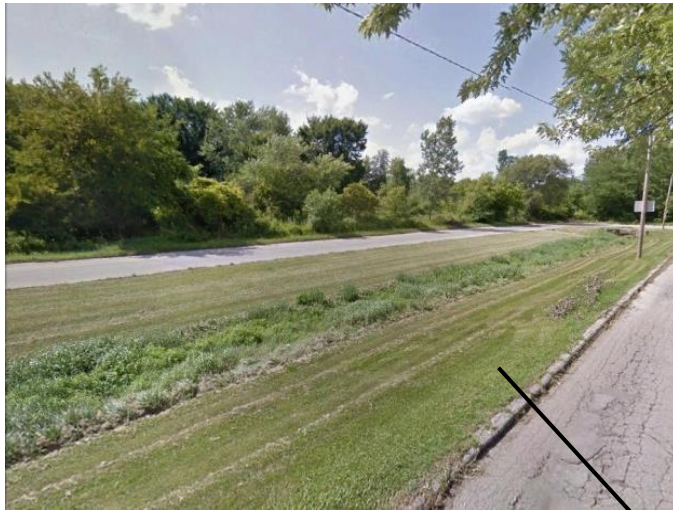
The subwatershed does not consist of a main watercourse and is almost entirely drained by storm sewers and overland flow paths. There is a section of open channel along Fillmore Boulevard in the Turkey Creek Meadows Subdivision; however no erodible velocities were shown in the channel (**Figure 55**) from the XP-SWMM analysis. A buffer has been established along the channel due to the configuration of roadway. The potential exists for a water quality sampling location at the downstream end of this open channel to represent baseline constituent levels from a subwatershed area consisting of entirely residential land use. This open channel also presents an opportunity for a pilot project to construct a “green street” or environmental roadway section with curb cuts and a native vegetated swale, which would replace the manicured lawns with native species to create a more naturalized area (**Figure 55**). Pre- and post-construction water quality sampling in the channel could be used to verify the effectiveness of the use of native species versus manicured lawns and the effect on water quality constituents from residential runoff. Continued maintenance on the open channel should remain in effect from a water quantity point of view to maintain conveyance.

**Figure 55. Fillmore Boulevard Swale**

The Turkey Meadows Subwatershed presents a very encouraging location for a pilot green street project as shown in **Figures 55 and 56**. This pilot green street project is the proposed improvement for the subwatershed.

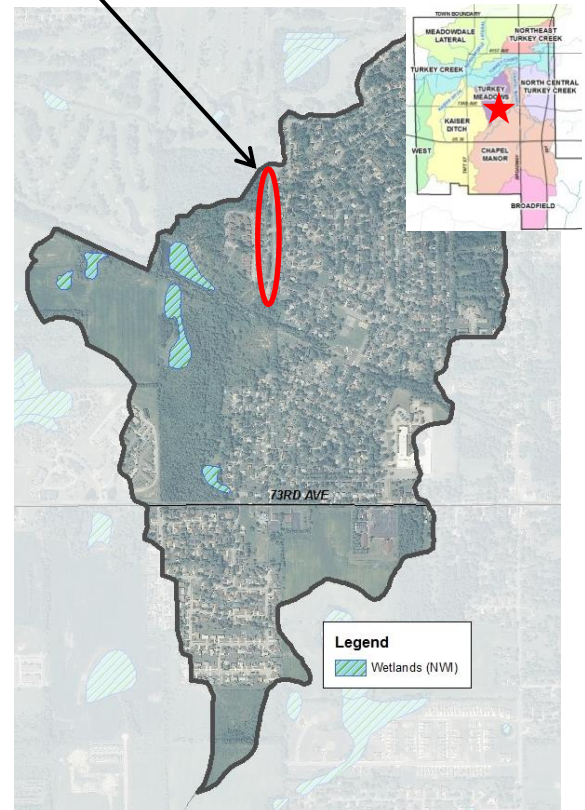
A water quality exhibit was created for the Turkey Meadows Subwatershed (**Figure 56**) using the database Water Quality Hot Spots layer in the master GIS database. The subwatershed figure does not indicate any instances of water quality hotspots, and data from IDEM and EPA exists. There are multiple wetland complexes in the areas near the abandoned railway in the west portion of the subwatershed. These complexes likely exist due to the depressional storage created from the railway embankment. This area also consists of forested areas and is currently undeveloped.

**Figure 56. Turkey Meadows Subwatershed Environmental Concerns**

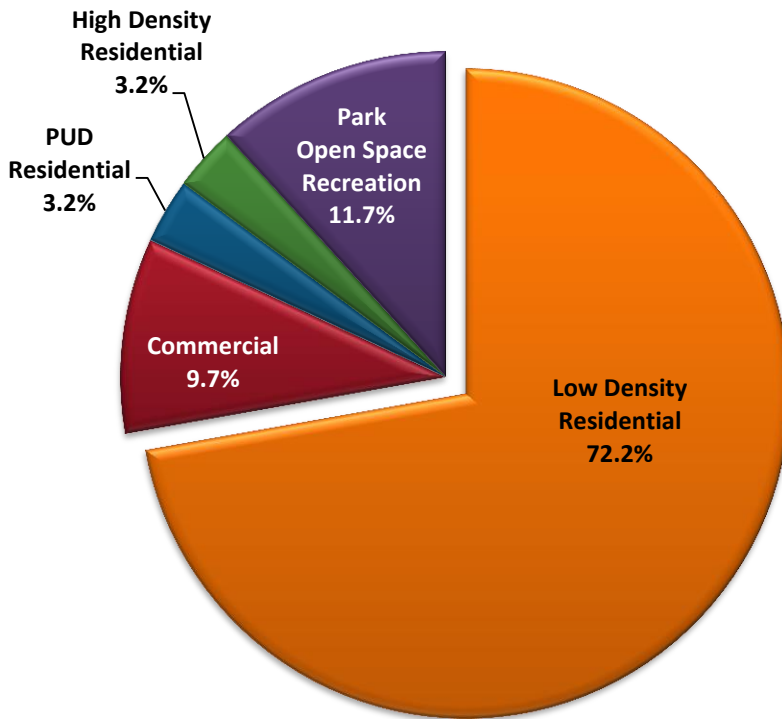
**Figure 58. Northeast Turkey Creek Subwatershed Land Use**

The total tributary area in the Northeast Turkey Creek Subwatershed is 566 acres of which six (6) acres are located outside the Town's limits. The subwatershed land use within the Town limits is low density residential, commercial and open space (Figure 58). The Broadway and 61<sup>st</sup> Avenue corridors in the subwatershed consist of the commercial areas with locations of high density residential areas. The northeast and west portion of the subwatershed is largely undeveloped.

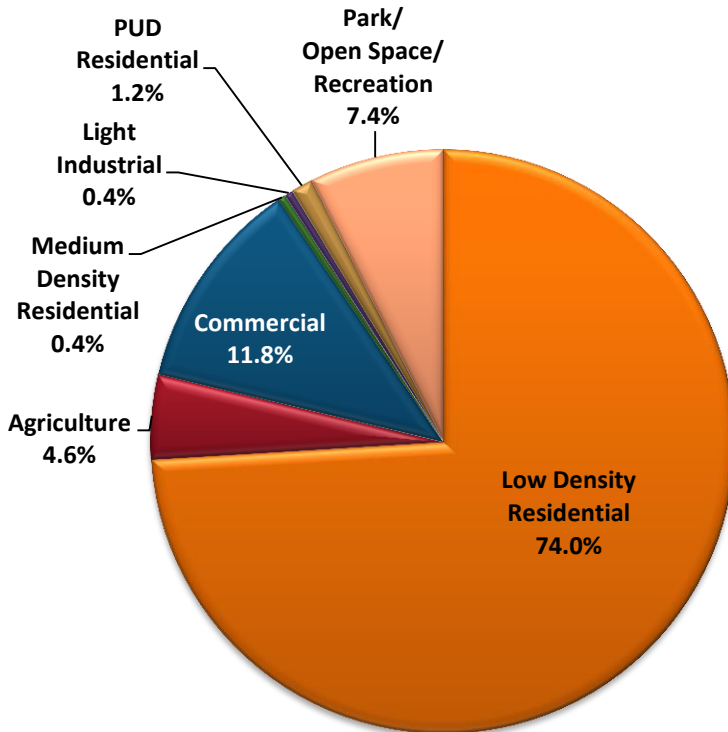
**Figure 64. Turkey Creek Subwatershed Land Use**

The total tributary area in the Turkey Creek Subwatershed is 1,584 acres. This is the total tributary area to this subwatershed as delineated for the purposes of the SWMP, within the Town. The total tributary area to Turkey Creek within the Town limits includes all of the subwatersheds in this SWMP with the exception of the Broadfield Subwatershed. The land use in the subwatershed is mostly residential and includes the Innsbrook Subdivision, Innsbrook Country Club and the Turkey Creek Golf Course.
