A Guide to the Indian-Cahokia Creek Watershed

MADISON COUNTY, ILLINOIS

THE INDIAN-CAHOKIA CREEK WATERSHED & THE PLAN

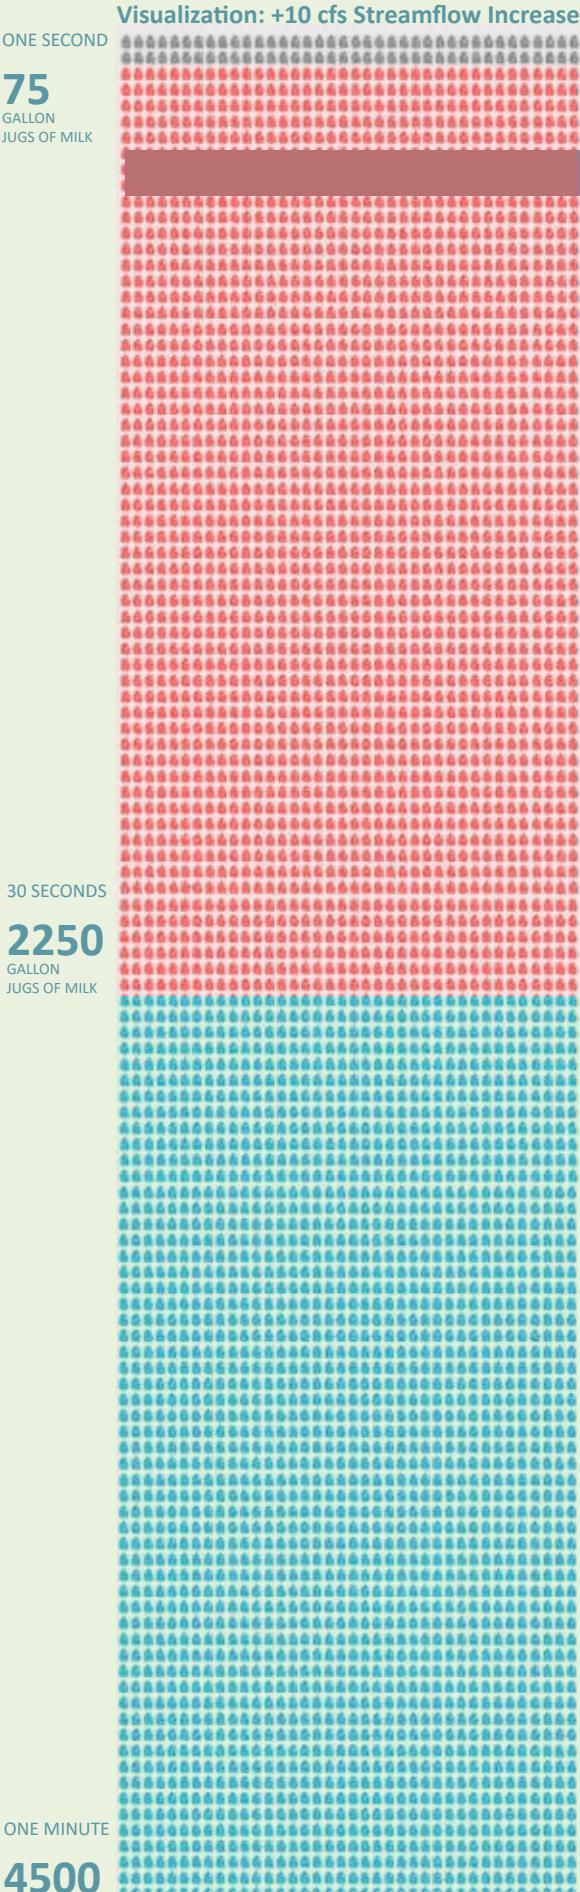
From 1941 to 2016, the average annual volume of water (velocity) passing through Indian Creek has increased 10 cubic feet per second (cfs). The infographic to the left demonstrates the exponential streamflow increases.

- To visualize a 10 cfs increase in Indian Creek streamflow, imagine 75 one-gallon milk jugs of water pouring through a creek in one second. The graphic to the left demonstrates one second, 30 seconds, and one minute totalling 4,500 gallon milk jugs of *additional* water.
- In 10 minutes, that amount flowing through the creek would equal 45,000 gallons (milk jugs) of water on top of regular stream flows- that is 10x the graphic to the left.
- In one hour, that amount would equal 270,000 gallons at a weight of 2,249,100 lbs.
- In a 24 hour period, that amount would equal 6,480,000 gallons.

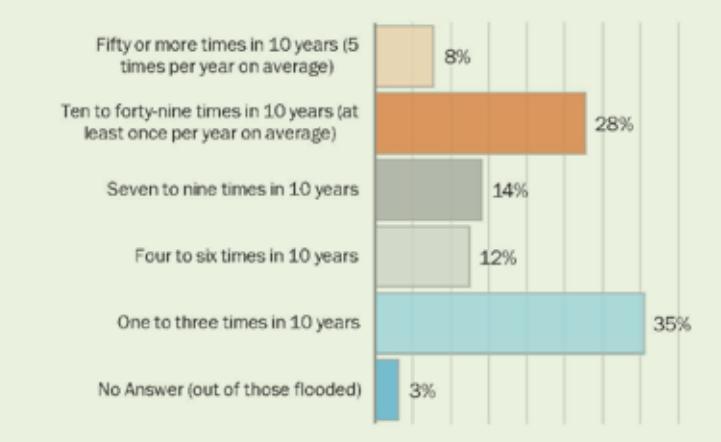
Frequency of Survey Responents' Flooding over 10 years.

In 2015, Madison County conducted a flood survey. Respondents in the watershed reported 69 floods per year outside the federally designated floodplains.

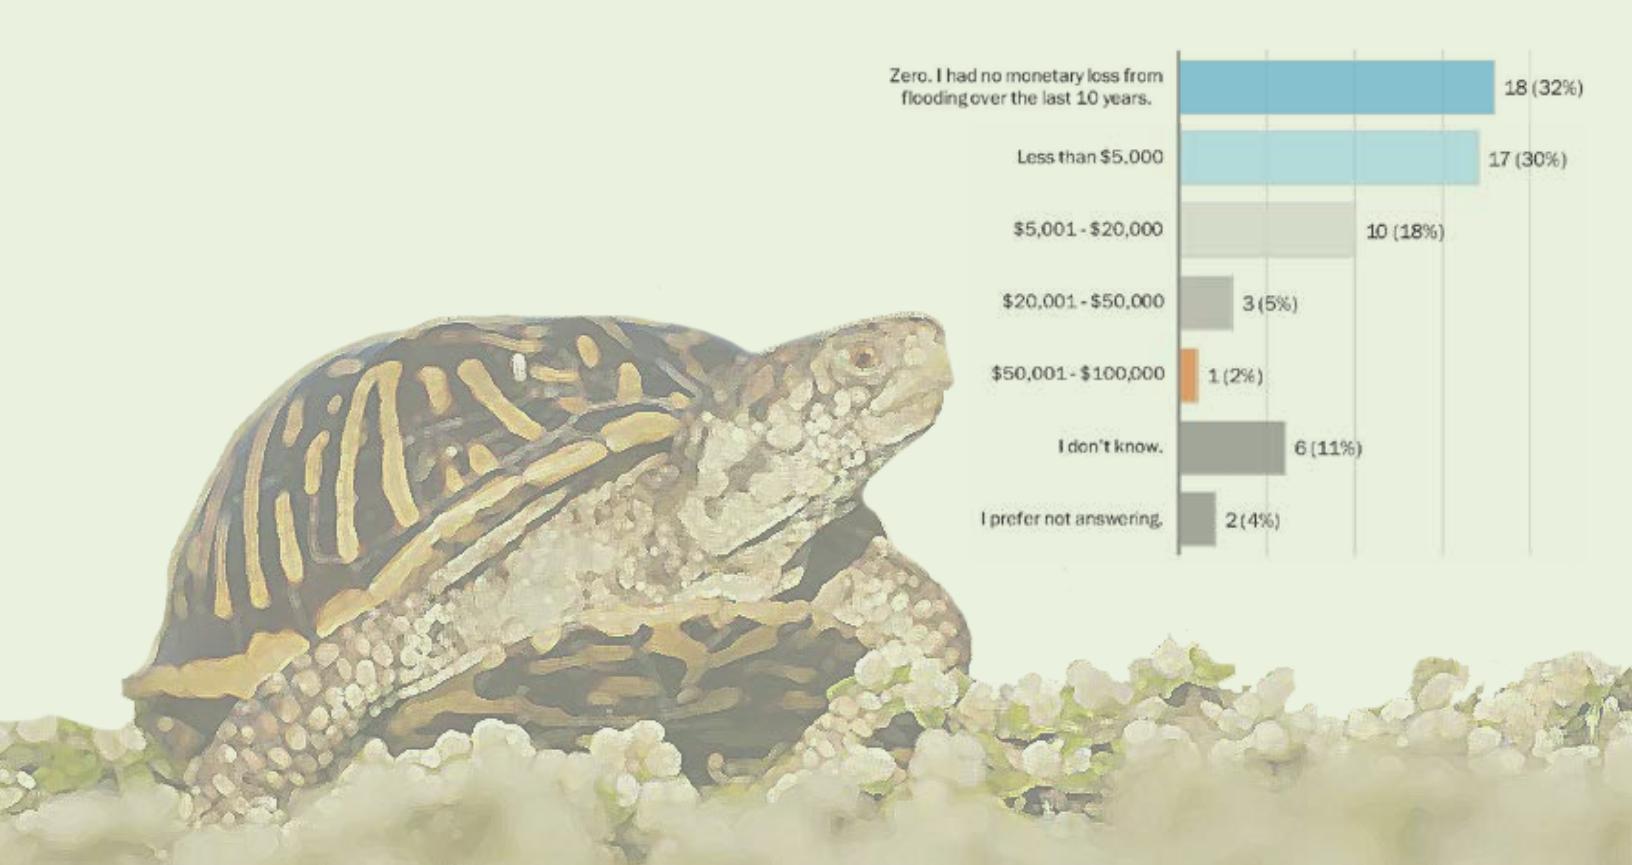
Costs Associated with Respondents' Flooding over the last 10 years.

Flooding and water pollution can have significant impacts on the watershed's residents. It is estimated that flooding cost residents \$12.8 million over a 10-year time span.

Flooding has also caused stress, loss of property access, lost business income, crop damage, and replacement costs of buildings and structures.

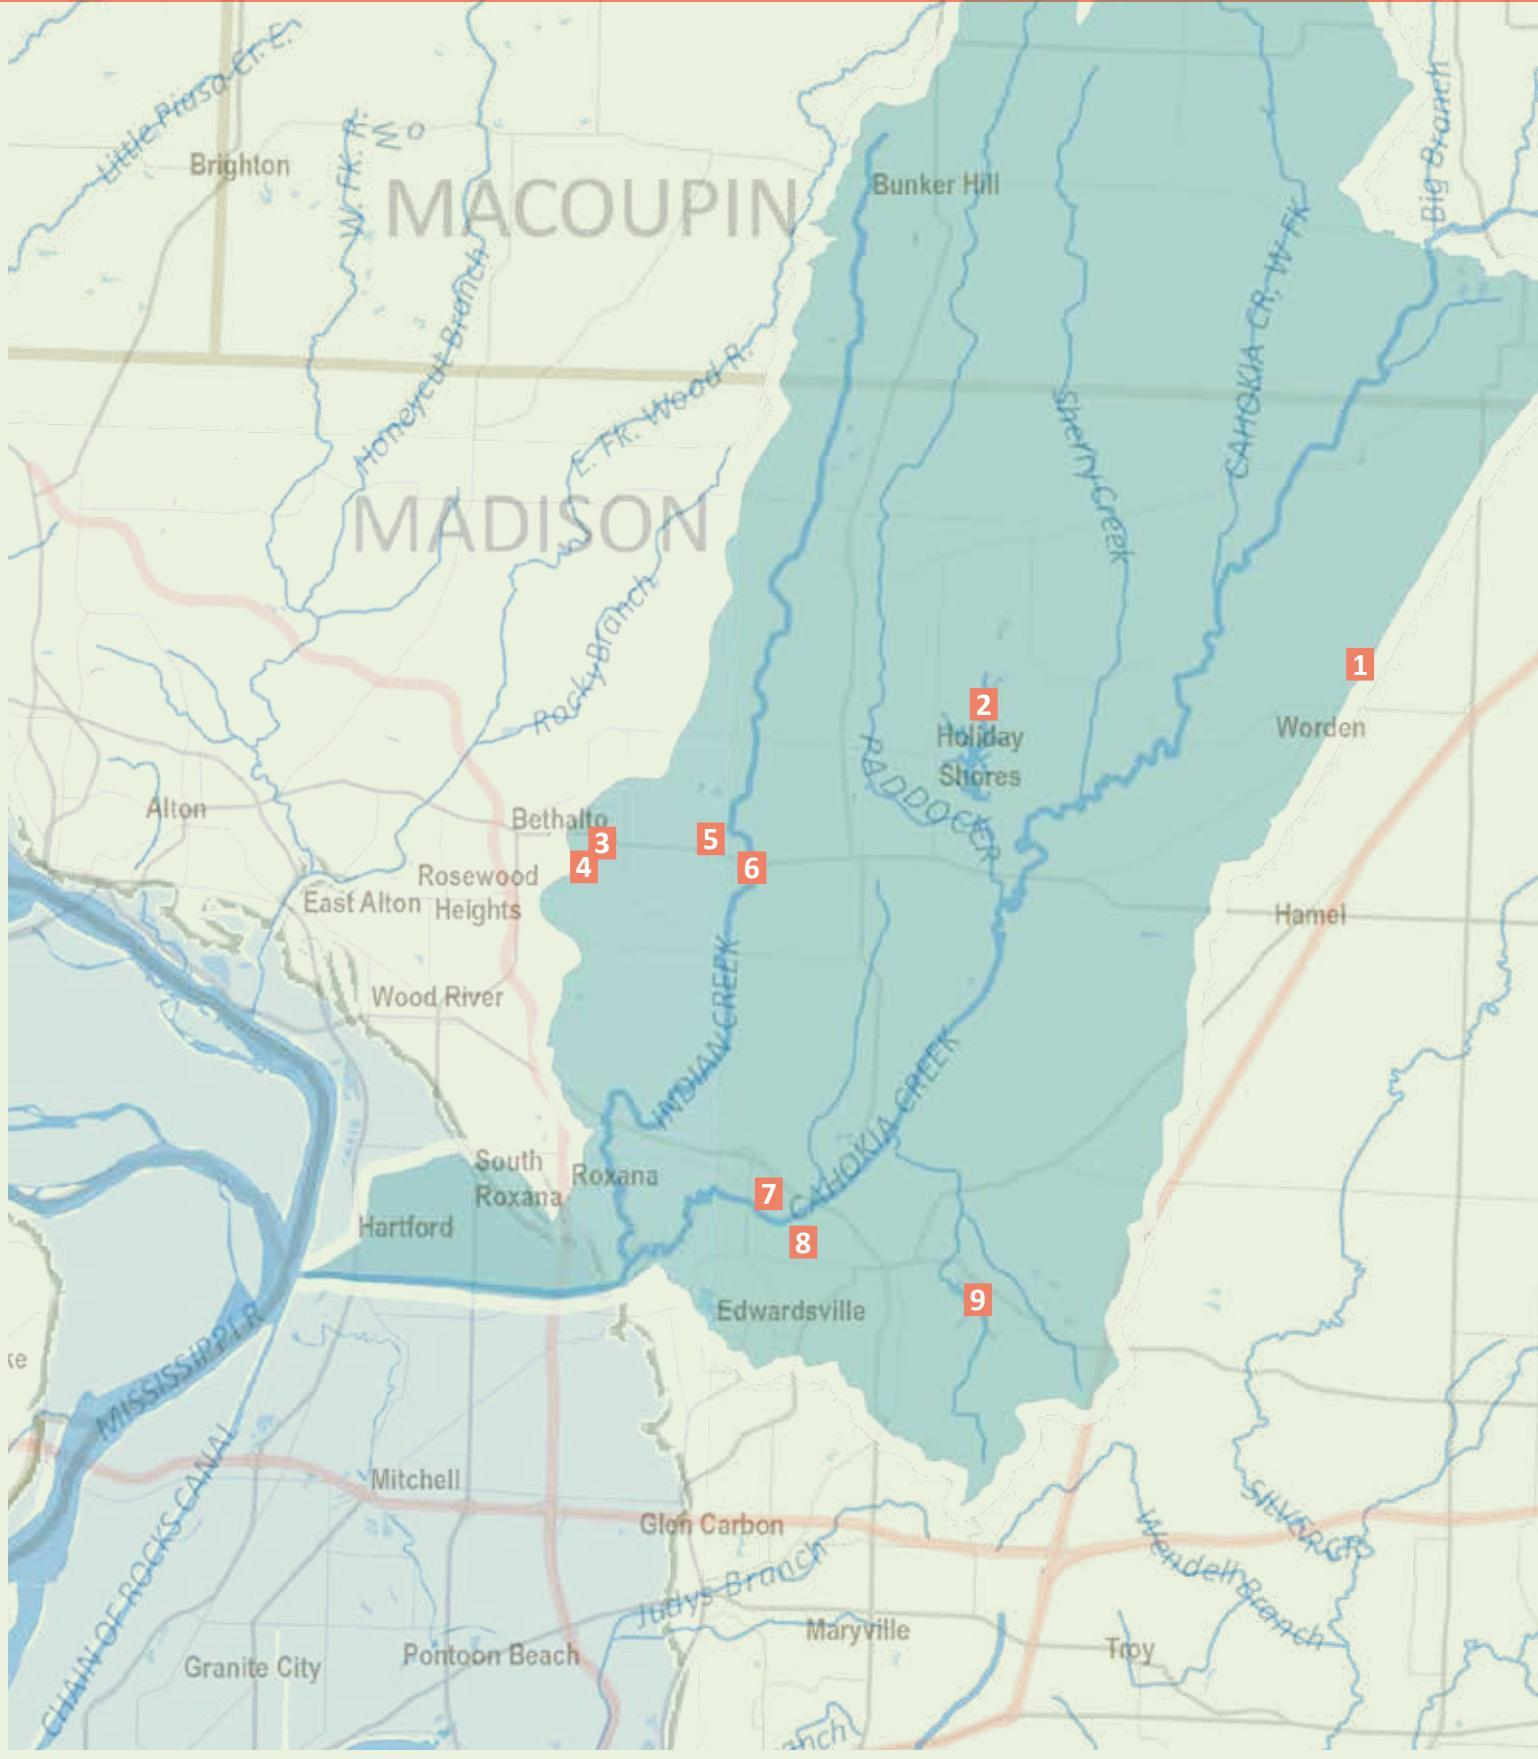
PROPOSED PROJECTS WITHIN THE WATERSHED

Nine specific project locations were identified in the watershed. These projects address life safety issues and multiple goals of the plan by implementing a variety of Best Management Practices. Madison County can use this short list to help communities and landowners in the watershed address needs identified in the stakeholder engagement process.

The following specific project locations are listed and numbered from north to south (not in order of priority).

- [2] Holiday Lake Flooding
- [3] Sewer Discharge into Ditches by Route 140 in Bethalto
- [4] Runoff from St. Louis Regional Airport (Bethalto)
- [5] Meadowbrook Flooding
- [6] Flooding On Route 140 at Indian Creek (Bethalto)
- [7] Flooding at Route 143, Route 159, & Old Alton Edwardsville Rd.
- [8] Flooding at The Watershed Nature Center
- [9] Dunlap Lake Siltation, Flooding, and Water Quality
