A Guide to the Canteen-Cahokia Creek Watershed

MADISON COUNTY, ILLINOIS

THE CANTEEN-CAHOKIA CREEK WATERSHED & THE PLAN

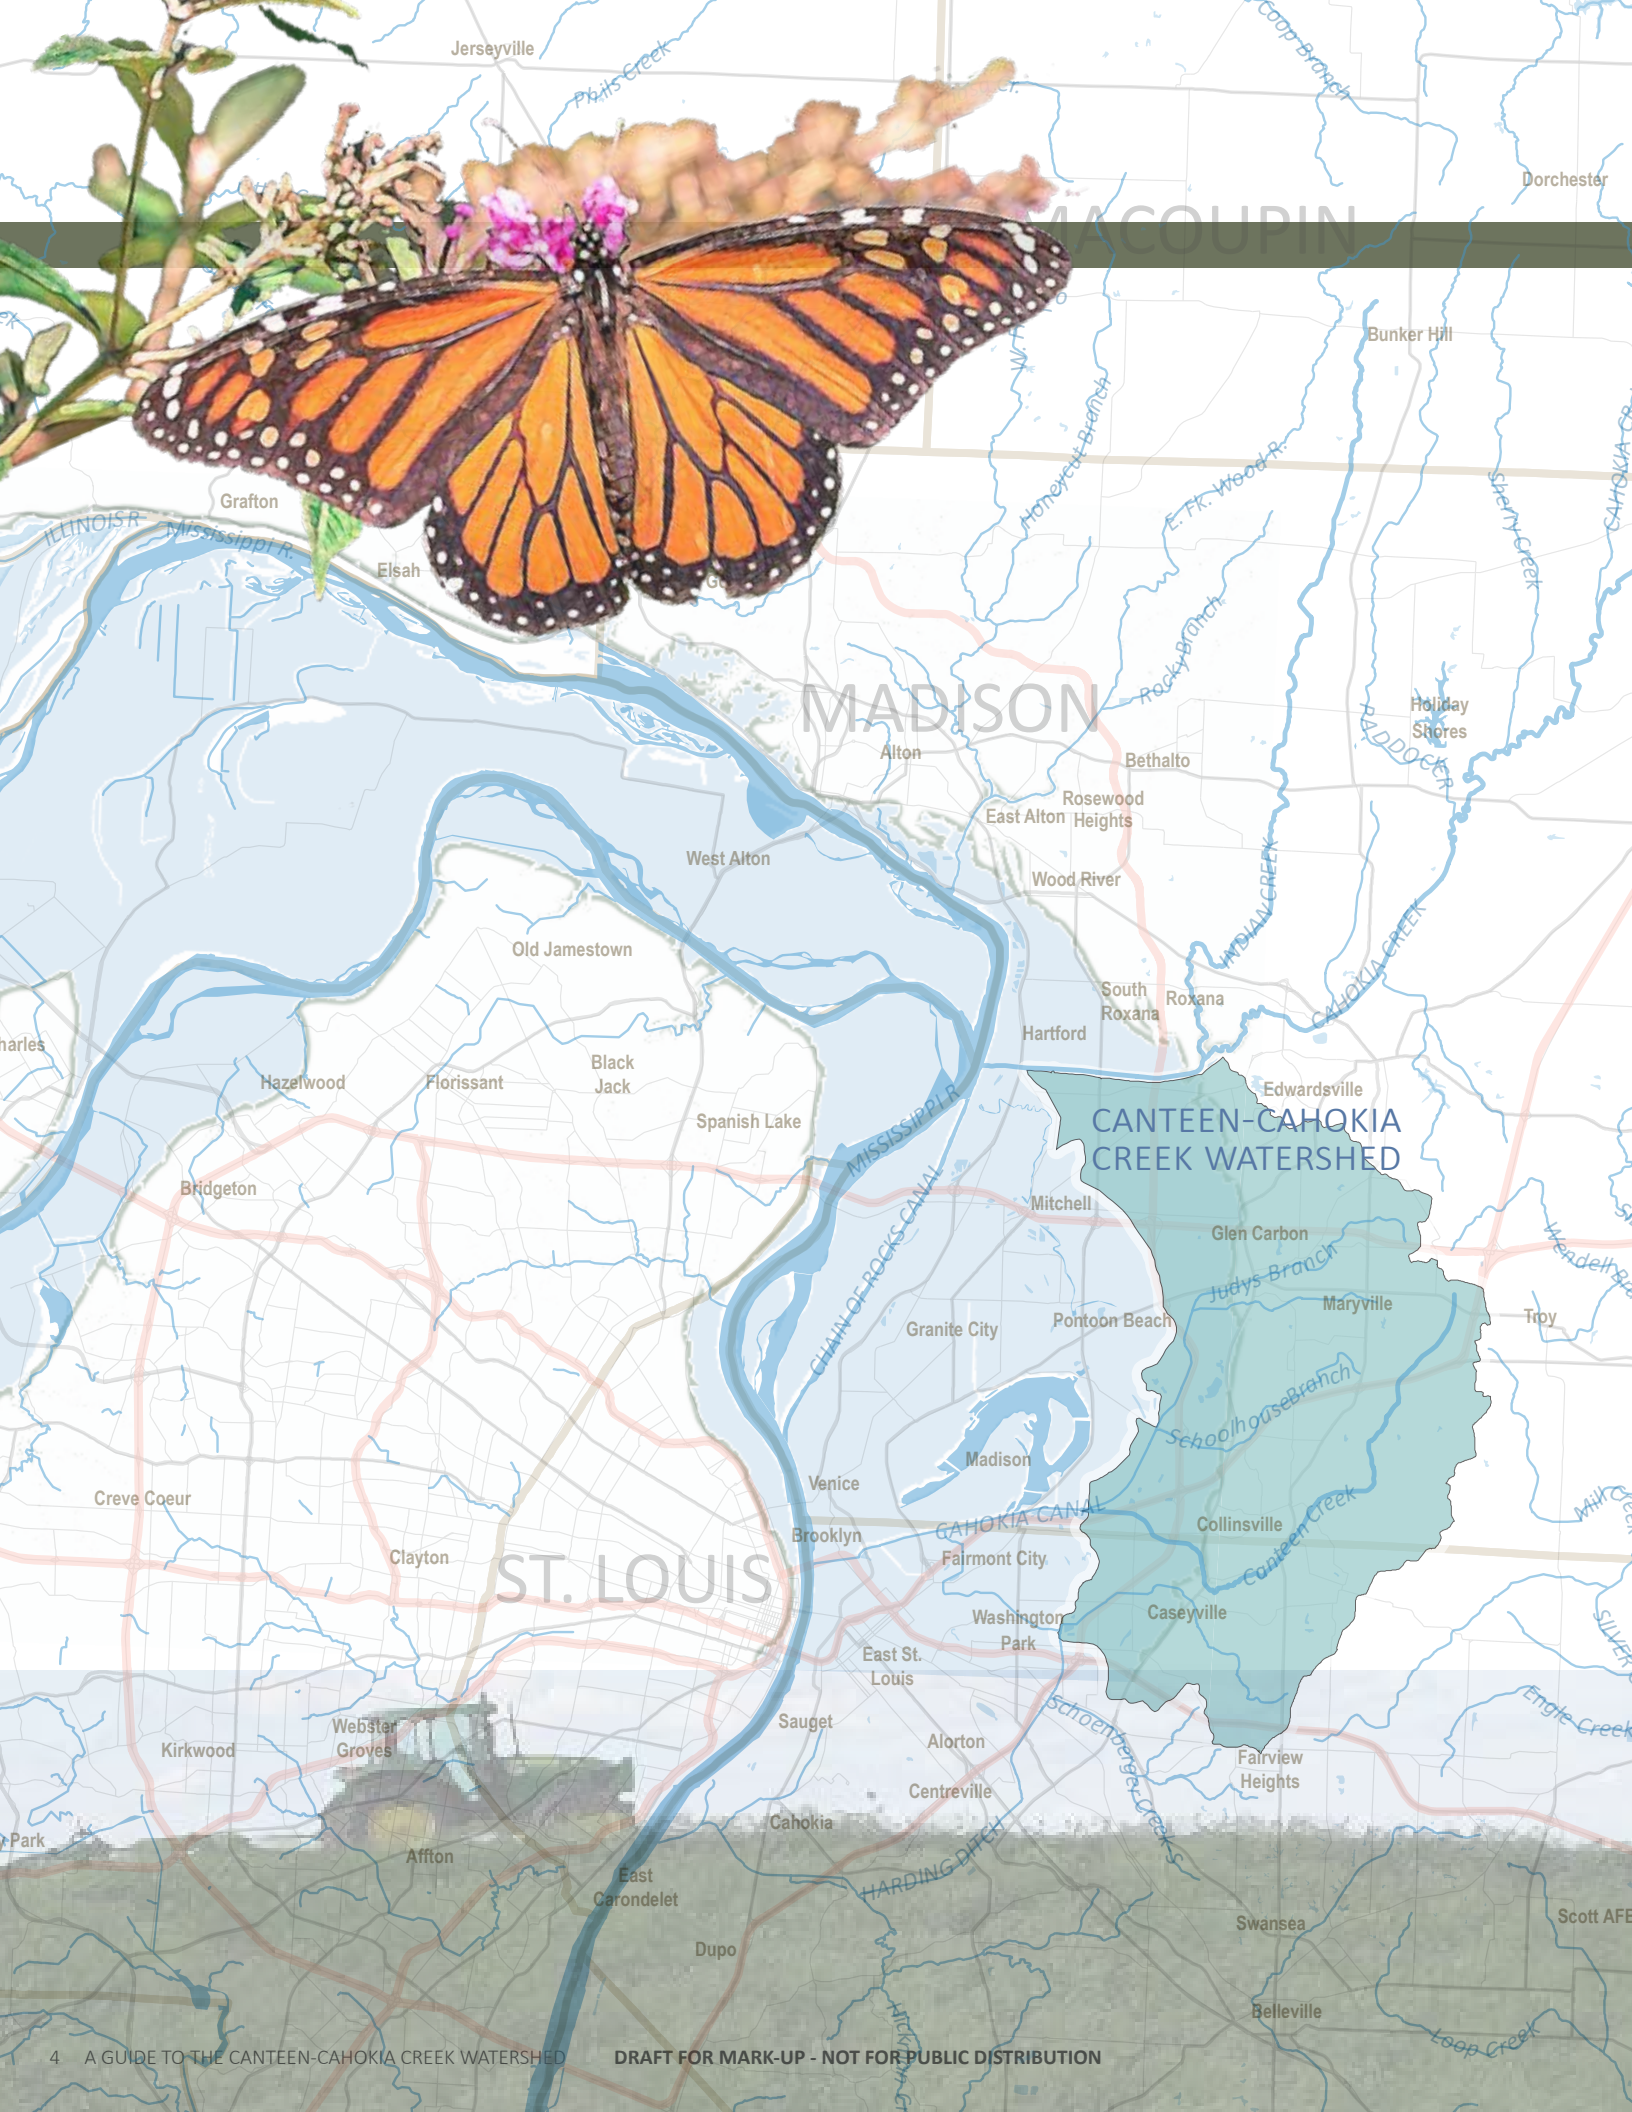
A map of the Canteen-Cahokia Creek Watershed in Madison County, Illinois. The map shows the watershed boundary in red, with major roads and towns labeled. Towns include Livingston, Worden, Hamel, Collinsville, Edwardsville, Glen Carbon, Maryville, Pontoon Beach, South Roxana, Troy, and Caseyville. The map also shows the Mississippi River to the east and various creeks and streams within the watershed, including Big Branch, Little Silver Creek, and East Branch Little.

Water in the Canteen-Cahokia Creek watershed generally flows east to west and south to north. Water flow starts from the top of the bluffs and drains into the Cahokia Diversion Channel before emptying into the Mississippi River.

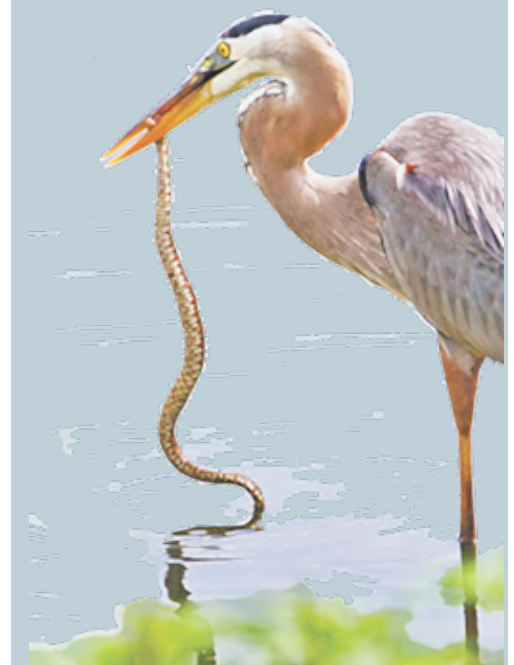
AVG IN WATERSHED (2018)	TARGET AMOUNT	
Dissolved Oxygen (DO)

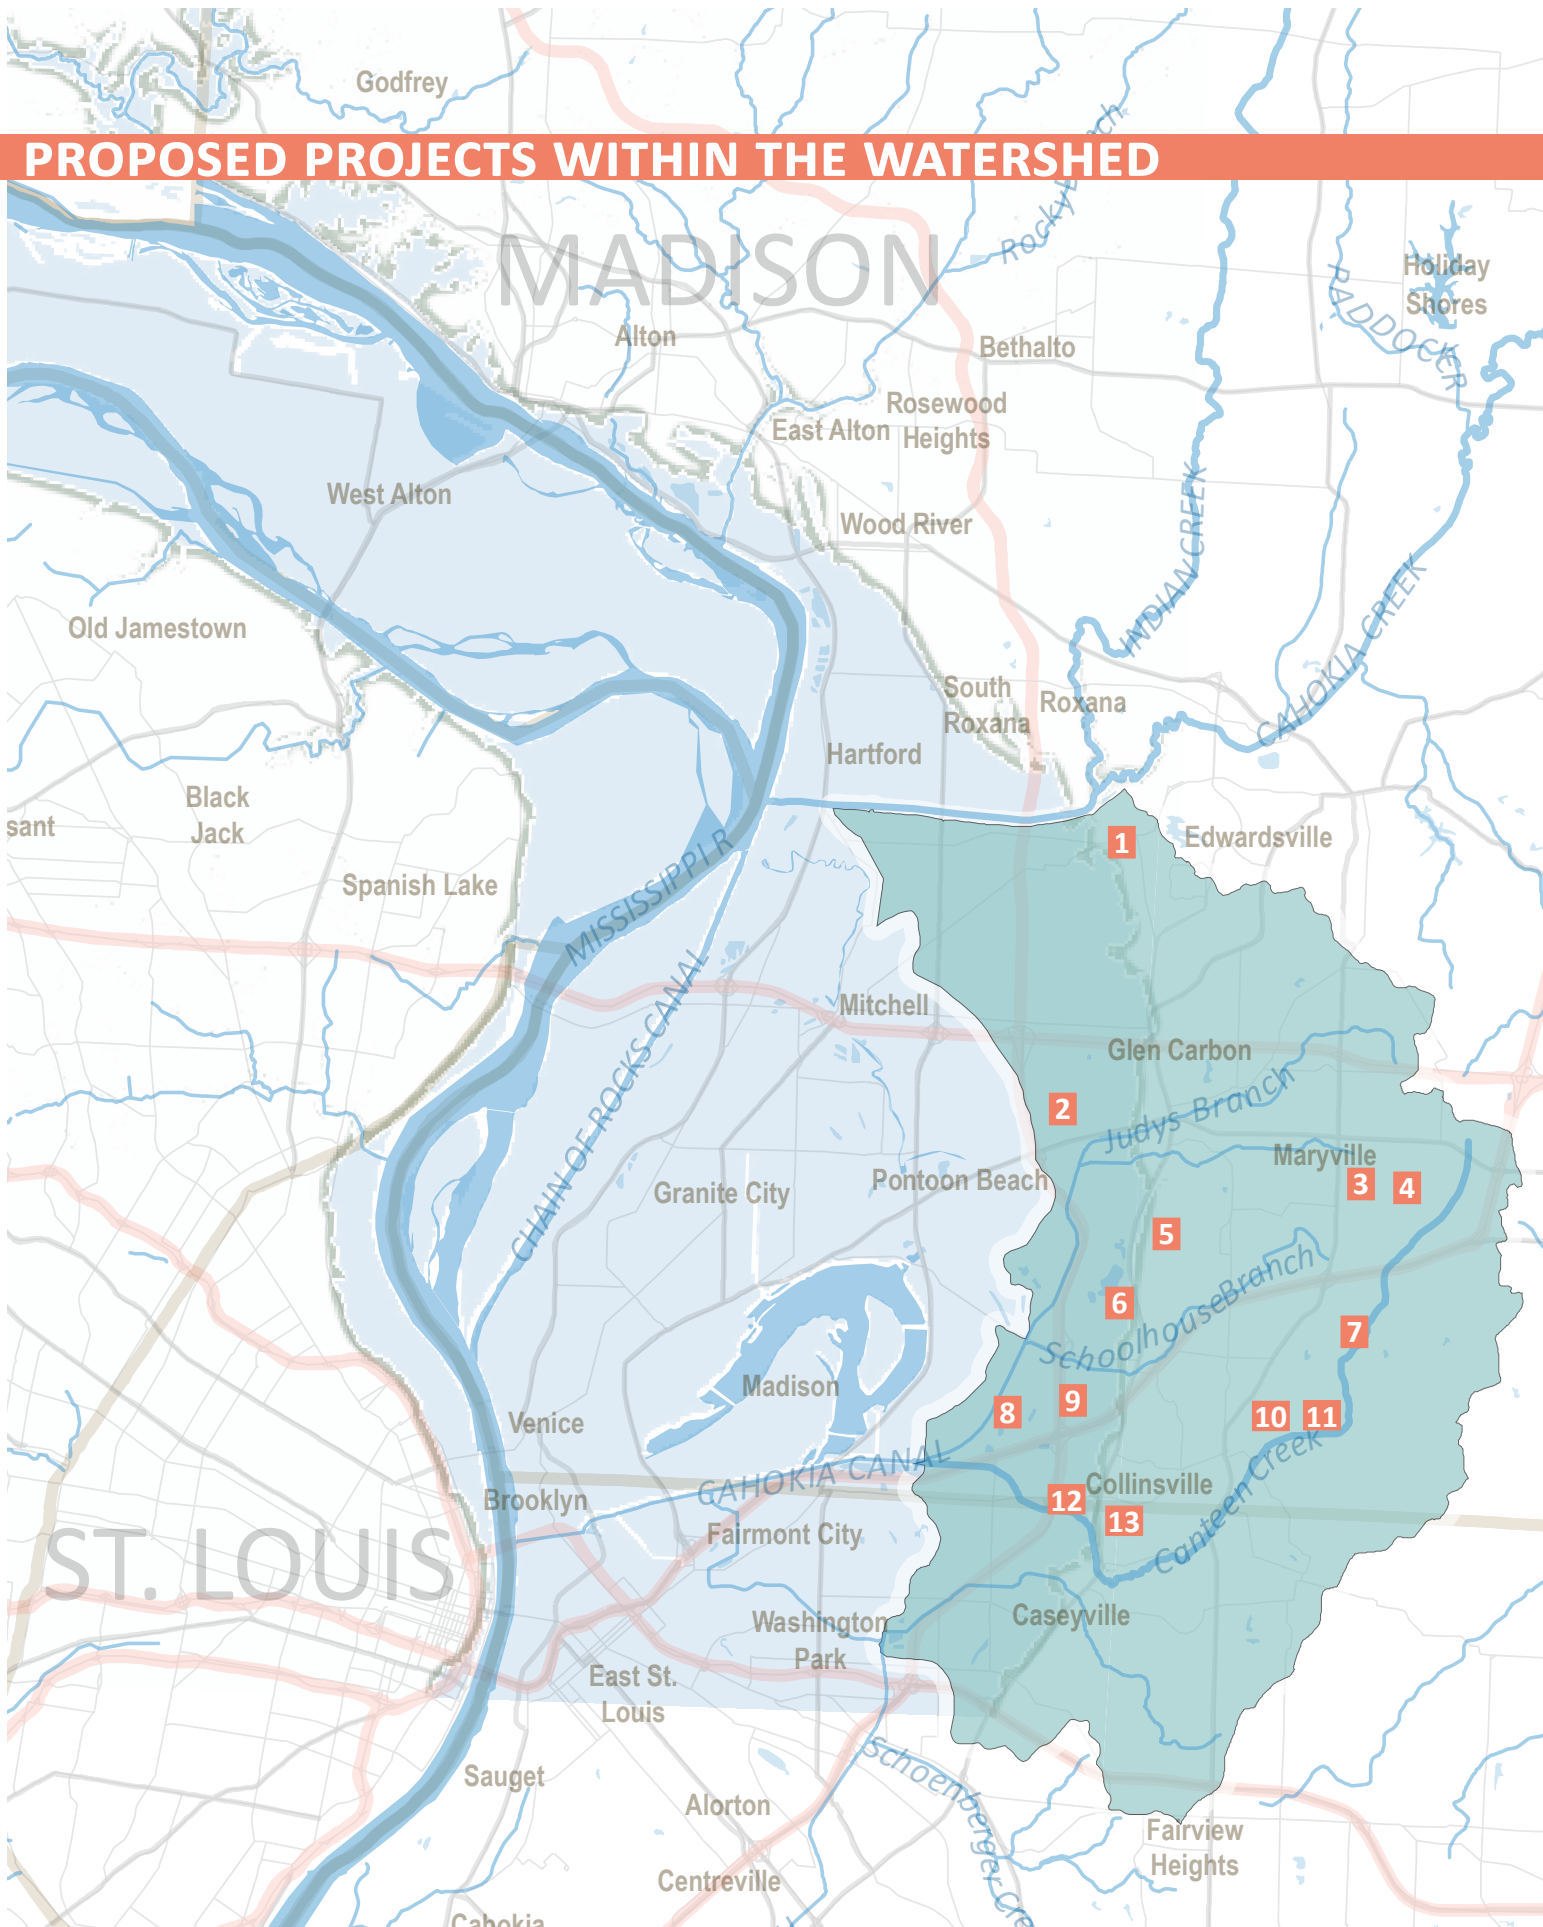
SPECIFIC PROJECT LOCATIONS

- [1] Old Cahokia Creek
- [2] County Ditch Erosion and Siltation
- [3] Retention Basin (Maryville)
- [4] Burdick Branch
- [5] Sugar Bend Subdivision (Collinsville)
- [6] McDonough Lake Flooding
- [7] Canteen Creek Erosion and Flooding (Collinsville)
- [8] Brushy Lake
- [9] Schnieder Ditch
- [10] Flooding Of Lebanon Rd Near Branch Rd
- [11] Canteen Creek Tributary Pollution
- [12] State Park Place Flooding
- [13] Canteen Creek West of Route 157

Thirteen specific project locations were identified in the watershed plan. These projects address life-safety issues and multiple goals of this plan by implementing a variety of Best Management Practices. Madison County can use this short list to help communities and landowners address the needs identified in the stakeholder engagement process.
